TECHNICAL BULLETIN

Ref Document No.	TB15008	Issue No.	1
Subject	Throttle Pedal Spring		
Release Date	21 st December 2015

Purpose – Advise COALTRAM® owners/operators of a change to the torsion spring used to return the throttle pedal to idle.

Applicability – All in service COALTRAM® models CT08, CT10, CT10LP and CT13.

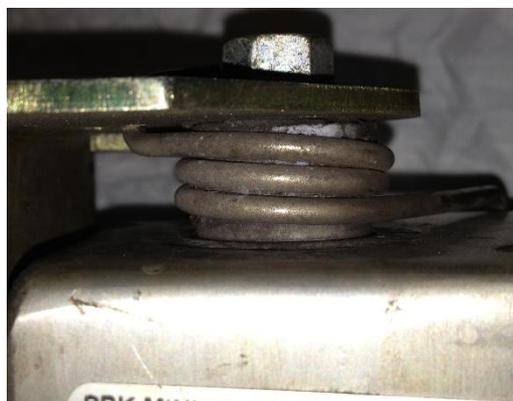
Figure 1: Old spring with 2 full coils (3 visible strands)

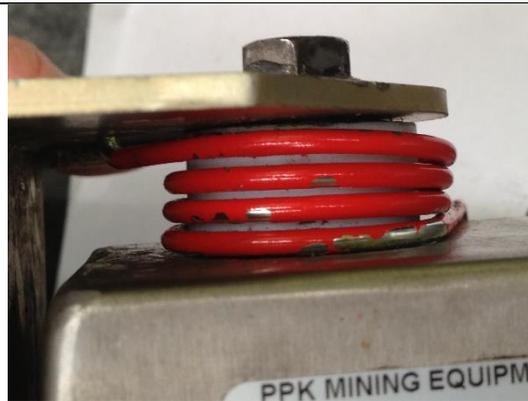
Figure 2: New spring with 3 coils (4 visible strands)

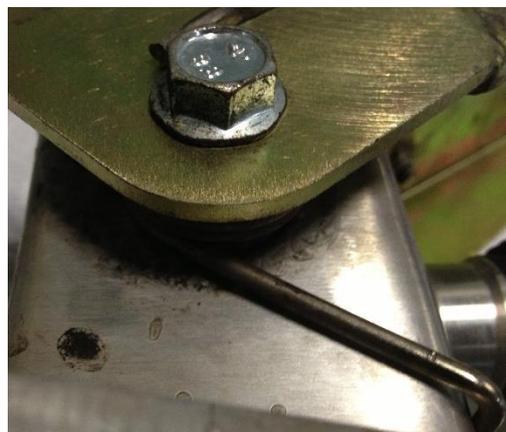
Figure 3: Old spring - small diameter coil (does not extend out to edge of pedal)

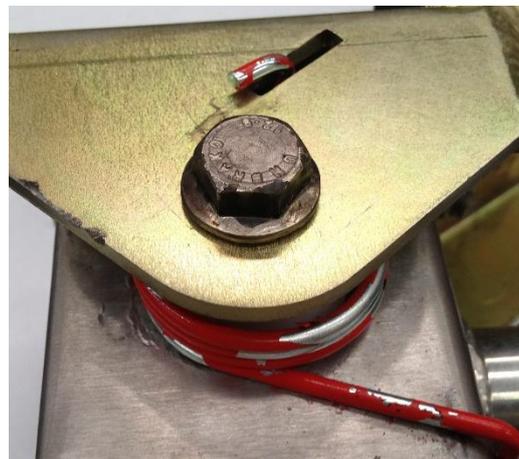
Figure 4: New spring larger coil diameter (almost lines up with edge of pedal)
