# TECHNICAL BULLETIN

Ref Document No.	TB15003	Issue No.	1
Subject	Accelerator pedal position sensor - Hardware upgrade		
Release Date	12/03/15		
Associated Bulletins	TB15001, TB15002

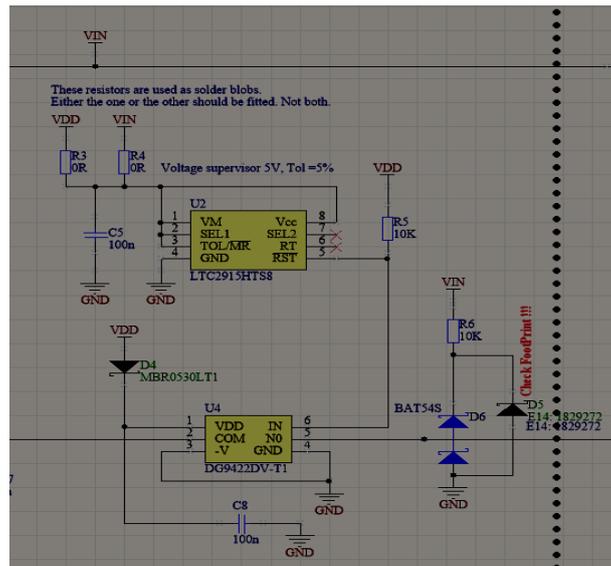
A design modification commenced with the intension of monitoring the incoming supply voltage and blocking return currents on the signal line. Tests were conducted with a voltage monitor and analog switch modified into the existing electronic circuit. The intended protection against unstable supply and erroneous signal line reverse currents were achieved with the intended circuits.

A supplementary certification of the new sensor with the additional circuits is now in place. The certificate is attached. The following figure depicts the circuit improvement.
