## TECHNICAL BULLETIN

Ref Document No.	TB15004	Issue No.	1
Subject	Throttle Cover		
Release Date	6 <sup>th</sup> May 2015

**Purpose** – Advise COALTRAM® owners/operators of the impact holding a magnet against the throttle pedal sensor housing.

**Applicability** – All in service COALTRAM® models CT08, CT10, CT10LP and CT13

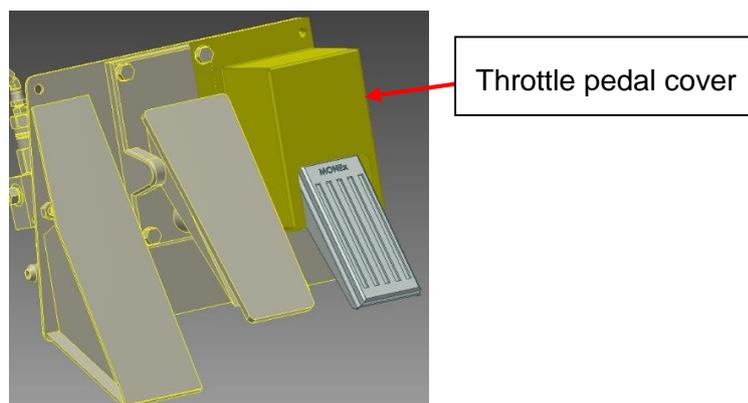
Figure 1: throttle pedal cover installed

Upon request PPK have designed a cover that can be attached to the pedal assembly. The cover, made from mild steel, creates a gap around the throttle pedal sensor housing sufficient that the magnetic field, from a relatively strong magnet, is dissipated to a point that it does not affect the throttle sensor. Below is a model image showing the throttle pedal cover in yellow.

1. PPK recommends Coaltram owners/operators conduct a site based risk assessment to determine if the cover is required throttle sensor is required.
2. Install label 5520009578 if deemed necessary.
3. If cover is deemed necessary and installed - add removal of cover and clean to monthly/250 hour service schedule. Parts required for cover:
  - 1 off throttle pedal shroud (Part # 5520009569)
  - 1 off throttle pedal shroud under plate (Part # 5520009570)
  - 4 off M4 nyloc nut (Part # 3015)
4. The components will be available 18<sup>th</sup> May 2014.
