1 Overview

Date of Notification	17 th September 2013
Component Affected	MONEx Part 11019 Throttle Sensor
Certified Part	12505
Customer Part	5520002123
Batch Affected	11019-1 to 11019-182 11019-184 11019-190 to 11019-193

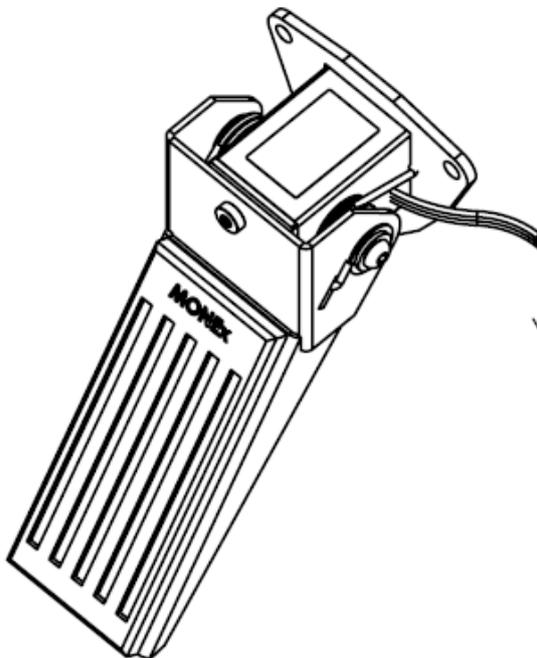
The throttle sensor is fitted with a double torsion return spring. The spring ensures the pedal returns to the idle position when released.

Evidence has been found of the spring cracking or breaking on one or both sides after various periods of operation in the field.

The throttle pedal may fail to reliably return to idle position causing engine speed to remain high even after the throttle is released.

1. Inspect all throttle sensors springs for cracks or breaks at next 2000 hour service. It should be noted that one side of the spring may fail and the throttle will remain functional. However, throttles should be returned for repair with any sign of spring crack or breakage.
2. Return any throttle sensor in the affected serial number range for spring replacement.

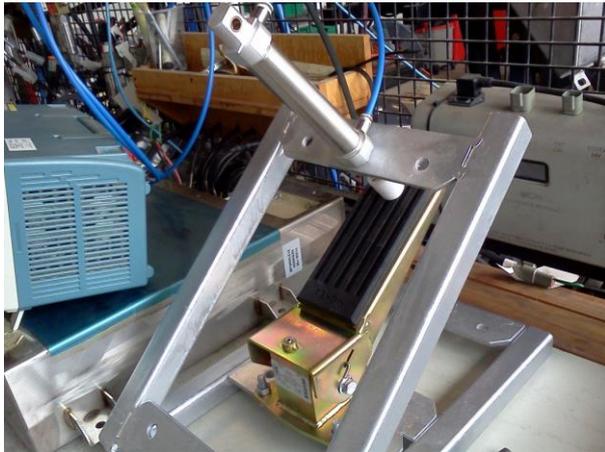
A test jig was constructed which fully operated the throttle and recorded spring images every 10 cycles.

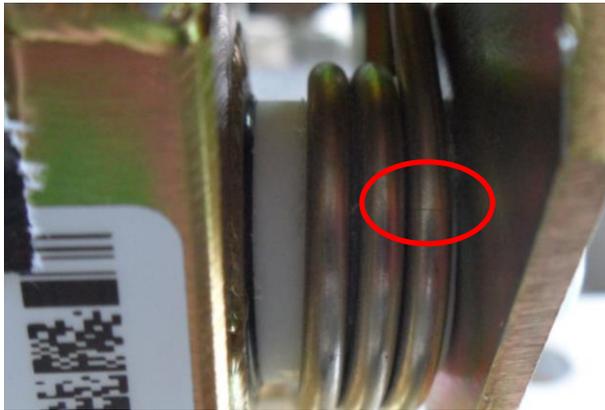
1. First crack appears at around 110,700 cycles

The spring cracks and break are consistent with those observed in returned throttles from the field. This confirmed the root cause as fatigue failure of the spring material.

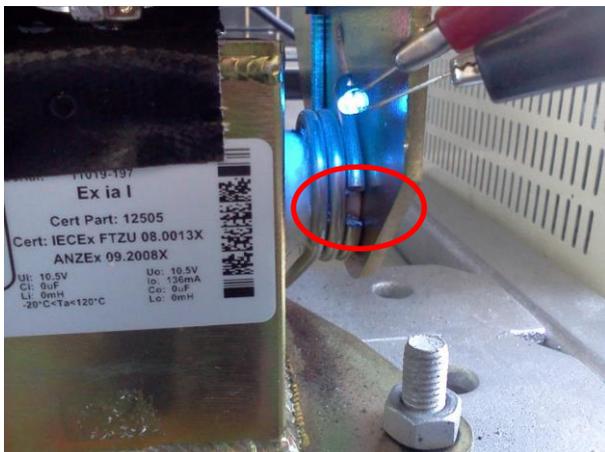
2. Second crack appears at around 230,700 cycles
3. First break-off at 502,240 cycles

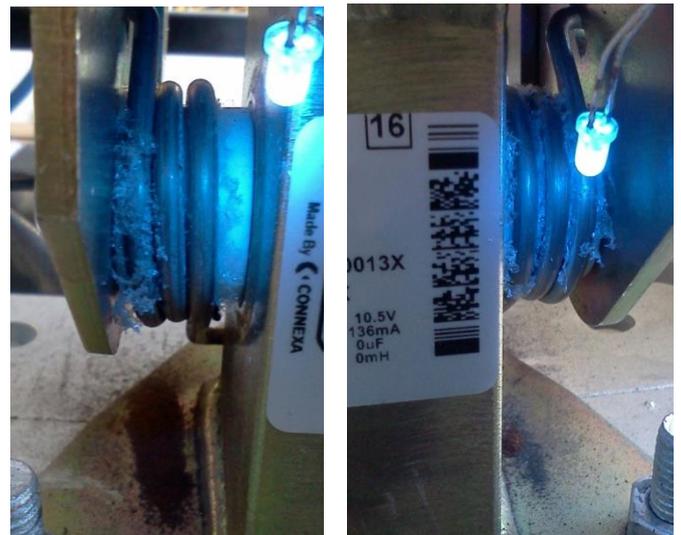
Further cycle tests were conducted for the new spring. Test completed with no sign of failure on duplex spring after 1,000,000 cycles.

Some feathering of the Teflon bushing was observed but the throttle continued to operate normally.

A new spring material was finally selected which offered superior elastic properties in the required range with maintained corrosion resistance.
