# TECHNICAL BULLETIN

Ref Document No.	TB14002	Issue No.	Rev 1
Subject	Throttle Sensor		
Release Date	3 <sup>rd</sup> July 2014

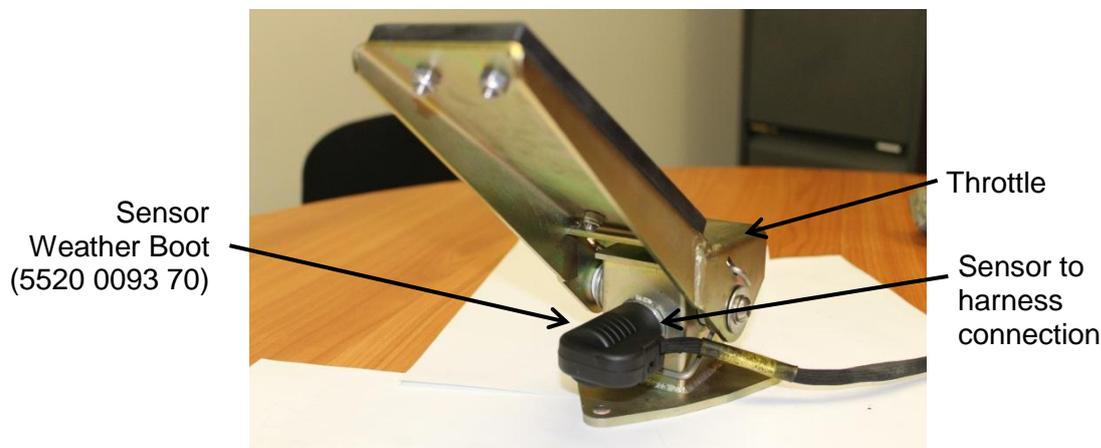
The investigation found the root cause of the throttle disconnection to be a loose connection at the deutsch plug connection between the throttle and the cable harness.

- PPK will continue to investigate a reduction in time to return engine to idle if the signal between the throttle sensor and ECUEX is lost.
- OEM service sheets call for the inspecting condition and integrity of all MONEx electrical components (existing).
- The throttle sensor to wiring harness connection can be fitted with a Sensor Weather Boot to assist in providing an increase in protection to the connector and cable. This cap is similar to that used on other sensor connections though includes a drain hole so it cannot act as a reservoir (part number 5520009370). This is shown in the image below.
