TECHNICAL BULLETIN

Ref Document No.	TB15005	Issue No.	1
Subject	Turbo Impacting on Methane Junction Box Mounts		
Release Date	20 th October 2015

Purpose – Advise COALTRAM® owners/operators of the possibility of the turbo impacting with the methane junction box mounts.

Applicability – All in service COALTRAM® models CT08, CT10 and CT10LP.

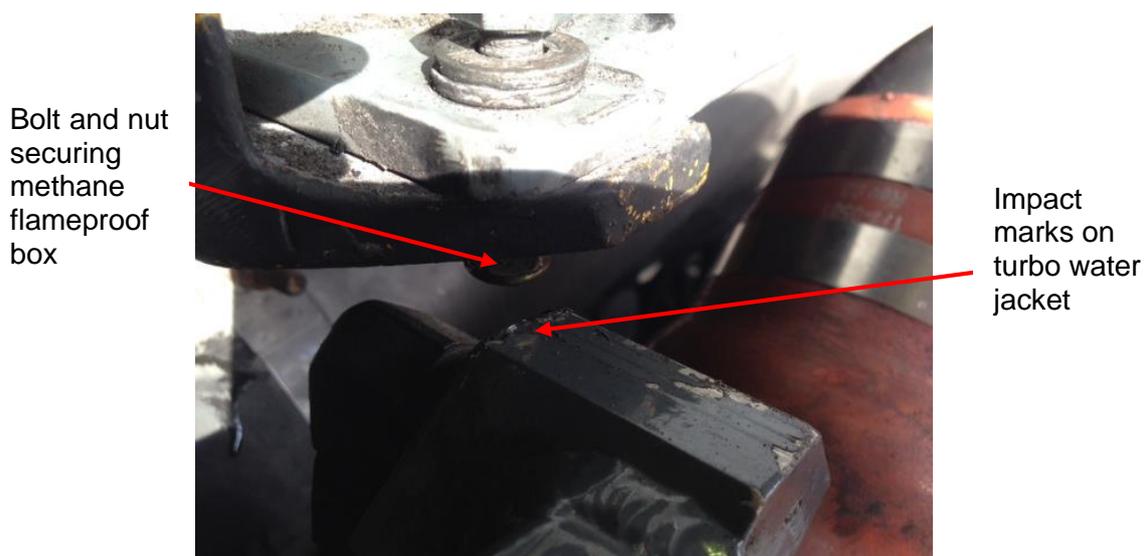
Impact marks were found on the turbo inlet snail water jacket. From the turbo's close proximity to the methane flameproof box mounting bracket it was determined that it had been frequently coming into contact with the nut and bolt that secure the methane system flameproof box to its mounting bracket (see Figure 1 and 2 below).

Impact marks on turbo water jacket

The impacts have been caused by the proximity of the methane flameproof box to the turbo. The engine mounts allow some movement of the engine to absorb vibration and engine torque. The resulting movement has allowed the turbo to impact with the methane flameproof enclosure. The engine mounts were inspected and deemed to be in an acceptable condition.

It is believed that the impact between the turbo and the mounting bolt and nut caused additional unforeseen stress on the joint causing the studs to come loose.

1. PPK recommends Coaltram owners/operators inspect their Coaltrams at the next available service for impact between the turbo intake water jacket and the methane system flameproof box bracket and securing fasteners.
2. If there are impact marks present between the turbo water jacket and mount bracket or fastener, or the gap between them is 10mm or less PPK recommend carrying out the modifications as shown above at the next convenience.
3. If the turbo is impacting on the fastener only, the fastener should be removed until the riser plates can be installed.
4. Please contact your PPK service centre for the modification to be carried out if required, or follow SWP CT8.34 for the recommended installation procedure. Parts required: Methane cover (5520002654), methane riser brackets (5520009767 & 5520009768) and M8x25 bolts (4 off – 0147132503).

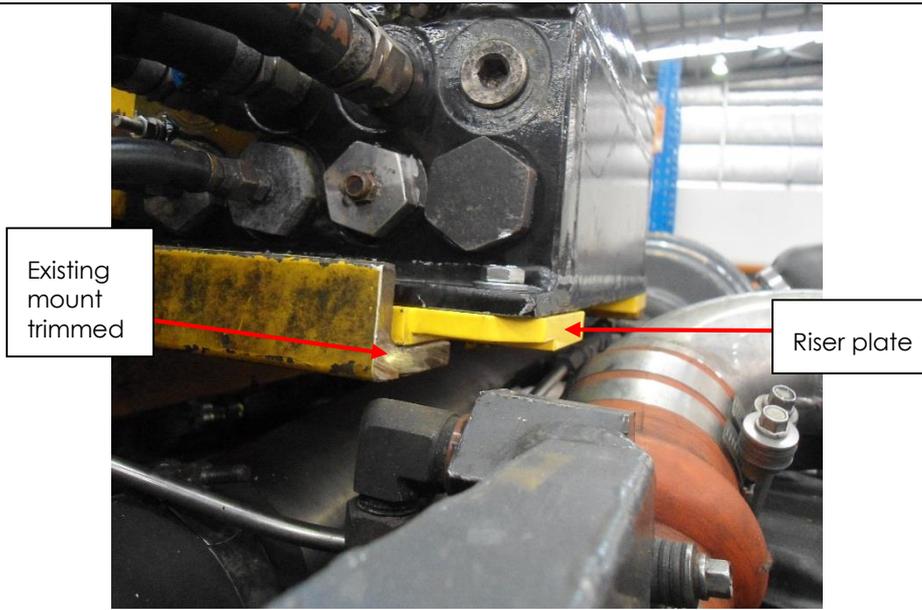
Figure 3: Riser plates installed

PPK has designed a retrofit modification to the methane system box bracket to create more room between the turbo and the bracket and fasteners. The modification includes cutting away part of the mount, installing riser plates and installing a new cover because the junction box has been lifted. See figures 3 and 4 below.

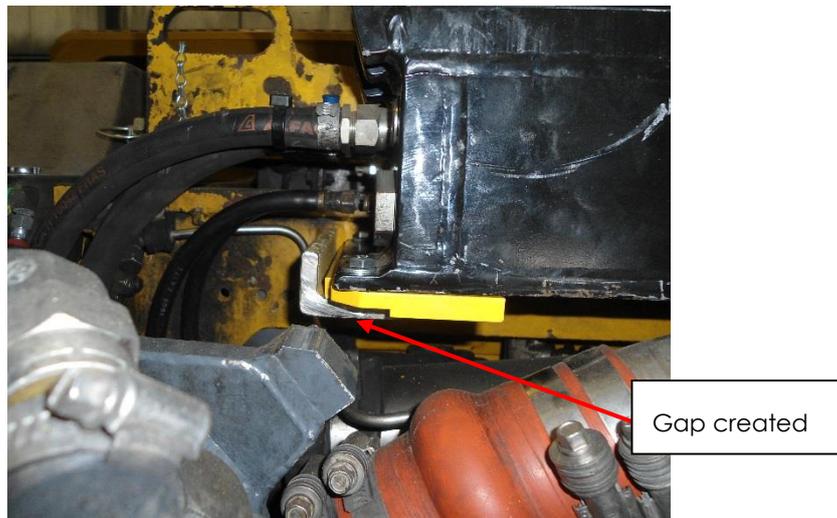
Figure 4: Riser plates installed
