TECHNICAL BULLETIN

Ref Document No.	TB17001	Issue No.	1
Subject	HA108 Footswitch Enclosure		
Release Date	10 th February 2017

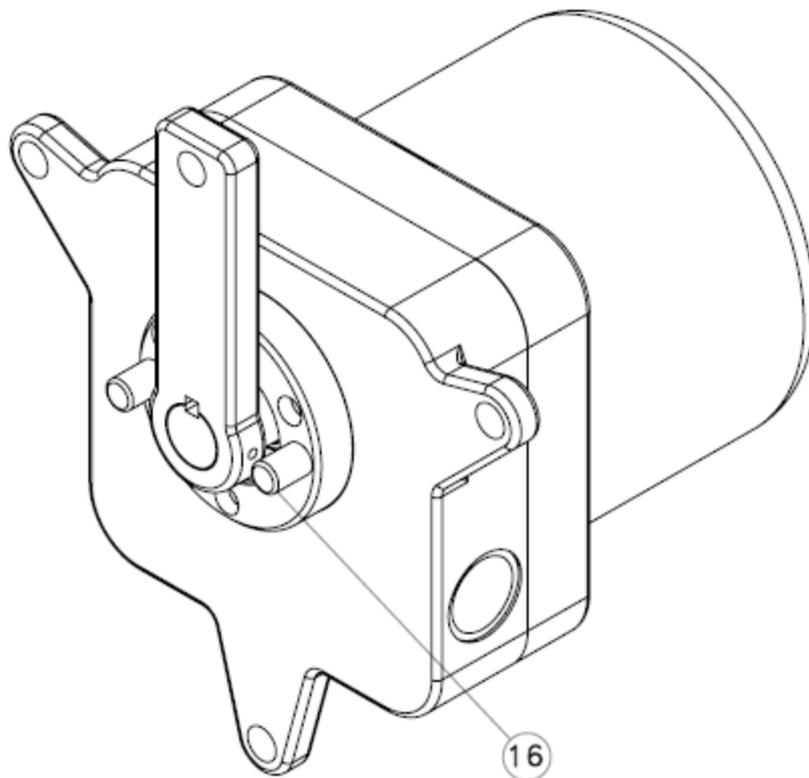
Service inspection has found the use of 10mm roll pins instead of the specified 10mm Dowel pins shown as item 16 (DP10020) on approval detail HA108-AD. Further inspections demonstrated a consistent failure of the 10mm Dowel being dislodged.

Vibration & heavy contact during operation found to distort the hole in which the dowel is secured, causing it to fall out.

If no other system safeguards are in place, over engagement of throttle componentry can occur.

This can result in damage to the dowel pins and associated locating joint of the throttle stop. Also, possible throttle control issues may present themselves by over / under extending the throttle linkage (subject to individual machines installed functional control and engineering measures; e.g. over-rotation condition functions etc.).

1. Inspect enclosures at next routine service/inspection.
2. Replace with appropriate part (DP10020) if necessary via press fit, where elongation or distortion of the retaining hole has not occurred.
3. Recommended replacement of the end cap fitted with dowels further secured via the application of a small tac weld (P/N HA108-2-2-D).
