TECHNICAL BULLETIN

Ref Document No.	TB15002	Issue No.	1
Subject	Accelerator pedal position sensor - Mechanical upgrade		
Release Date	12/03/15

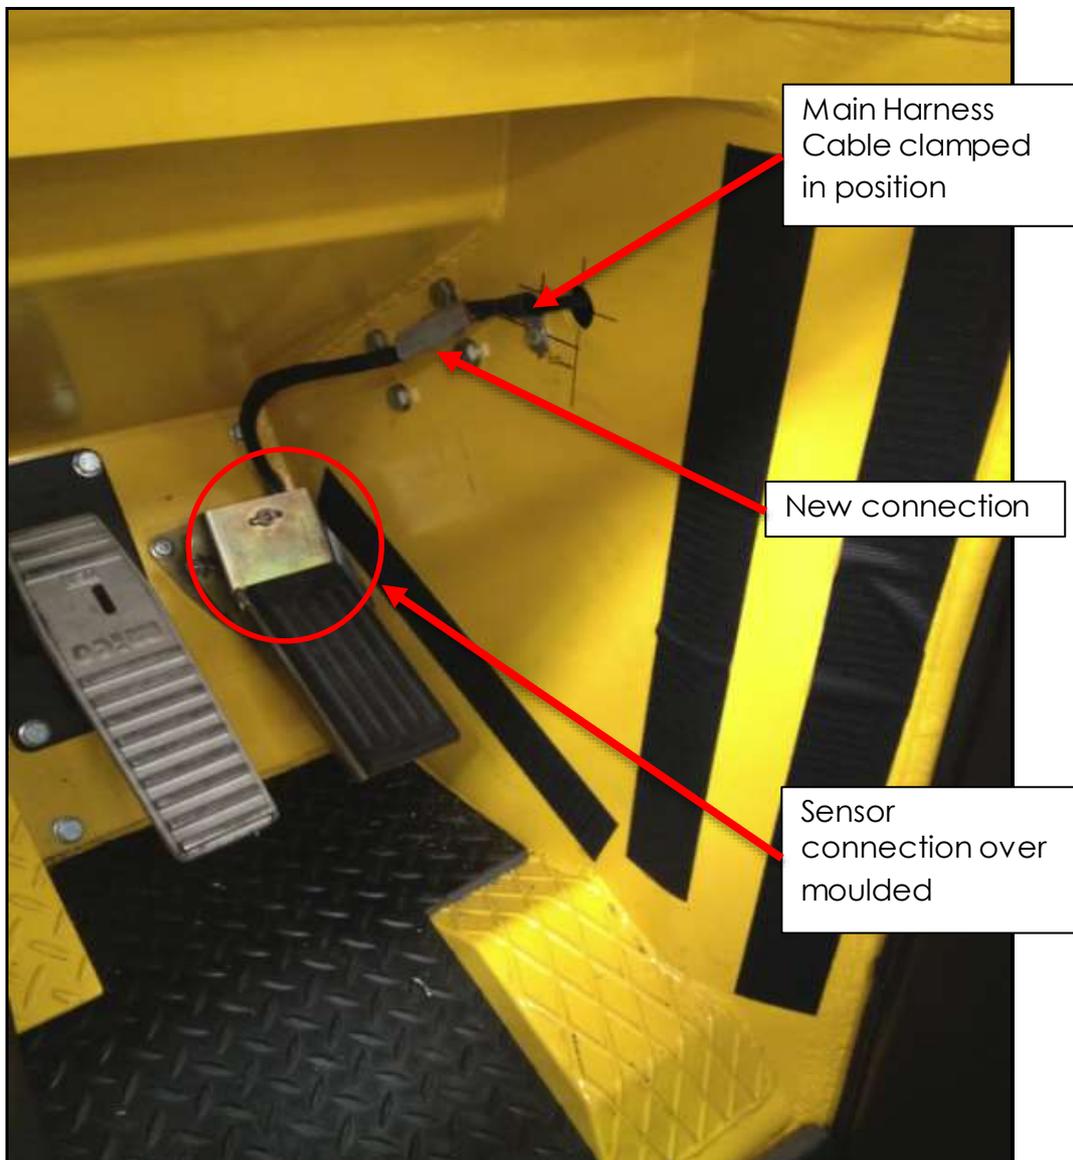
Figure 1.0.

PPK identified that the current location of the sensor's electrical connection would be frequently subjected to water and other contaminants.

The sensor's 600mm cable extension, will be connected to the main harness at a higher point in the cabin foot well. The new connection will also be located behind sound suppression padding when installed.

The new connection can be seen in figure 1.0 below:

PPK recommends ALL COALTRAM® owners / end users immediately implement the accelerator pedal position sensor – mechanical upgrade.
