SAFETY BULLETIN

Ref Document No.	SB15004	Issue No.	1
Subject	Unplanned Engine Cranking		
Release Date	9 th March 2015

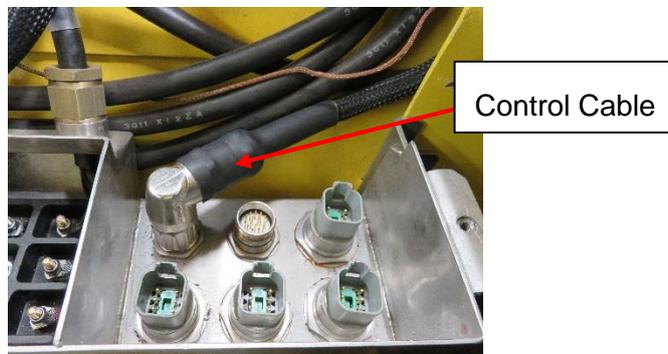
Figure 1: Cable Connected to Power Manager

1. Review MONEx Product Bulletin ZUQPTY4FSNWN-67-134 and Engineering Bulletin EB13007.
2. At the next weekly service interval inspect all control cable installations by removing the multi-pin connector and checking for evidence of corrosion in the pins or sockets. If corrosion is evident, the control cable should be replaced and normal start sequence operation confirmed. Where there are concerns of corrosion in the mating plug, the Power Manager should also be returned for inspection and testing.
3. Control Cable 5520002073 should be installed so the exit of the over-moulding is vertical and down to allow any water to drain as pictured below (some components are removed to allow view of the cable routing).

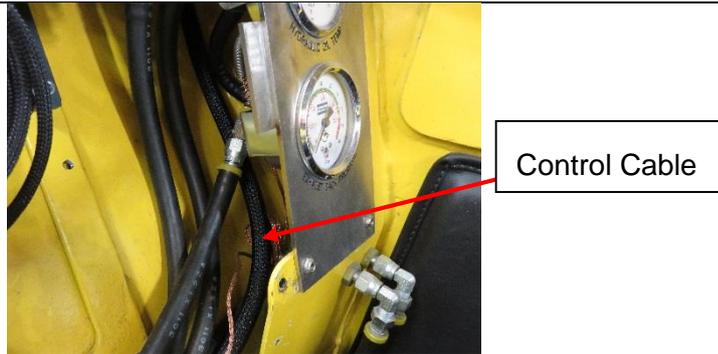
Figure 2: Cable Running Around Edge Behind Dash

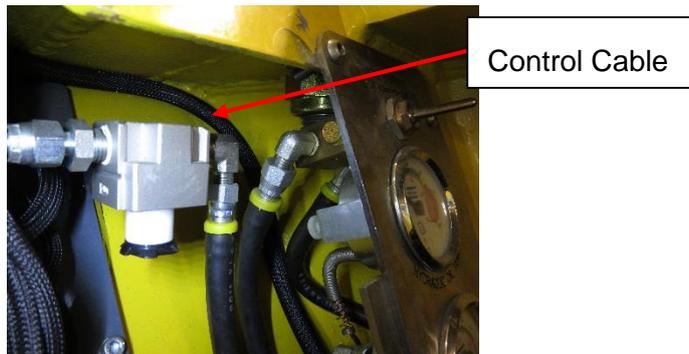
Figure 3: Cable Continuing Around Edge

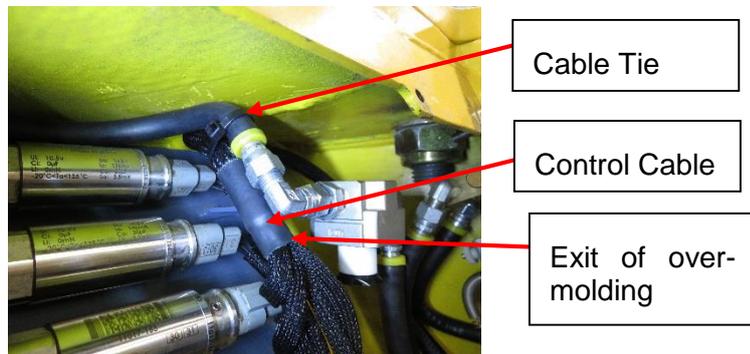
Figure 4: Cable Tied in Place With Over-molding Verticle
