TECHNICAL BULLETIN

Ref Document No.	TB13001	Issue No.	1
Subject	Park Brake Valve – Failure to Apply		
Release Date	21 st October 2013

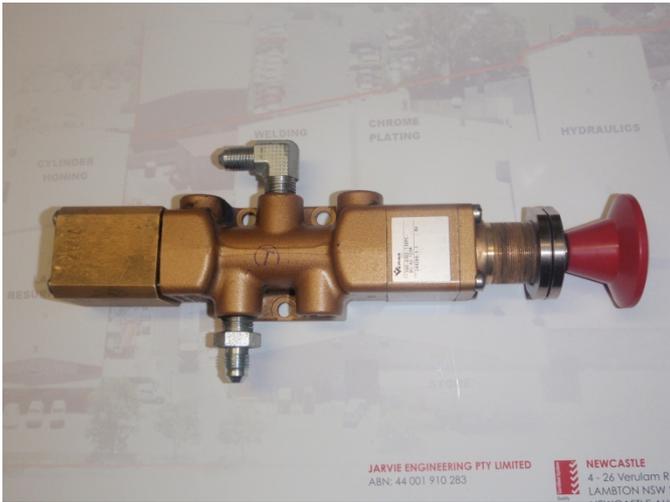
Figure 1 – Assembled Valve

All three valves were dismantled by the distributor to determine the cause of the failures.

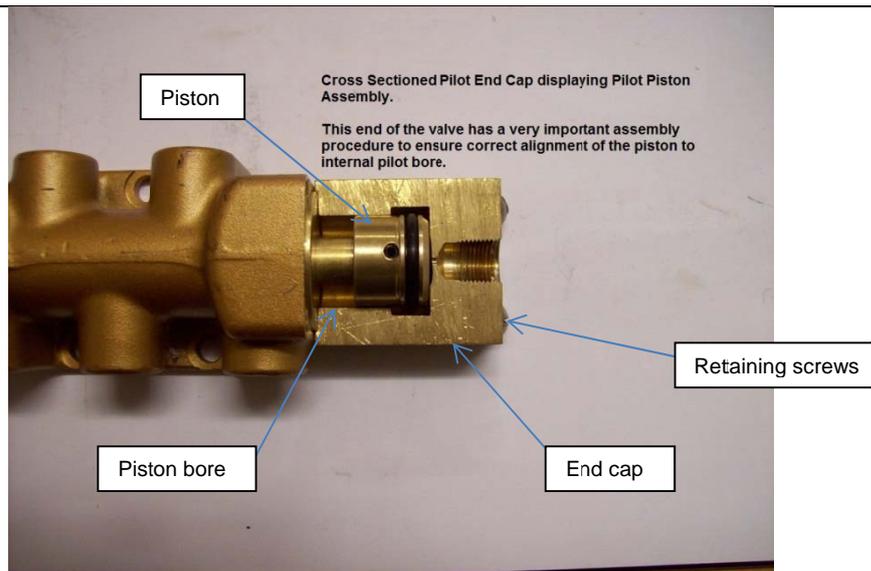
Figure 2 - Cross Section Pilot End Cap/Piston Assembly

The cause of the malfunction in the valves was a lack of lubrication and misalignment of the end cap and pilot piston assembly. A cut away view of the end cap and piston assembly is shown in Figure 2 below.

The pilot piston to spool connection is a floating design which allows the piston to centralise and align itself when entering the pilot end cap bore upon actuation. Both the pilot piston & pilot end cap were measured & complied with the respective manufacturing drawings. Whilst the pilot end caps were without the 2mm x 45 degree internal pilot bore chamfer (recently introduced at the end of 2012 to improve the operation of the pilot assembly, but not rendering the original pilot end caps as unusable) the lead in edge was relieved of any sharp edges.

One VERY IMPORTANT assembly procedure with the pilot end of this V657 valve assembly is that when you fit the pilot end cap to the main 4 way valve section the valve MUST be actuated (pulled up). This will engage the pilot piston within the bore of the pilot end cap thus aligning & centralising the assembly. With the valve actuated the 4 retaining screws should be tightened.

1. Remove park brake valve from Coaltram at next available service opportunity, remove end cap, lubricate with Dow Molykote 55 O-ring grease and reassemble with appropriate alignment when reassembling.
2. Ensure all maintenance staff are made aware of correct assembly technique for fitting pilot end cap as per above description.
3. Complete park brake tests as per service sheets.
4. Refer SWP CT6.51 Park Brake Valve Lubrication for checking and lubricating park brake pilot end cap and piston.
