TECHNICAL BULLETIN

DOCUMENT NUMBER:- 913-6 TB 1- 0908

Document name:- “Failure of Differential mounting bolts on bolster”

Date: - 16/09/08

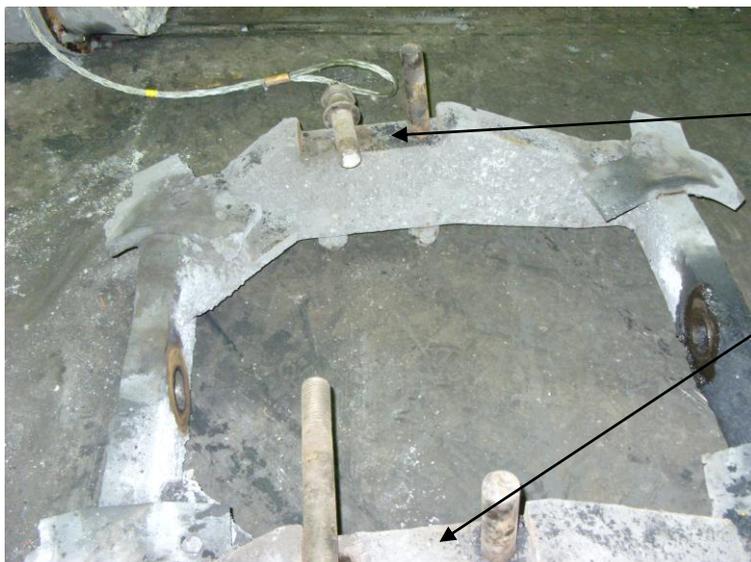
The 3 bolts out of 4 appear to have failed in tension due to the necking noticed on the area just below the bolt head. The fourth bolt has evidence of the nut being stripped on the bolt.

The evidence also shows that the differential was not sitting down correctly inside the bolster cradle as evidence of dirt was found between the faces. Approximately 2 to 3 months before this incident about July, 2008, during a routine inspection it was identified that 2 differential mounting bolts out of the 4

were broken on this occasion. The mine site personnel installed 2 new bolts and replaced the other nuts on the other 2 bolts as a precaution. It was possible coal dust/loose dirt had been caught between the 2 mounting surfaces and differential has worked itself loose during further operation causing additional stress loading on bolts

As can be see from this photo the top end of the bolster appears to have some compression marks on the face between the differential and the bolster, while the bottom end only had loose dirt sitting on the faces indicating no compression between the faces.

1. It is recommended that all 913-6 LHD's with similar design bolsters check all differential mounting bolts for tension as recommended by the OEM's as soon as possible and record information in safety file. Action to be taken as identified.

2. All bolts to be high tensile in grade 8 or better
3. All washers are to be high tensile
4. All nuts should be a nyloc nut with consideration for a high tensile nut double locked if nyloc nuts not available. No evidence shows that a nyloc nut is any weaker in construction than a standard high tensile nut. Both nuts have the following characteristics according to the bolt manufacturing charts

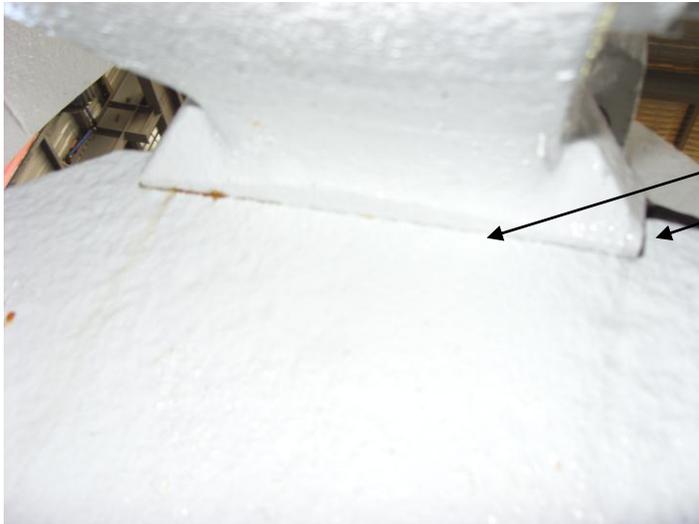
Check for no movement in this area and also dirt built up under the faces

- Tensile strength – 150,000 lb
 - U Yield – 130,000 lb
 - Proof test – 120,000 lb
5. All faces to be checked to ensure no movement is evident between the bolster frame and the differential as shown in photo below.

6. Monitor the free movement of bolts in the differential housing and repair or replace as required if movement becomes too excessive due to wear.

7. All bolts to be checked for tension every 250 hours of operation. This could be done by simply a tap with the hammer. Every 1000 hours should use a tension wrench.
8. If bolts found loose faces between the bolster frame and the differential are to be cleaned before re-tensioning.
