TECHNICAL BULLETIN

Ref Document No.	TB16001	Issue No.	1
Subject	Crowd cylinder Gland Bush Bolt Failure		
Release Date	8 th March 2016

Purpose – Advise COALTRAM® owners/operators of the possibility of the crowd cylinder gland bush retaining bolts failing.

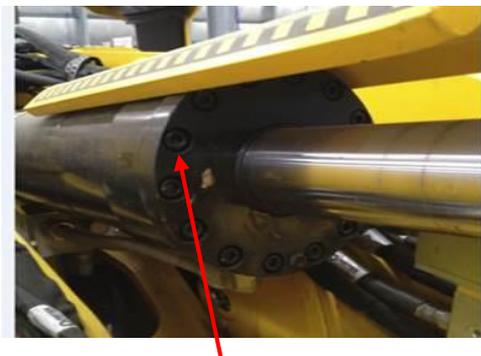
The crowd cylinder was of the older style (figure 1) using a counter bored gland cap and retaining bolts.

Original style Crowd
Cylinder with bolts heads
counter bored

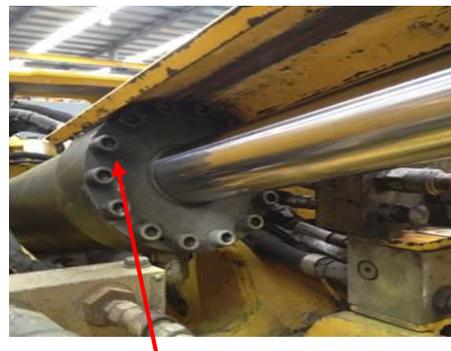
Figure 1

New style Crowd Cylinder
with bolt heads proud

The newer cylinder design does not have the counter bores in the gland cap and has larger bolts with the bolt heads standing proud of the gland cap, (Figure 1) split washers are fitted under the bolts.

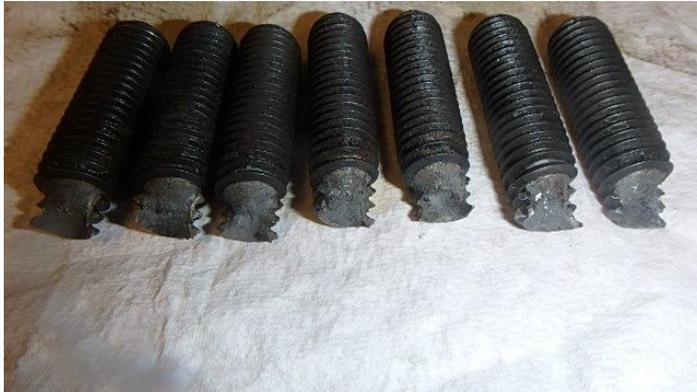
Figure 2

Seven of the gland cap retain bolts were recovered from site. From examination of the bolt failure surfaces it was evident that all bolts had experienced tensional failures (Figure 2).

The bolts were confirmed as being the correct grade, 12.9.

From examination of the bolts, it was determined that the bolts had been exposed to a tensional load that exceeding their upper yield value.

The bolt diameter was measured and an average reduction of diameter of 17.75% was recorded (commonly referred to as necking).

1. PPK recommends that all CT10 Coaltram owners/operators inspect their CT10 Coaltrams at the next available service for loose crowd cylinder gland / bush retaining bolts.

2. For the original style crowd cylinder the M12 x 50mm SHCS 12.9 grade are to be torqued to 143 Nm dry. For the new style crowd cylinder the M16 x 50mm SHCS grade 12.9 are to be torqued to 330 Nm dry. This torque is to be checked without the removal of the bolt.

3. If there are any bolts require tightening then all of the bolts and washers should be removed and replaced.
4. PPK can supply a replacement kit for the bolts and washers upon request – old style crowd cylinder P/No. 5520010076, new style crowd cylinder P/No. 55200010081.

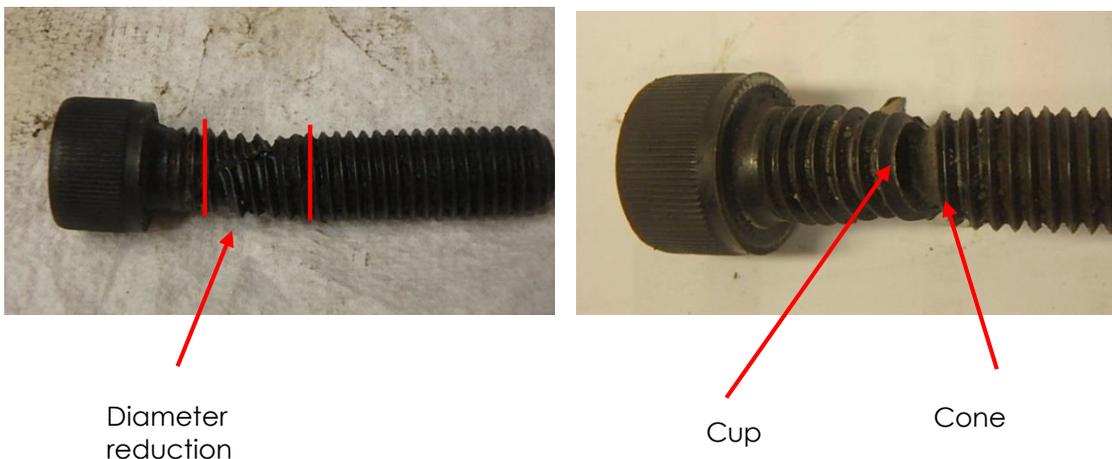
Figure 3

The failure surface of each bolt presented the typical cup and cone failure associated with a tensional load failures. (Figure 3)

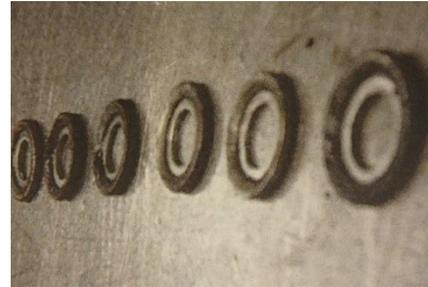
Figure 5

The soft washers were removed and replace them with harden steel Schnorr safety washers (Figure 4). This was done to stop the soft washer from crushing and eventually allowing the bolts to become loose (Figure 5).

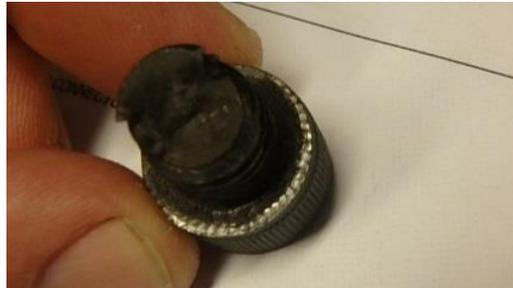
Figure 6

The crowd cylinder that experienced the failure did have the correct Schnorr safety washers installed. The underside surface of the bolt heads showed witness marks produced when using a Schnorr washer (Figure 6).
