ENGINEERING BULLETIN

Ref Document No.	EB15011	Issue No.	1
Subject	CT08 Boom Top Reinforcing Plate		
Release Date	1 st June 2015

Purpose – Advise COALTRAM® CT08 owners of a plate that is available to reinforce the CT08 boom.

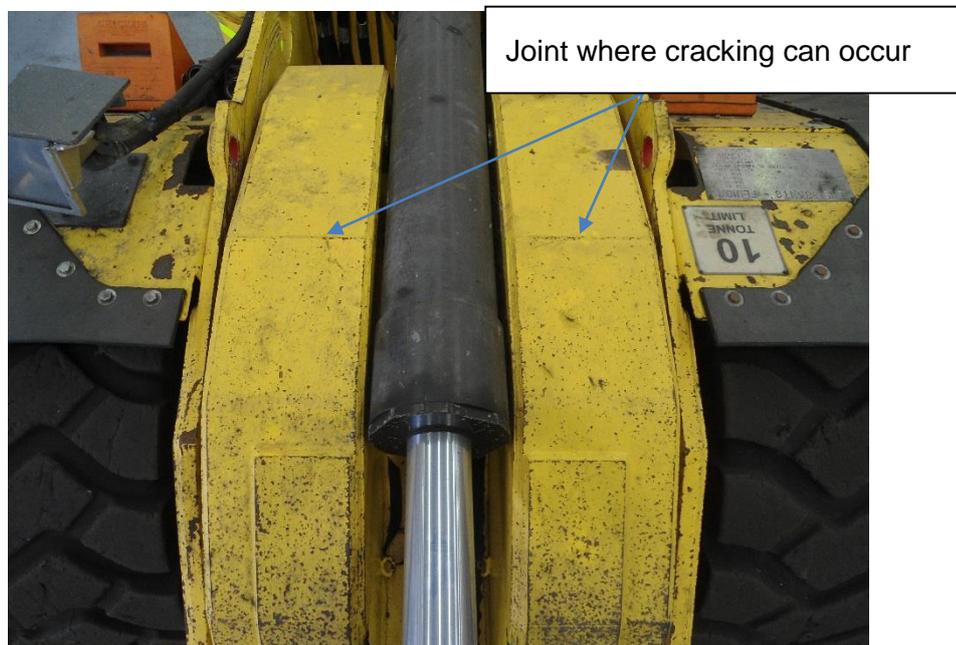
Figure 1: COALTRAM® CT08 boom

Fatigue cracking has occurred on the top plate section of the COALTRAM® CT08 boom where two plates are butt welded together. Refer Figure 1 for area of boom being described.

The area where the cracking has occurred is in a low stress area of the boom. The cracking can be attributed to the flexing of the boom through a butt weld joint. This joint is located between the two pressed sections that form the top of the boom. To address this issue a reinforcing plate has been designed that can be installed to spread any load passing through the weld and reduce flexing in the localised area. Refer Figure 2 below for boom installed with reinforcing plates.

1. PPK recommends inspecting COALTRAM® CT08 booms for the installation of the reinforcing plates.
2. If the reinforcing plates are not installed visually inspect the welded joints shown in Figure 1 for cracks and include the inspection in regular servicing events.
3. If no cracks are present continue using COALTRAM® CT08 and have the reinforcing plates installed at the next major service interval.
4. If cracking is present the boom will require repair and the reinforcing plates installed at the next appropriate service interval. Contact PPK service centre to have repair scheduled.
5. If the reinforcing plates are to be installed onsite a qualified weld procedure should be followed for a complete 10mm fillet weld with a parent material grade of 350 mild steel.
6. Part number for reinforcing plate – 5520009590. 2 off are required for installation.
