SAFETY BULLETIN

COALTRAM[®] CT08, CT10, CT10LP & CT13

Oil ingress to ECUEx

Ref Document No.	SB14001	Issue No.	1
Release Date	16 May 2014

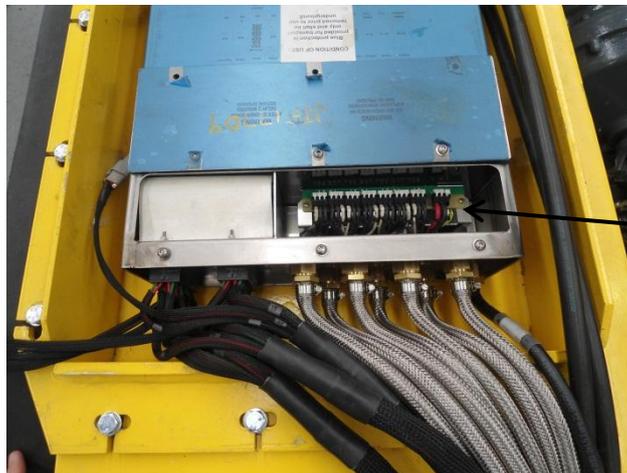
Area to check for oil

A COALTRAM[®] was experiencing abnormal throttle response with the source of the problem identified as oil ingress into the ECUEx termination area with enough depth (approx. 3cm) to bridge across the internal sensor connection terminals.

It was revealed that the oil had ingress from the solenoid in the HEP (injector) pump. The oil was able to track along the internal sheathing of the HEP coil into the casing of the cable. Due to the pressure from the HEP pump the oil travelled up the cable through the casing and into the ECUEx. The oil built up enough over time to a depth that could bridge the circuit causing signals to act abnormally.

At the next convenience remove the cover from the ECUEx and inspect for oil using the steps below. If oil present replace HEP coil refer SWP CT3.28. HEP coil part number – 5520002372 (CT08, CT10, CT10LP), 5520002379 (CT13).

4. Check for oil and clean/remove any that is present. If oil present replace HEP coil. Refer SWP CT3.28.
