# TECHNICAL BULLETIN

Ref Document No.	TB14001	Issue No.	1
Subject	HEP Solenoid		
Release Date	20 <sup>th</sup> May 2014

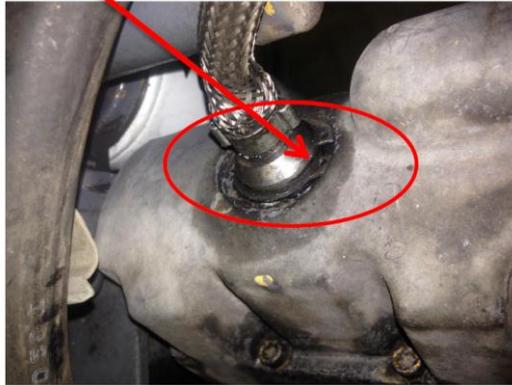
It was revealed that the oil had ingress from the solenoid in the HEP (injector) pump. HEP coil part number – 5520002372 (CT08, CT10, CT10LP), 5520002379 (CT13). The oil was able to track along the internal sheathing of the HEP coil into the casing of the cable. Due to the pressure from the HEP pump the oil travelled up the cable through the casing and into the ECUEX. The oil built up enough over time to a depth that could bridge the circuit causing signals to act abnormally.

Old coil with circlip retention

2. COALTRAM owners with the old pump solenoid coil may choose to continue using old pump solenoid coil and regularly monitor for any oil ingress as per Safety Bulletin SB14001 or replace with new pump solenoid coil. Vehicles fitted with the new style pump solenoid coil may continue running without modification.

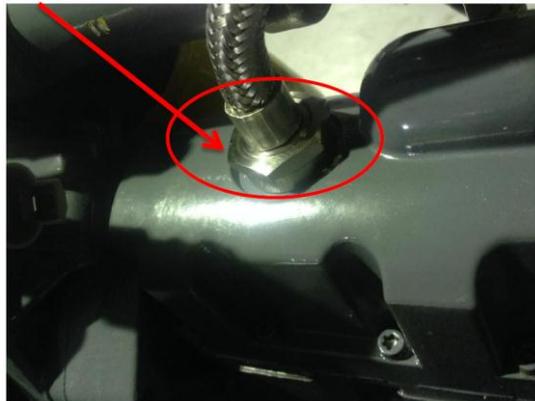
The supplier has recently redesigned the solenoid coil and the oil ingress can no longer occur in the updated design. Some of the new solenoids will be in circulation already. The updated coil is available to purchase under the same part number.

New coil with nut retention
