Technical Bulletin / Safety Alert

Unique ID No: DES2014-TBSA-04

Subject: MDR074246DES Low Water Test Valve Change

Applicable to: ALL VLI JUG-A-0 UL/UV Machines with MDR074246DES and MDR074246DES-1

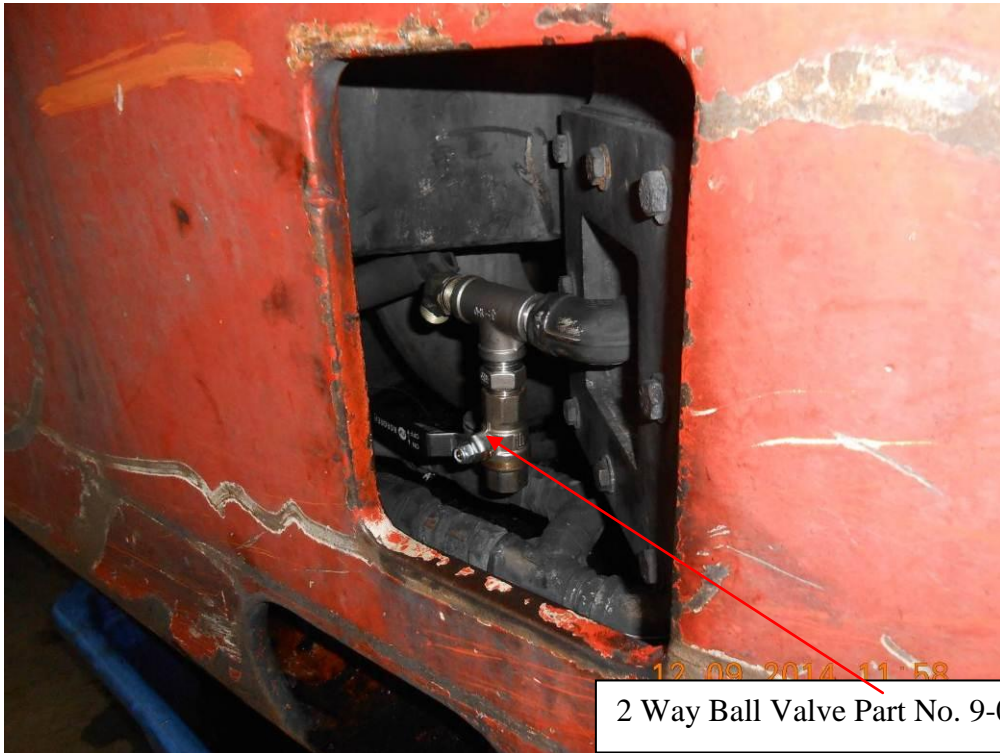
Figure 1: New 2 Way Low Water Test Valve Installation.

A HAZOP study and design change FMEA was completed, which supported this change. VLI subsequently installed and tested a 2 way low water test valve to a system, as depicted in Figure 1, to confirm correct fit and function. VLI now recommends the change from a 3 way ball valve to a 2 way ball valve for the low water test valve on design registered DES covered by MDR074246DES and MDR074246DES-1. The low water test valve decal, as shown in Figure 2, will need to be removed from its location on the exhaust conditioner tank and discarded.

VLI recommends all equipment owners and end users of VLI JUG-A-0 UL/UV with design registered diesel engine systems covered under MDR074246DES and MDR074246DES-1 adopt the new 2 way low water test valve as described in this TBSA at the next routine service interval.

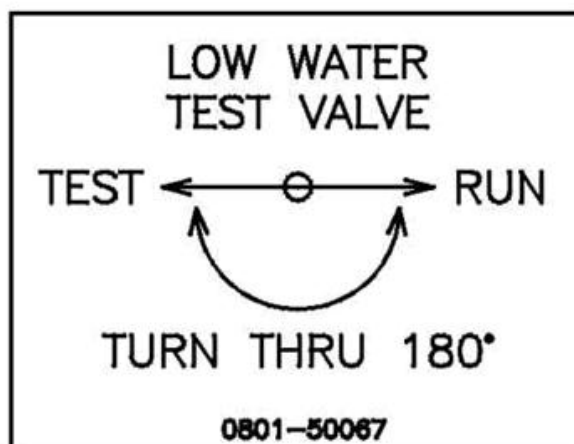
Figure 2: Three (3) Way Low Water Test Valve Decal – Remove and Discard

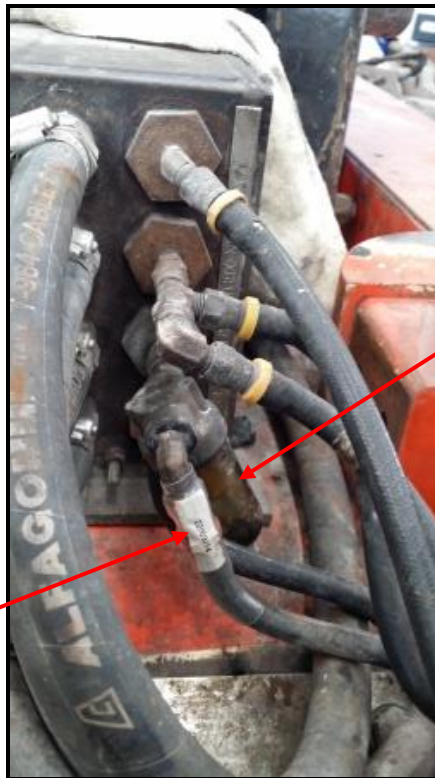
Figure 3

Date tag & heat-shrink applied to the air supply in –
NOTE: the heat-shrink must cover the end of the swivel nut on the hose tail.

Filter/drain fitted directly to shutdown system enclosure air supply in.

In order to detect any tampering with the pneumatic air supply to and from the shutdown system, clear 20mm (inside diameter) heat-shrink should be applied to the air supply hose at the time of making the final hose connections to the system. A date label should be attached to the 'air supply in' fitting/hose & clear heat-shrink applied as shown in figures 3 to 8 below.

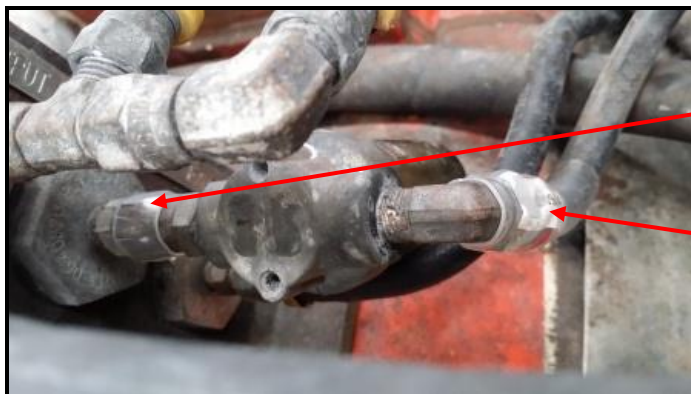
Figure 4

NOTE: for systems with the filter fitted directly there needs to be 2 pieces of heat shrink applied.

- One piece applied to the swivel nut & fitting that attaches the assembly to the enclosure (cut 20mm long).
- One piece that attaches to the supply hose (cut 75mm long)

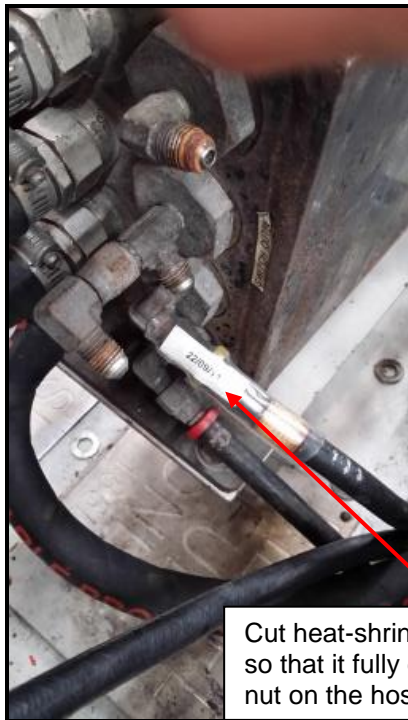
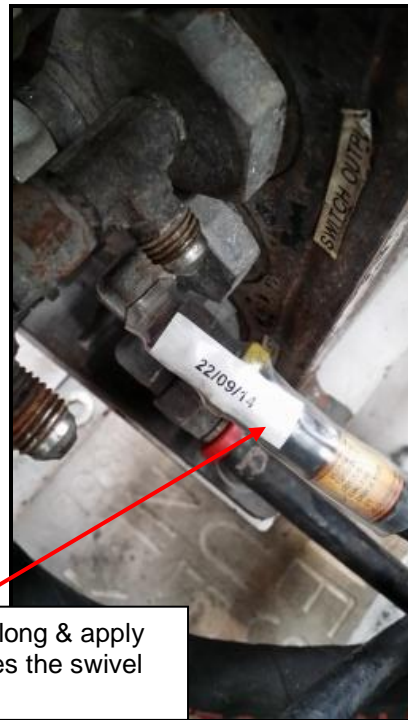
Cut heat-shrink to 75mm long & apply so that it fully encapsulates the swivel nut on the hose tail.
