## **Technical Bulletin / Safety Alert**

**Unique ID No:** DES2011-TBSA-04

**Subject:** Incident Notification - MDA DES 13017 Exhaust Flame Path Joint Failure

**Applicable to:** VLI Diesel Pty Ltd Diesel Engine Systems covered under approval no. MDA DES 13017 (Driftrunner & Brumby)

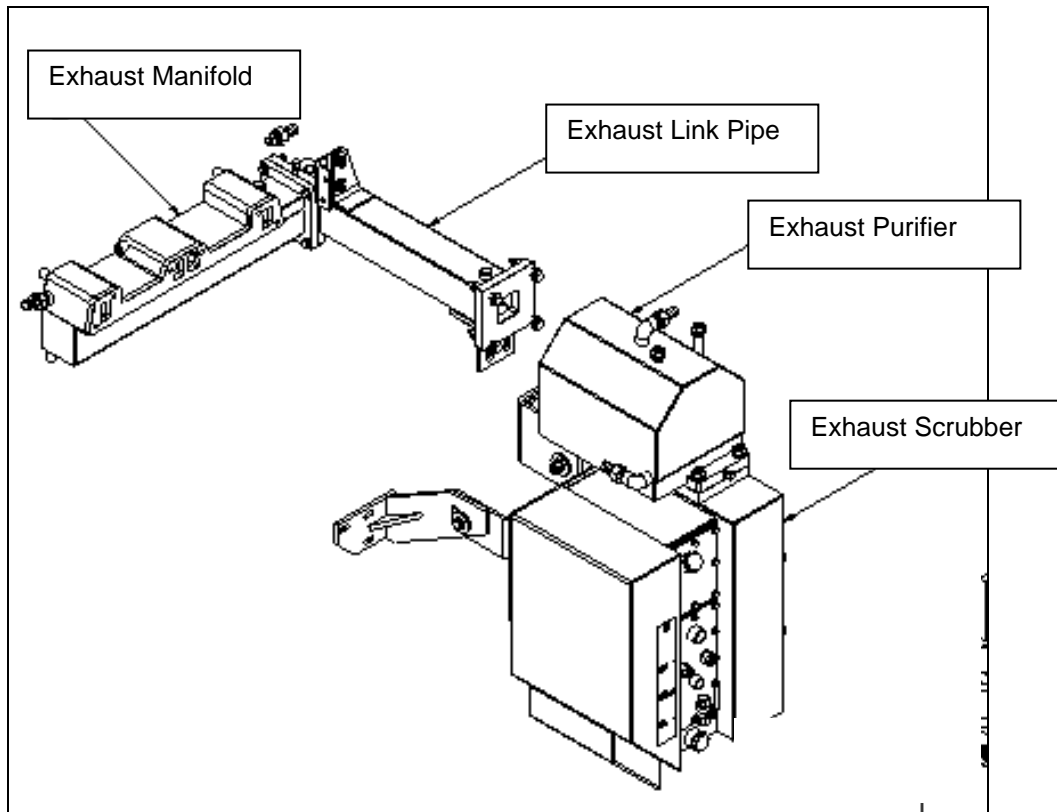
Figure 1 provides a schematic representation of the diesel engine exhaust system under investigation.

**Figure 1: Schematic representation of exhaust system.**

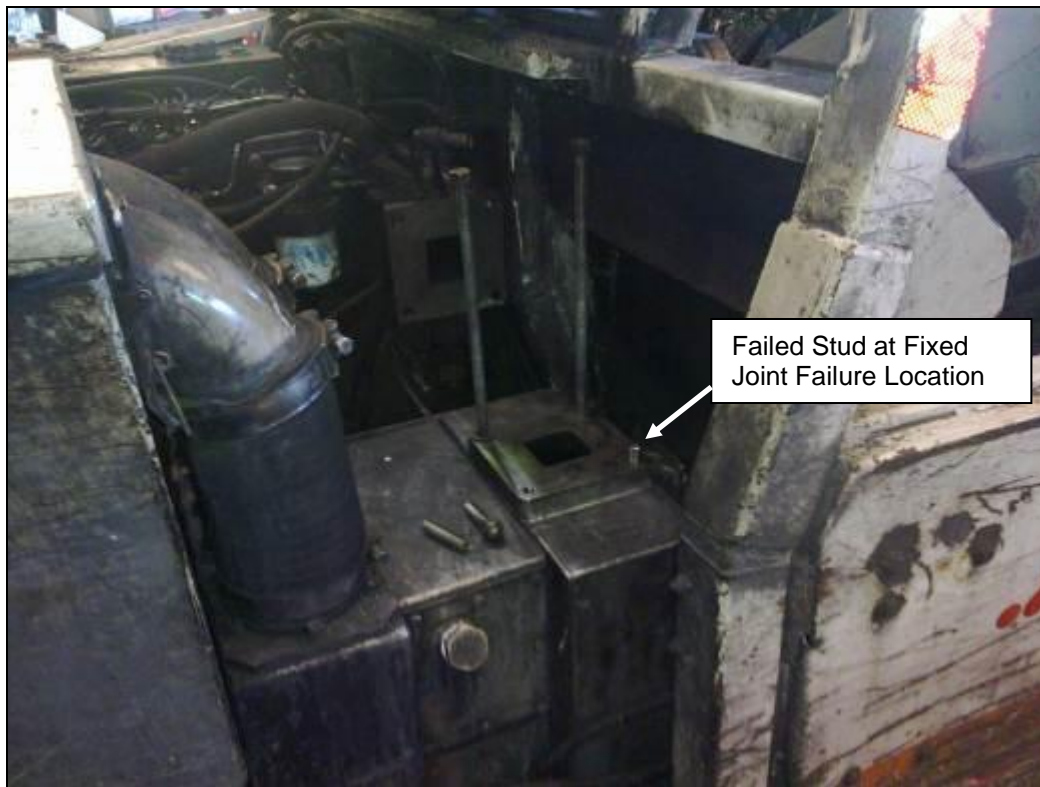
Failure of the exhaust system flame path occurred at the fixed joint between the exhaust purifier and the exhaust scrubber tank (Figure 2).

**Figure 2: Photograph of the disassembled exhaust system in chassis (with purifier removed), highlighting failure location.**

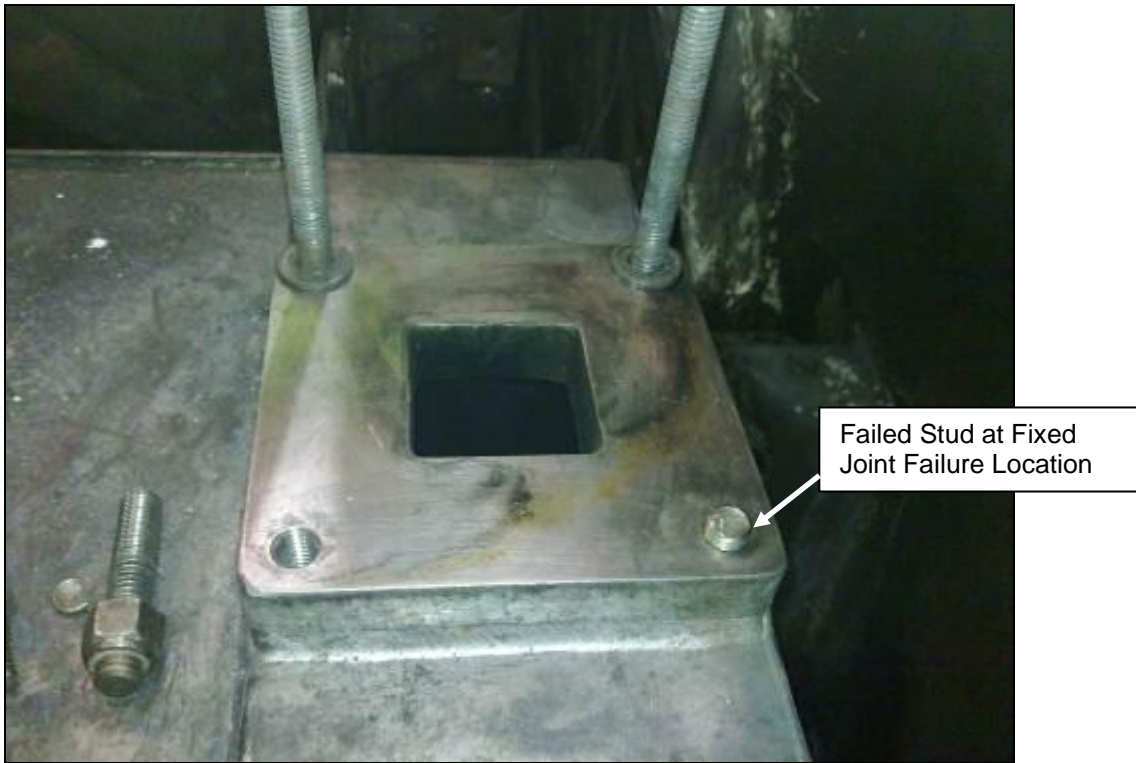
The off drivers side rear stud securing the purifier to the scrubber tank had failed and the appearance of the stud fracture surface was considered consistent with a rapid fatigue failure (Figure 3).

**Figure 3: Photograph showing the failed stud at the fixed joint failure location between the purifier and the scrubber.**

Failure of the fixed joint between the purifier and the scrubber tank of the diesel engine exhaust system has resulted from the flange joint becoming loose, leading to stud fatigue fracture and ultimately joint separation.

All coal mines with VLI Driftrunner and VLI Brumby vehicles containing explosion protected diesel engine systems covered by approval no. MDA DES 13017 (with and without purifiers fitted) are recommended to inspect these vehicles at the earliest possible opportunity to confirm the security of exhaust system flame path fixed joints and mounting bolts. Further routine inspections need to be completed as per VLI service sheets (attached).

Where repairs are required to these exhaust systems, please ensure only OEM supplied components are used.

Please note, as per DES approval drawing information, all fasteners are to be SAE Grade 5 or metric equivalent as a minimum, and all fasteners to have 5 full threads of engagement. When replacing washers ensure hardened steel washers are used.

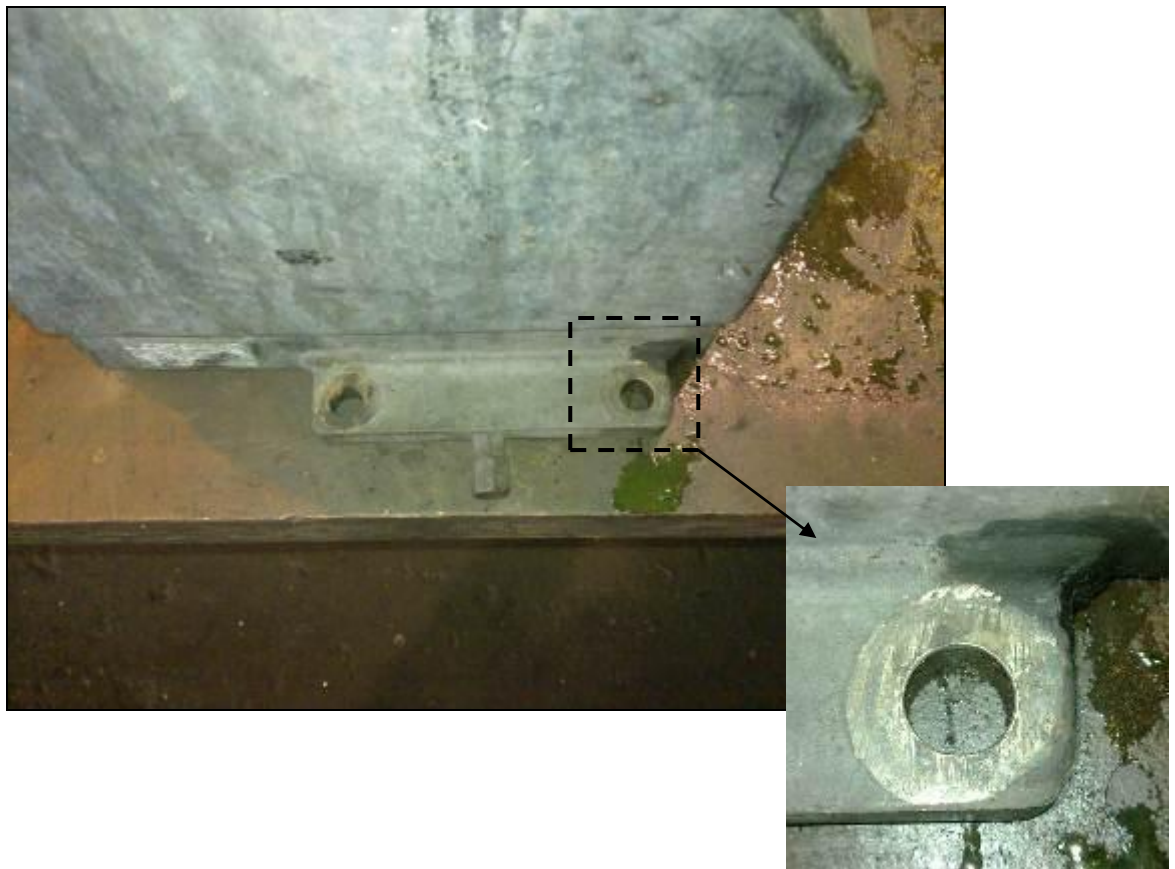
Closer inspection of the upper purifier mounting flange identified evidence of fretting at the location of the washers (Figure 4), indicating this joint had been loose.

**Figure 4: Photographs showing the mounting flange on the purifier, highlighting the fretting where the washers were located.**

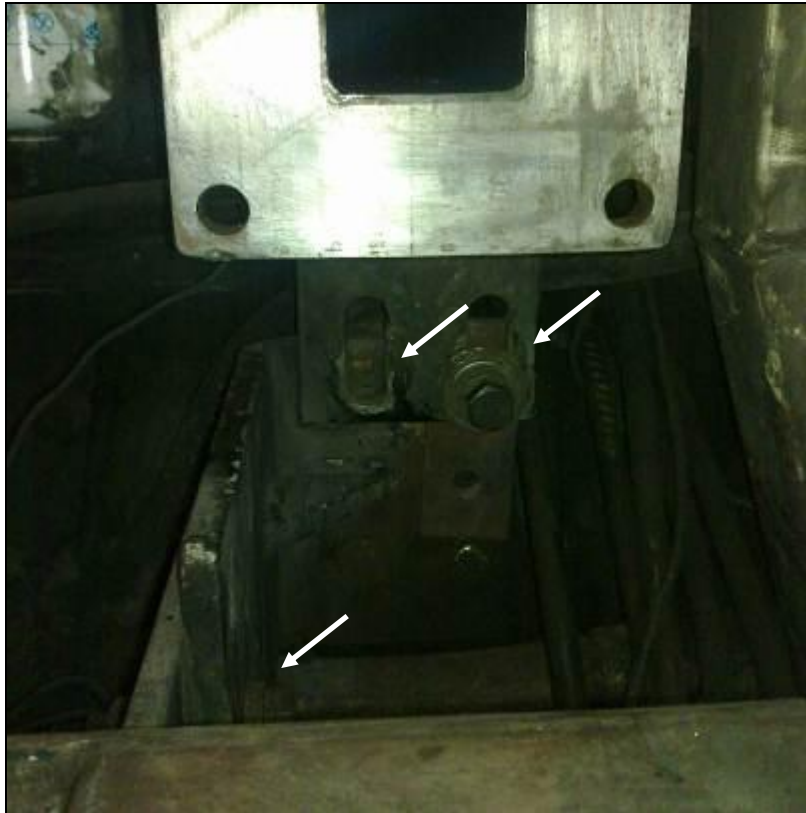
Visual examination of the link pipe supporting bracket and the adjacent scrubber supporting bracket fastened assemblies exhibited evidence of movement and wear (Figure 5). This suggested the assembly might have lacked sufficient support during previous periods of service. This could have placed additional stress at the fixed joint between the purifier and the scrubber leading to relative movement, fretting, stud fatigue and ultimately stud fracture and joint separation.

**Figure 5: Photograph highlighting the apparent movement of the fastened supporting bracket assemblies.**

Exhaust link pipe and scrubber tank supporting bracket fastened joint movement might have contributed to the initiation of this failure.

VLIDD to review the design of the exhaust system supporting structure to establish if improved support to the link pipe, purifier (or link pipe extension) and scrubber tank can be achieved without compromising the integrity of the explosion protected exhaust system.
