Technical Bulletin / Safety Alert

Unique ID No: GEN2010-TBSA-05

Subject: Mine Loader Front Driveshaft Centre Bearing Failure (Fire)

Applicable to: All JUG-A-0 UL/UV Machines

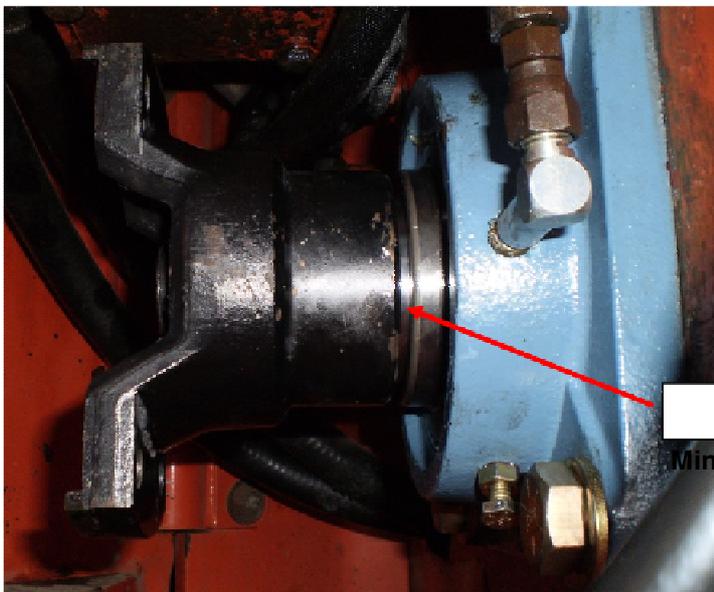
Initial investigation found that there was no clearance between the spline yoke & the bearing inner race.

Further investigation shown the root cause of the fire was determined to be the installation of the incorrect bearing housing. The housing has different dimensions placing the centre bearing closer to the spline yoke on the transmission end causing interference and pre-loading on the bearing.

All JUG-A-O machines (V1, V2, and V3) need to have the following yoke to centre bearing clearance check.

Min 1mm clearance between flange & inner race

Note: - this applies to all current original version centre bearing driveshaft assy's, should there not be clearance here the bearing & shaft assy must be replaced.
