Technical Bulletin / Safety Alert

Unique ID No: DES2011-TBSA-05

Subject: MDR090376DES Exhaust System - Incident Notification

Applicable to: VLI Diesel Pty Ltd Diesel Engine Systems covered under design registration no. MDR 090376 DES (Driftrunner & Brumby)

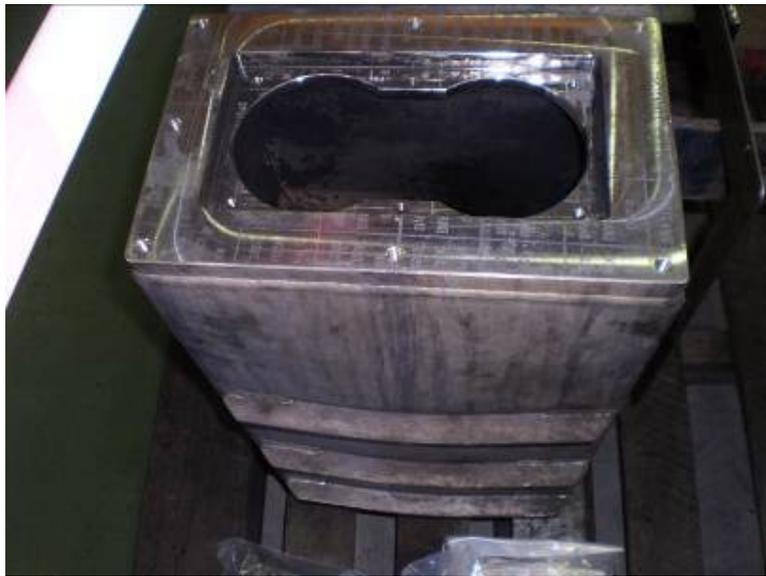
Figures 1 and 2 show the scrubber tank and purifier element assembly as received by VLI, where the tank expansion and purifier element damage can be seen.

Figure 1: Exhaust Tank Expansion.

VLI conduct code D examinations at time of manufacture as per AS/NZS 3584. In house testing has shown the scrubber will exhibit deformation on front and rear sides (as installed) as a result of the pressure test. A maximum deformation has been nominated for assessment purposes (see procedure below).

- Ensure all OEM maintenance and service procedures are followed.
- Ensure only OEM parts are used.
- Carry out scrubber tank assessment as per procedure below and report any non-conformances to the OEM.
- Carry out exhaust back pressure test as per procedure below and report any non-conformances to the OEM. This test should be repeated and recorded at mandatory exhaust analysis intervals.
- Exhaust emissions should be monitored post purifier as an indicator of effective function.

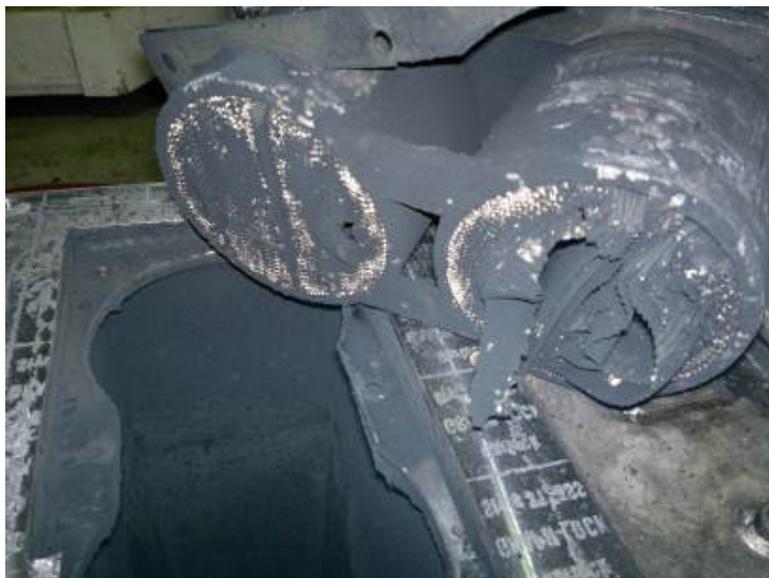
Visual examination of the purifier identified excess buildup of contaminants such that light was not visible through the intact sections and collapse of the purifier substrate apparent on one side.

Figure 2: Exhaust Purifier Element Deformation / Damage

Purifier damage appears to be due to excess buildup of contaminants. This could be attributed to poor fuel, incorrect or poorly maintained fuel systems and/or abnormal duty cycle. A maximum exhaust back pressure is nominated to assist in identifying purifier/scrubber condition.

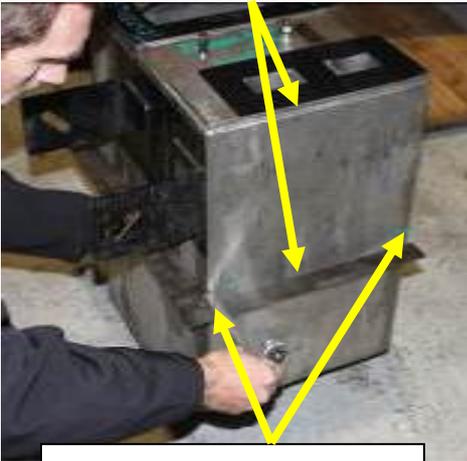
Front surface measure approximately 270mm down from top

Front surface Maximum deflection 15mm

- To be conducted by competent persons
- Ensure machine isolation procedures are followed
- Ensure measurements are taken from nominated points perpendicular to the inside surface at the level indicated (Max deformation 15mm front face and 11mm rear face)

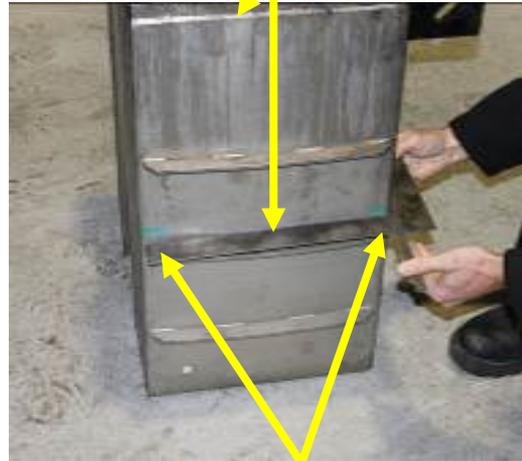
Rear surface measure approximately 330mm down from top

Rear surface Maximum deflection 11mm
