## **Technical Bulletin / Safety Alert**

**Unique ID No:** DES2011-TBSA-08

**Subject:** JUG-A-0 UL/UV Diesel Engine System - Inlet Manifolds

**Date:** 11<sup>th</sup> February 2014

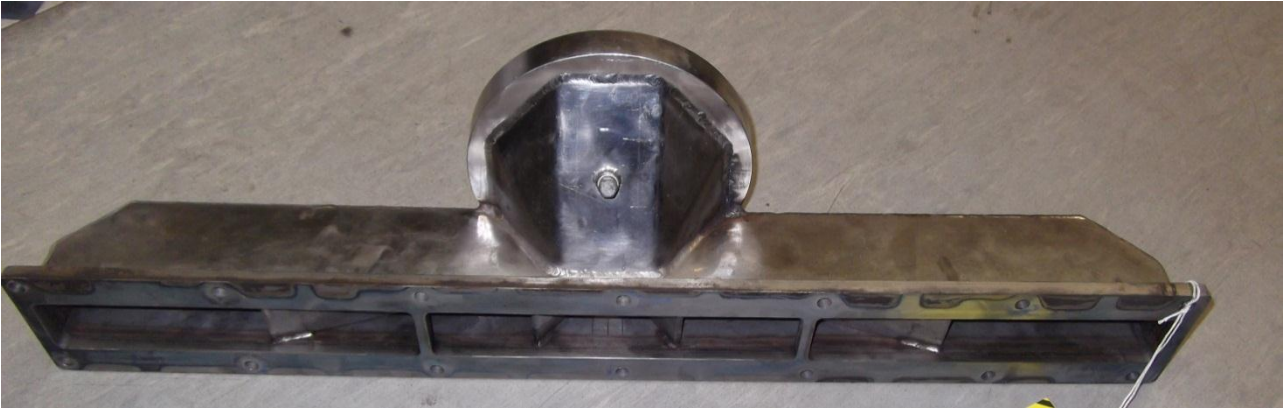
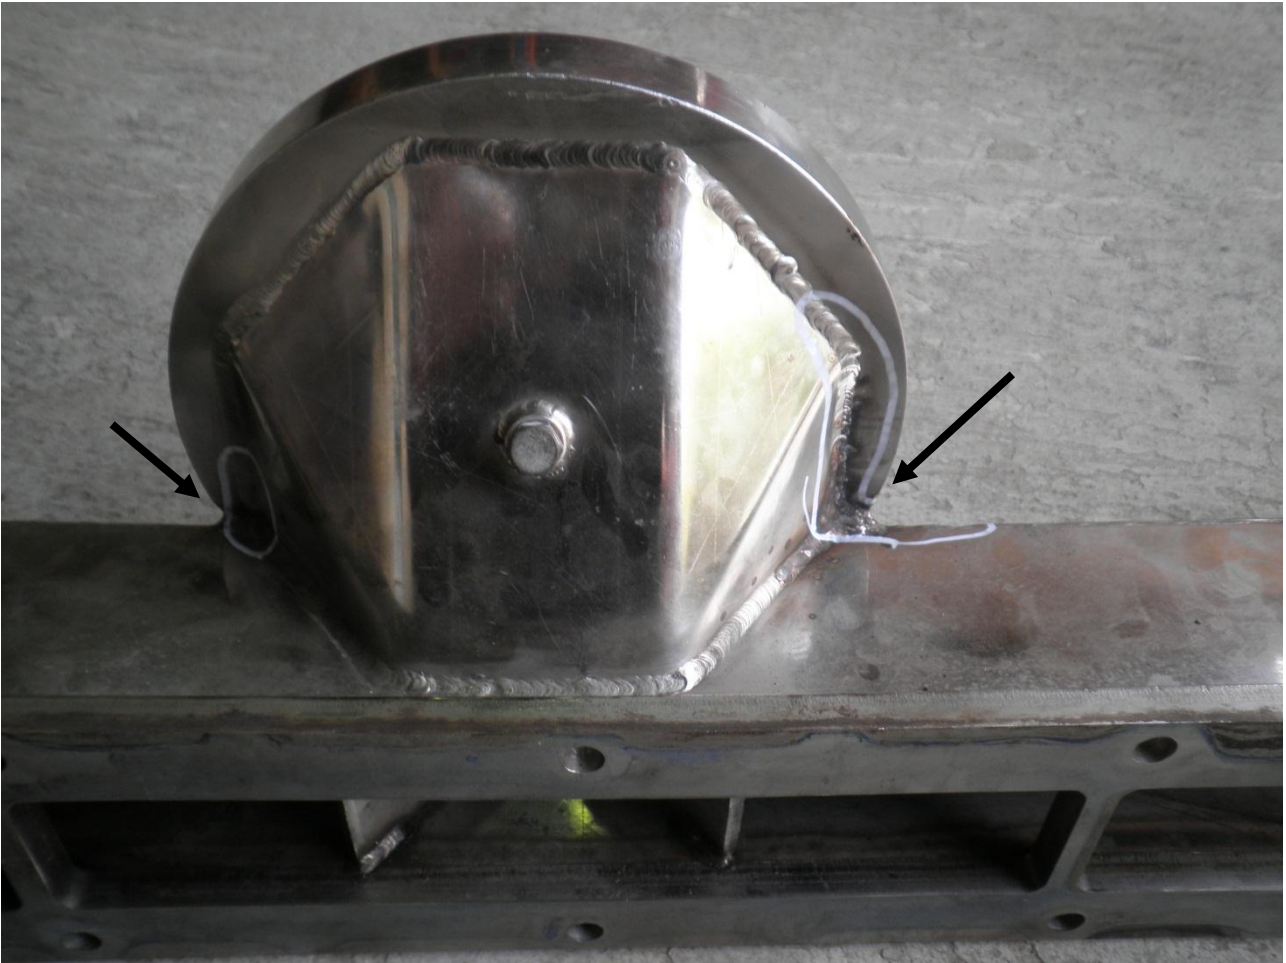
- 1. Inlet Manifold Cracks:** Cracks have been identified within welds between the main ducting and the flametrap housing ducting as shown below in Figure 1. The appearance of the cracks was consistent with fatigue. These cracks have to date only been identified on more recent machines with the gear driven supercharger air inlet configuration (commonly referred to as V3 machines). Machines with the earlier belt driven supercharger air inlet configuration (commonly referred to as V2 machines) have not exhibited this cracking phenomenon, although the inlet manifold component is common to both versions. A comparison of the differences between the general arrangement of the air inlet configurations of the V2 and V3 machines has highlighted the requirement for additional support for the air intake ducting and strangler valve components on V3 machines to reduce the load on the inlet manifold at the flametrap housing. To address this VLIDD has developed a support bracket (Part No. 0508-60081) for the air inlet ducting and strangler valve assembly for V3 machines (machines with gear driven superchargers), as shown in Figure 2. Additional support for the flametrap housing can also be obtained with the addition of supporting braces to the exterior of the inlet manifold, as shown in Figure 3, which would need to be completed by VLIDD in conjunction with a Code D inspection. A more rigorous design review of the air intake assembly support requirements has also commenced.

**Figure 1:** Photographs showing a JUG-A-0 air inlet manifold, highlighting the location at which fatigue cracks have been identified.

4. Visually inspect all JUG-A-0 air inlet manifolds for crack indications in the welds.
5. Conduct soapy water inspections on all JUG-A-0 air inlet manifolds fixed joints.
6. Inspect all JUG-A-0 air inlet manifold mounting bolts to ensure correct type and size (M8 X 25 SHCS Grade 12.9), and installation torque (28 ft.lb), and replace as necessary.
7. Where inlet manifold cracks or insufficient fixed joint integrity are identified, please contact VLIDD to discuss rectification requirements.
8. Where no crack indications or fixed joint integrity issues are identified, continue to inspect the air inlet manifold weld and fixed joint integrity as per the recommended VLIDD service schedule, obtain and install air intake strangler support bracket (Part No. 0508-60081) at the earliest opportunity. At the next Code D service, the inlet manifold is to be returned to VLIDD for assessment.

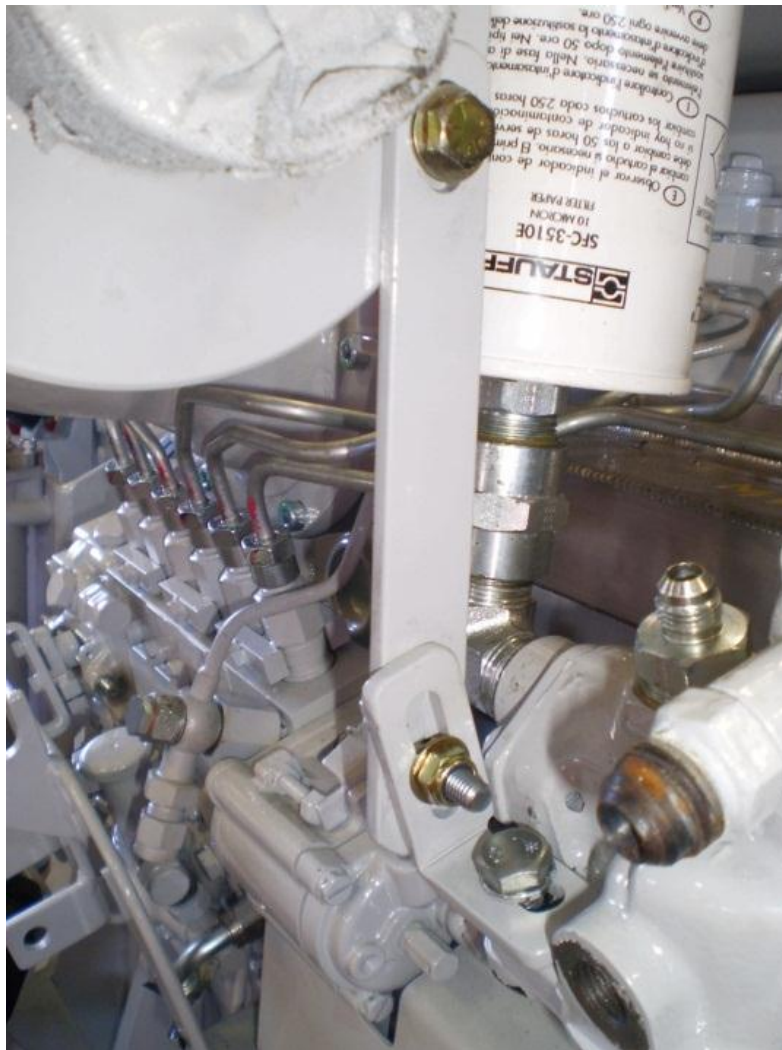
**Figure 2:** Photograph showing the support bracket (Part No. 0508-60081) for the air inlet ducting and strangler valve assembly for V3 machines (machines with gear driven superchargers), as installed.

To address inlet manifold cracks VLI developed a support bracket (Part No. 0508-60081) to provide support for the air inlet ducting and strangler valve assembly on machines with gear driven superchargers.

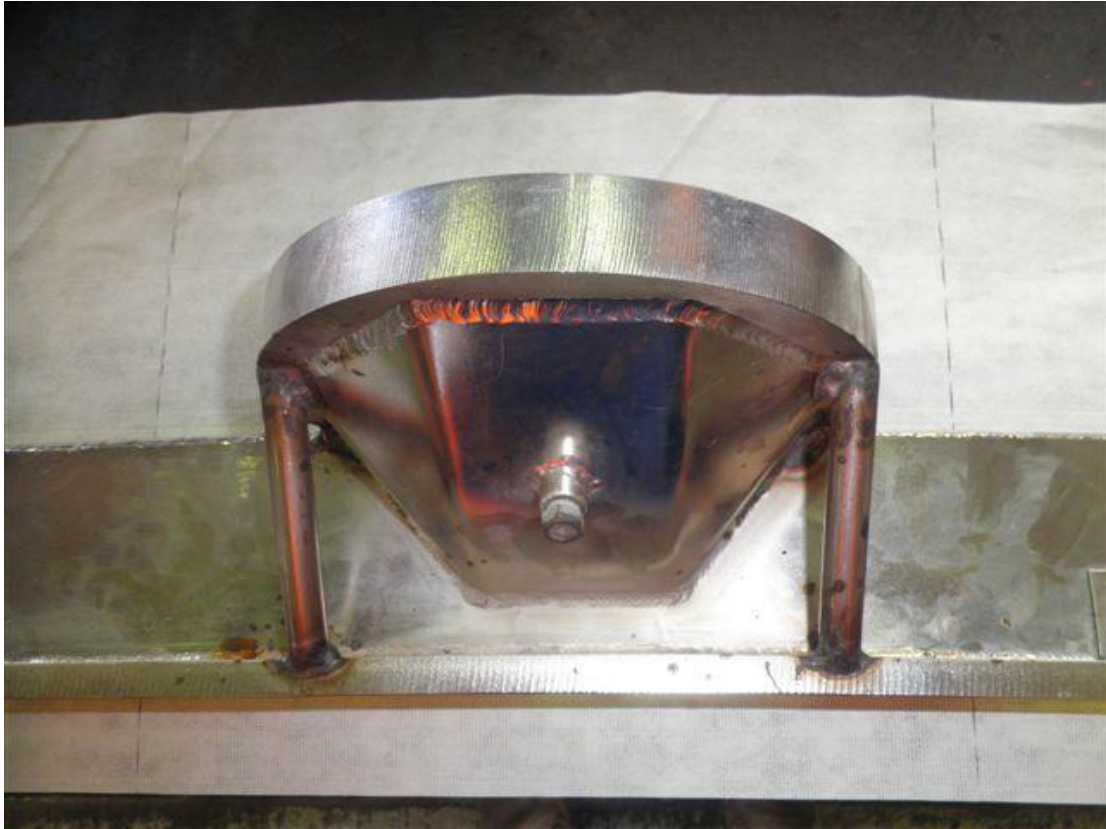
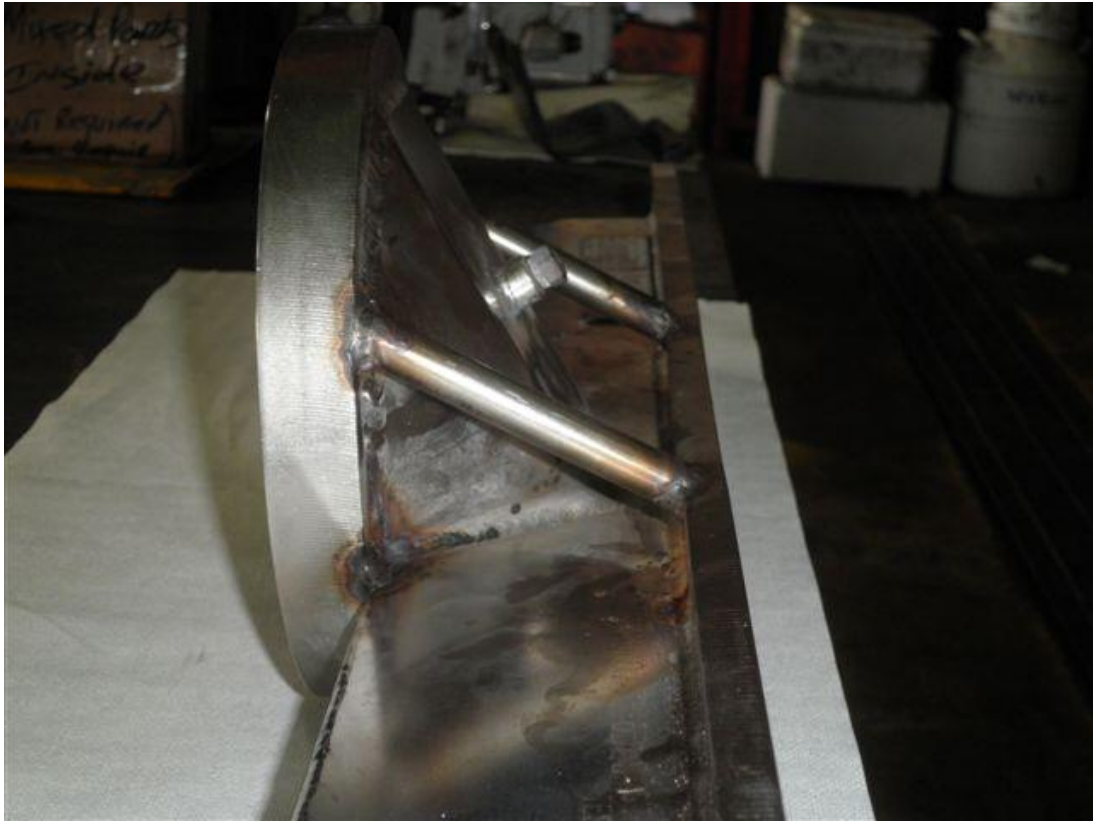
**Figure 3:** Photograph showing the additional supporting braces added to the exterior of the inlet manifold for additional support for the flametrap housing.

VLI will now introduce the previously mentioned optional support braces to all new production of inlet manifolds, and recommends installation of these support braces to existing products at the next major service interval, either by modification or exchange.
