Technical Bulletin / Safety Alert

Unique ID No: DES2011-TBSA-06

Subject: JUG-A-0 UL/UV Diesel Particulate Matter Filter Fire – Incident Notification

Date: 29/02/2012

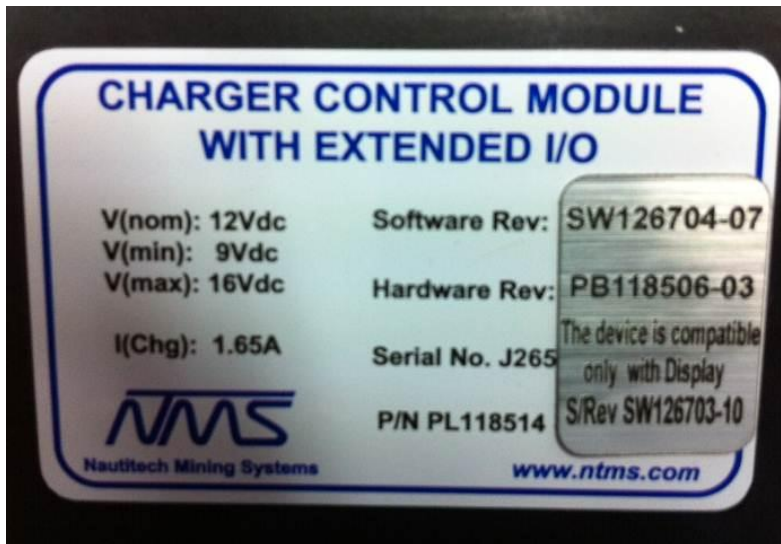
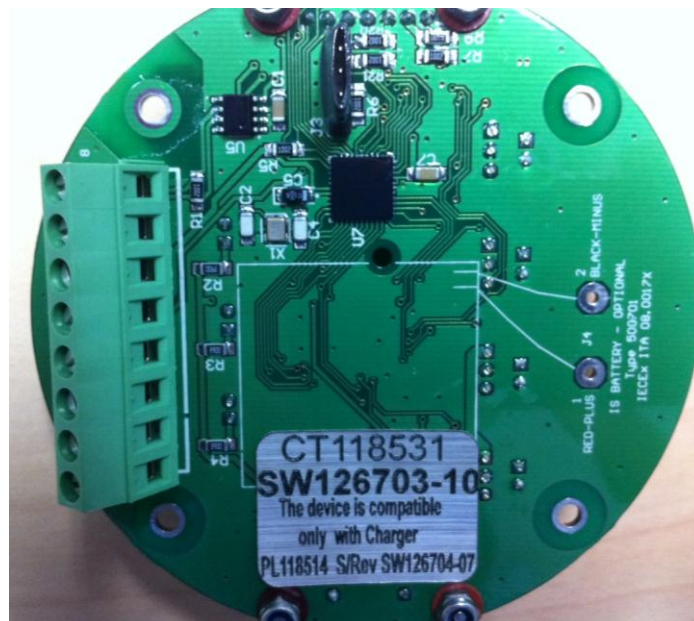
All new and service exchange JUG-A-0 shutdown system charger units and display boards will contain the software update. In order for updated components to be effective, both the display and charger unit must be changed out at the same time. Changing only the display or only the charger will result in a software conflict and the JUG-A-0 will not start.

Each component is labeled with software revision and software compatibility as shown in the following photographs:

It is recommended that all applicable JUG-A-0 UL/UV equipment owners and end users update equipment with the latest display and charger at the next major electrical code service interval.

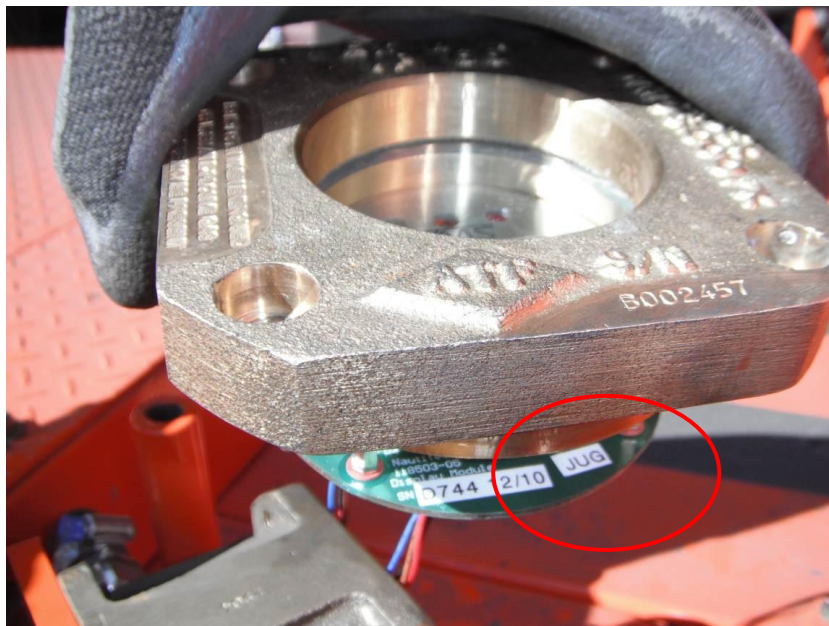
It has been identified that with regards the physical appearance of the circuit boards, the only difference between the two (2) components is an identification label. The JUG-A-0 circuit board includes a “JUG” label (Figure 1) and the circuit board compatible with other OEM systems will not include this label (Figure 2). Each circuit board will also display a unique serial number; however this does not identify compatibility with the machine shutdown system.

Figure 1: JUG-A-0 Display Unit highlighting the “JUG” label attached to the circuit board.

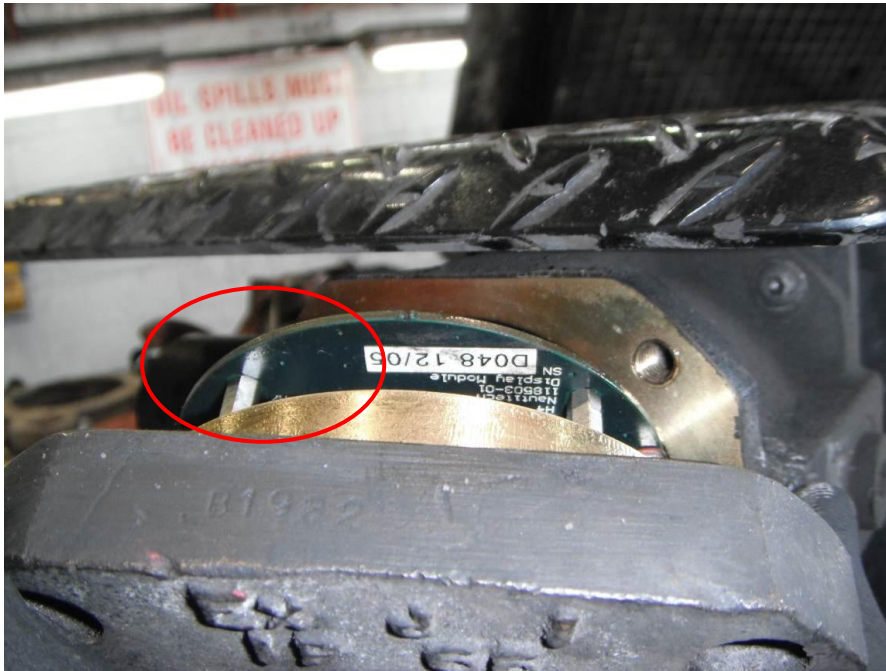
Figure 2: Other OEM Display Unit highlighting the absence of the “JUG” label.

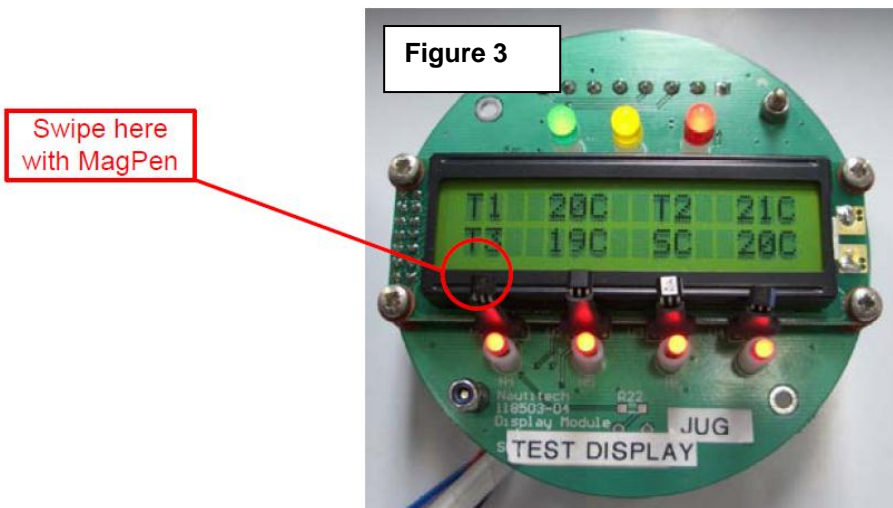
- All JUG-A-0 UL/UV equipment owners and end users to inspect machines for correct operation of shutdown systems and correct circuit board installation as per following procedure.
- The simplest method for checking the correct circuit board is installed to the machine is to power up the display unit and using magnetic pen swipe the far left key and observe that the screen will display the temperatures at T1, T2, T3 and SC (supercharger), which identifies that all sensors are operating correctly (Figure 3).
