Technical Bulletin / Safety Alert

Unique ID No: TBS2011-TBSA-01

Subject: VLI Driftrunner Transport Braking System – Door Interlock Valve

Date: 16th November 2011

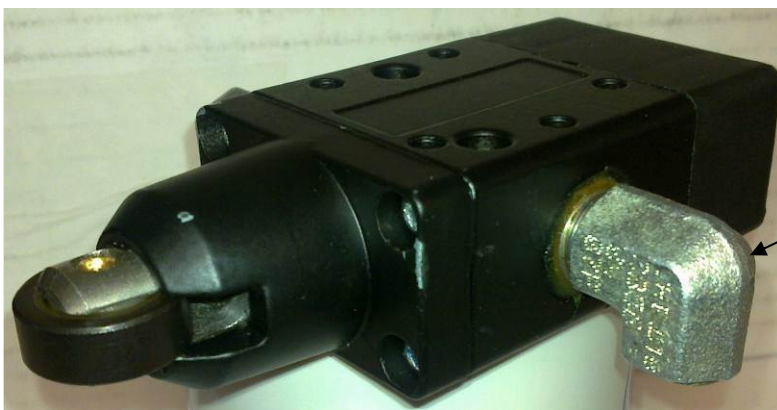
1. Due to redundancy within this system, the door interlock valve still meets CAT 3 standard.
2. The original FMEA identified the risk of contamination and accordingly an additional filter was added to the circuit for the MDR 083991 TBS. All systems should be upgraded to this design registered system as the Previous MDA approval has expired.
3. In addition to the already comprehensive OEM Maintenance recommendations an additional recommendation from this review is to remove and clean the door interlock valve at Code D (2000 hrs or two years).
4. Further to this an additional plug to prevent ingress of foreign material is being introduced (refer image below).

Cut off fitting in the exhaust port. Note orientation of fitting to minimise ingress of foreign material.

1. All VLIDD transport braking systems to be serviced and maintained in accordance with OEM recommendations.
2. All transport braking systems to be upgraded to the appropriate design registered system.
3. Door interlock valves to be removed and cleaned at the Code D mechanical inspection interval (every 2000hrs or 2 years, whichever occurs first).
4. Door interlock valves to have cut off fittings installed to exhaust ports to assist with the prevention of ingress of foreign material.
