Technical Bulletin / Safety Alert

Unique ID No: TBS2015-TBSA-01

Subject: Driftrunner Axle – Steering Component Failure

In-service failure of safety critical steering component

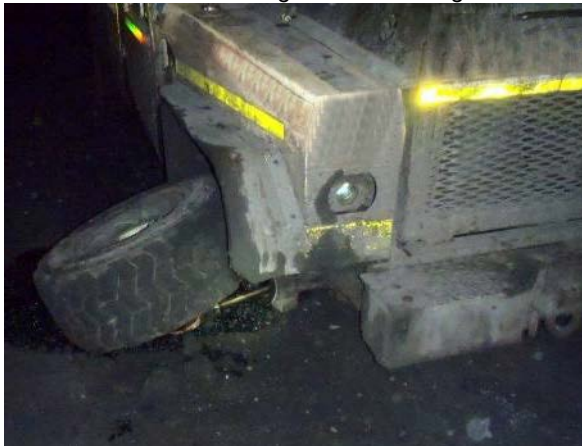
Photo 1: Failure to front right-hand steering knuckle

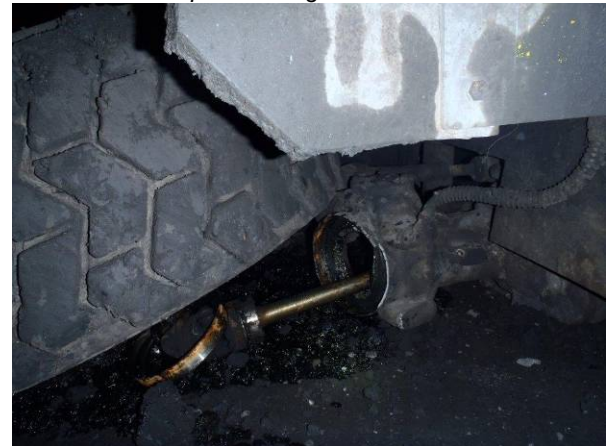
Photo 2: Close-up view of right-hand failure

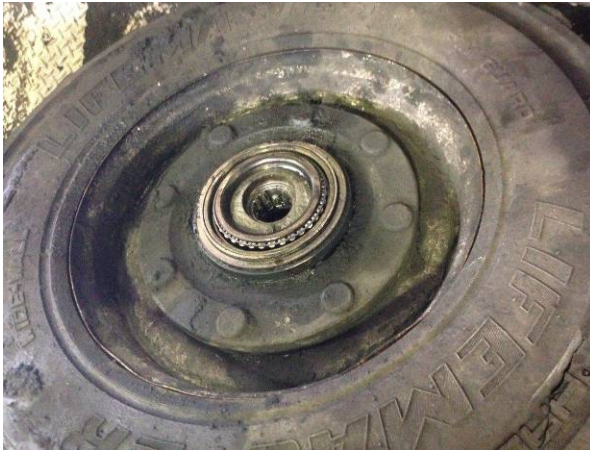
A metallurgical evaluation of the weld repaired swivel housing confirmed failure had initiated from the weld repair.

Photo 3: Failure to stub axle left-hand side

VLI does not recommend repairs to the swivel housings of any axle assemblies. VLI recommends worn or damaged swivel housings be replaced.

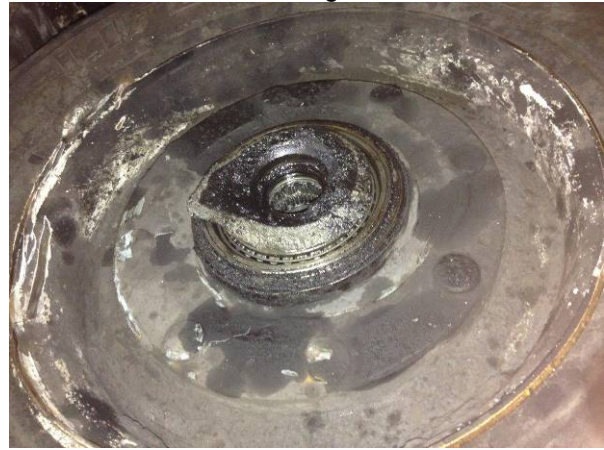
Photo 4: Failed stub axle right-hand side

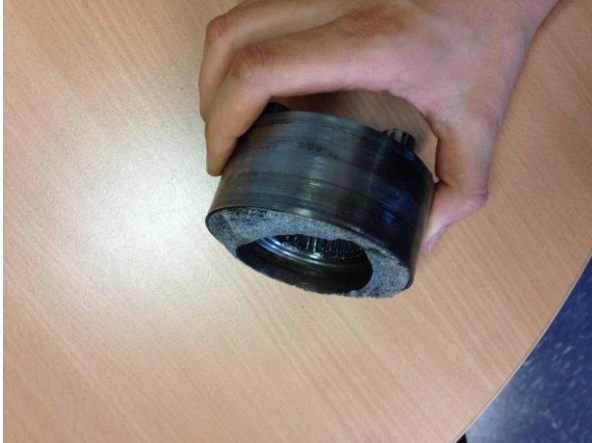
Visual examination of the sleeved swivel housing identified failure had initiated adjacent to the end of the sleeve.

Photo 5: Stub axle re-sleeved

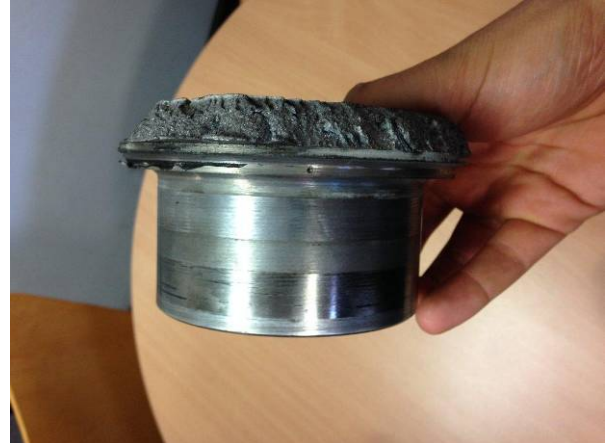
Photo 6: Failed stub axle
