ENGINEERING BULLETIN

Ref Document No.	EB15005	Issue No.	2
Subject	Re-Orientation/modification of MONEx Exhaust back pressure sensor		
Release Date	16 th April 2015		
Client	COALTRAM® Owners / Operators		
Facilitator	PPK

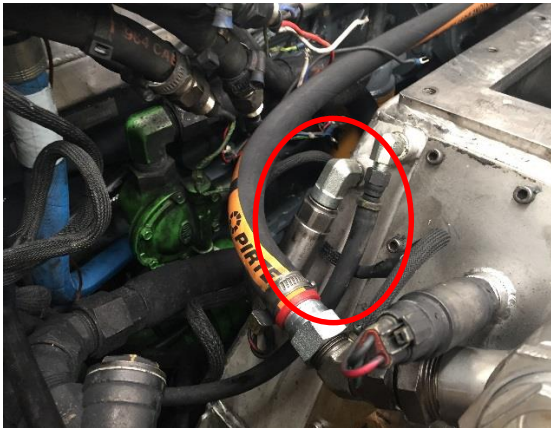
Image 1.

Component inspection revealed excessive carbon build-up on the sensor & within the elbow pathway. The current orientation does not allow for the adaptor pathway to self-drain after vehicle is shutdown. As a result diesel particulate matter is pooling and contaminating the sensor, fouling the elbow pathway.

The following images show the current Exhaust back pressure sensor position (Image 1) and 90° elbow orientation (Image 2).

PPK recommend replacement of the 90° elbow (part No.5520000693) to reduce contamination of the back pressure sensor head.

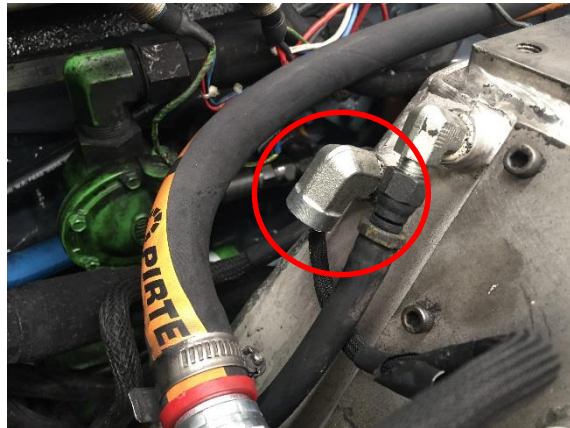
Image 2.

The pooling of contaminants against the sensor is due to the 90° elbow orientation.

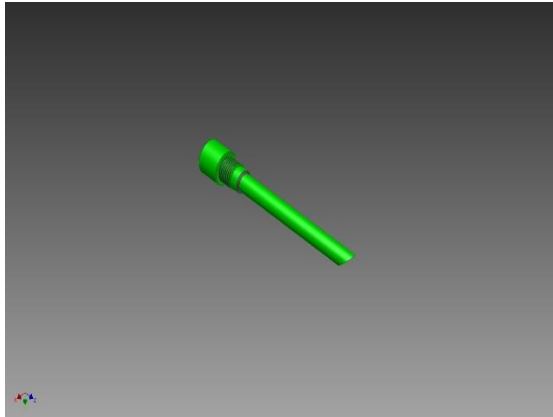
The following images show; Image 1. Back pressure sensor extension component. Image 2. Cross section of the back pressure sensor reorientation and fitment. Image 3. Expanded view of the Exhaust back pressure sensor, Sensor extension and scrubber weldment. Image 4. Installed sensor extension and sensor.

A back pressure sensor extension was designed (part No. 5520009545). This relocates the back pressure sensor higher in a downward orientation, eliminating the trapping of Diesel particulate debris.
