Technical Bulletin / Safety Alert

Unique ID No: GEN2010-TBSA-03 Rev: 1

Subject: JUG-A-0 UL/UV Pneumatic Horn Circuit

Applicable to: All JUG-A-0 UL/UV V2 & V3 machines.

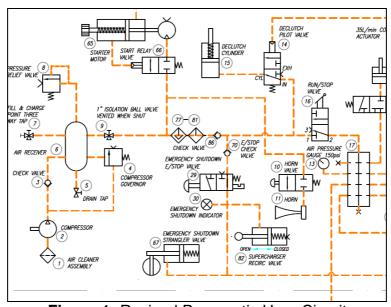
Figure 1: Revised Pneumatic Horn Circuit

Investigation of the occurrence described above identified that the rate of air delivery to the circuit containing the horn valve and horn was insufficient to replenish the air being exhausted by the horn, when the horn valve was activated continuously for extended periods. In this case, air pressure in the circuit was able to reduce to less than 60psi, which was the minimum pilot pressure required for the park brake valves.

It is recommended the pneumatic horn circuit is separated from the pneumatic circuit and installed as per the revised schematic shown in Figure 1 below. Figure 2 shows the original installation schematic. The complete revised pneumatic schematic is also attached.

A one way check valve (part no. 0601-60008) has also been installed in the safety circuit and the air pressure gauge source relocated. The check valve is located after the filter / drain / lubricator. The air pressure gauge is now sourced from the manifold.
