Technical Bulletin / Safety Alert

Unique ID No: TBS2012-TBSA-01

Subject: Driftrunner & Brumby Master Cylinders – Incident Notification

Date: 20th September 2012

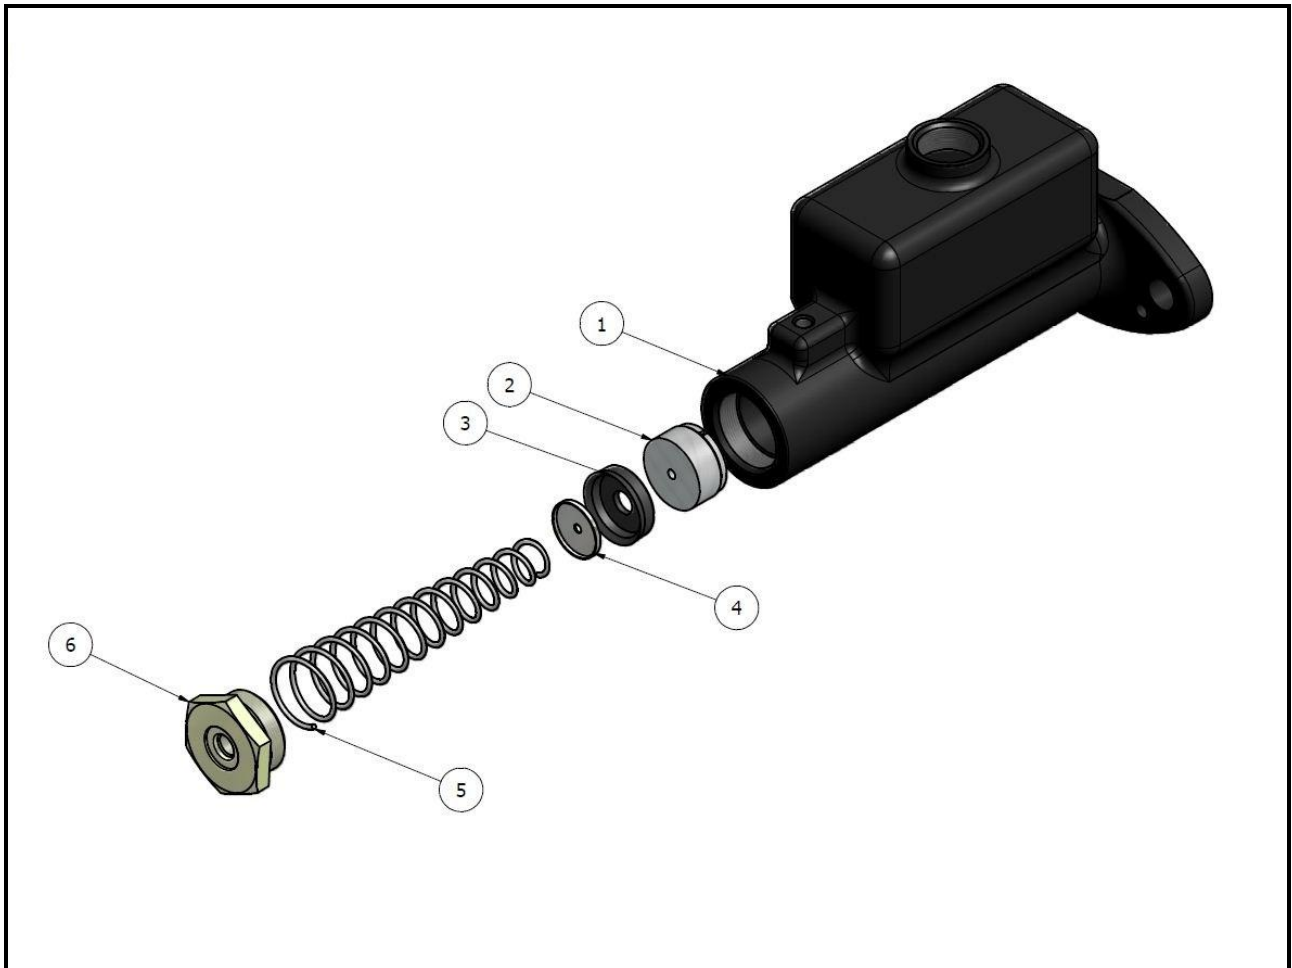
Incidents were reported of pressure decay of the service brake system on Driftrunner vehicles.

Initial investigations identified bypassing in the master cylinder and the supplier confirmed that a batch of piston cup seals (refer item no. 3 in Figure 1 below) did not conform to designed dimensional requirements. An interim batch of seals was produced to address non-compliant product whilst the master cylinder supplier resolved the original issue with the piston cup seal supplier. It has been reported that some of the interim batch of seals have suffered a similar bypassing issue to that of the original supply. Due to this non-conforming product the master cylinder supplier has sought piston cup seal supply from an alternative (Quality System endorsed) supplier and these new seals are now available.

Figure 1: Master Cylinder Assembly GA. Item 3 is the piston cup seal.

Equipment owners and end users should continue to inspect ABC brand master cylinders installed to their Driftrunner and Brumby vehicles. Mico master cylinders are not affected. All ABC master cylinders must be tested as follows:

1. Gauge (nominally 0 – 2000psi) to be installed down-stream of the master cylinder.
2. Service Brake pressure applied and held.
3. Observe pressure gauge. Pressure (nominally 1100 – 1200psi) must not decay within approximately 30 seconds.

Any master cylinder assemblies that do not meet the above performance test requirements are to be removed from service and replaced with conforming product supplied by VLI Diesel Pty Ltd.
