SAFETY BULLETIN

COALTRAM® CT08 AND CT10

Transmission cover not latched securely leading to injury

Ref Document No.	SB13001	Issue No.	1
Release Date	04 April 2013

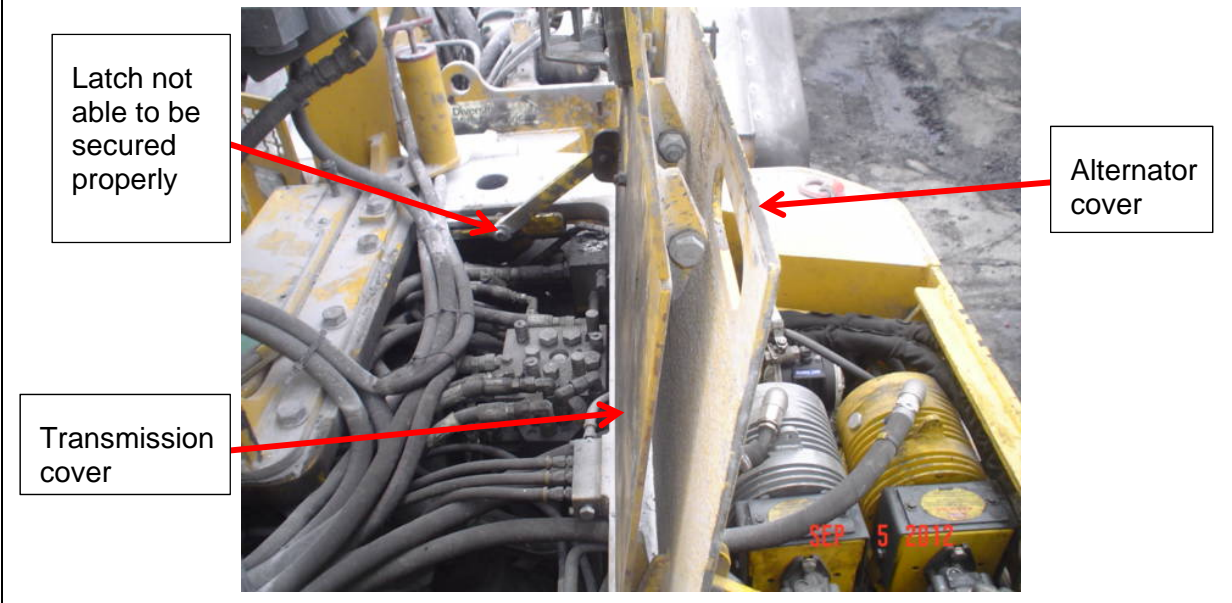
It was revealed that when the alternator cover is raised and latched in position, the transmission cover is able to rise past vertical and rest against the alternator cover however cannot be securely latched in place.

In order to unlatch, either of these covers, they must first be taken past the vertical position and then lowered. In this particular incident, both covers were open, the alternator cover latched and the transmission cover resting against it. The alternator cover was then moved in order to be closed, which required it being taken past the vertical position. Subsequently the transmission cover which was resting on the alternator cover was moved past its vertical axis and fell closed. This action caused the fingers of an adjacent worker to be struck and an injury was sustained.

It is recommended to shorten the transmission cover latch (Part No. 5575701153) by 50mm in order to allow the cover to be securely latched when the alternator cover is in the open position. This will enable personnel to correctly latch the cover in the open as it removes the need to travel over centre. Refer Figure 1 below for details of modified latch.

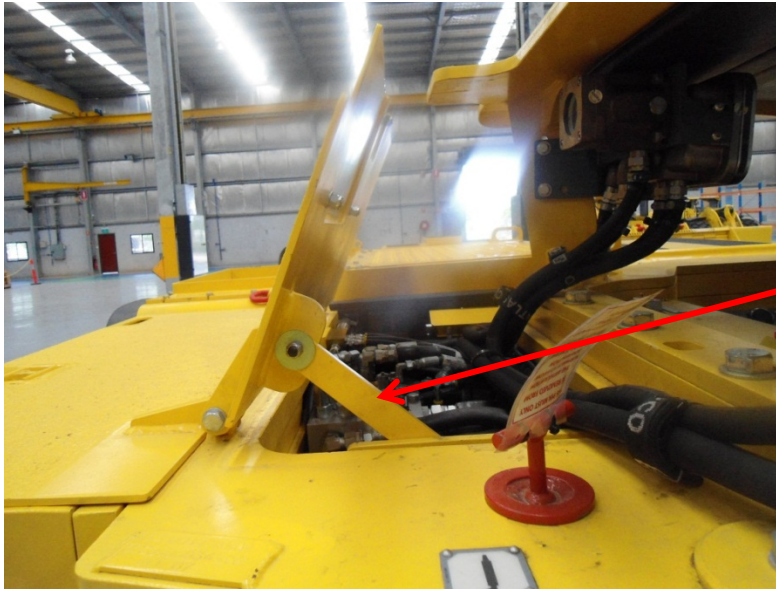
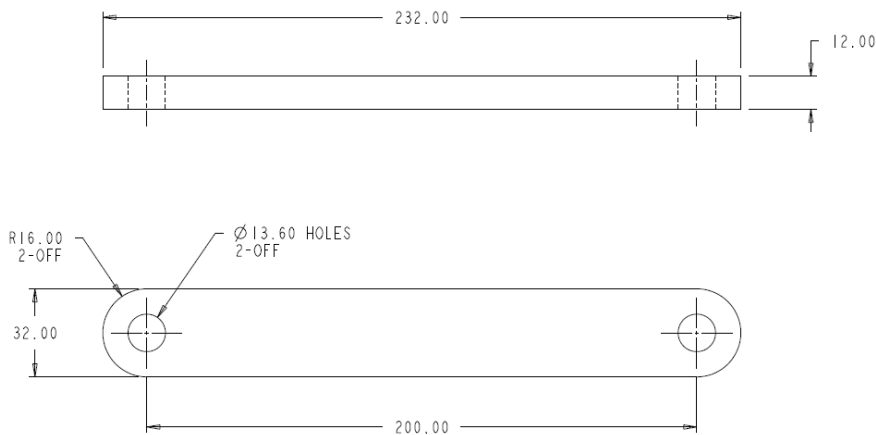
Figure 1. Modified latch details

Transmission cover latch
