Technical Bulletin / Safety Alert

Unique ID No: TBS2009-TBSA-03

Subject: Brake Valve Failure

Applicable to: JUG-A-0 UL/UV Machines (N.B. – this may affect other machines using the same valve, owners and end users should consult the relative OEM for their recommendations)

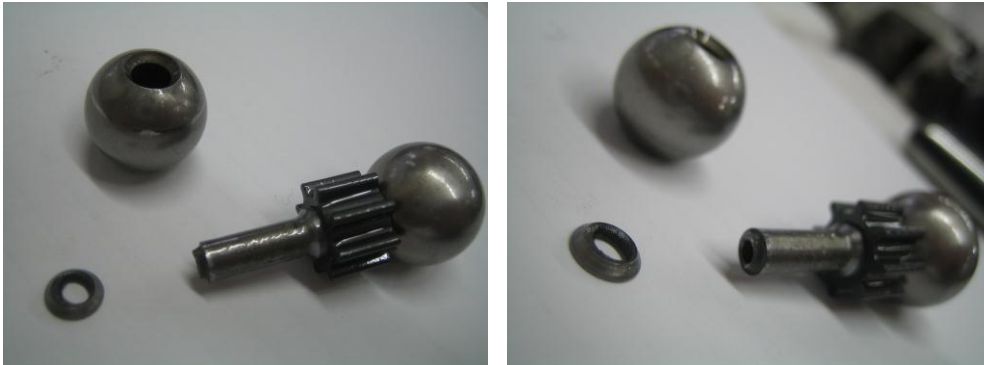
The Service Brake Valves from the original failures were stripped down to find that the porting valve had fractured leaving the ball section on one end free to close off the Tank port (T) & leave the Pressure port (P) open to the Actuator port (A), refer Figure 1.

Figure 1: Photographs showing the failed porting valves from the original 2 off service brake valve failures in 2009.

The service brake valve failures reported in this TBSA were caused by the fatigue failure of the internal porting valve assembly. This prevented an adequate rate of decay of oil pressure holding the SAHR brake units off, resulting in the loss of service brake function and the brake valve failure incidents reported.

VLI recommends the service brake valve on all JUG-A-0 UL/UV machines be replaced or overhauled at intervals not exceeding 5000hrs service life.

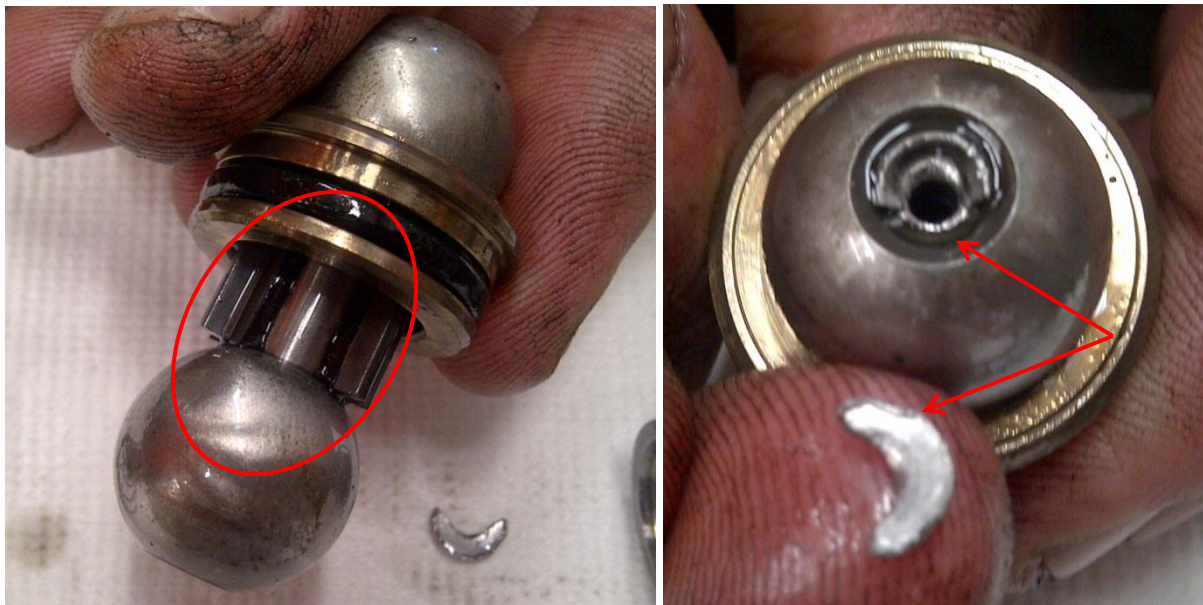
Disassembly of the service brake valve from the most recent incident identified that the porting valve had a small section of metal missing from one of the swaged ends of the shaft connecting the ball sections (the ball sections remained intact and connected), and the spline on the shaft appeared to have fractured and there was a piece missing, which was not recovered, refer Figure 2.

It was considered that the missing spline piece combined with the small piece of swaged metal could have hindered the porting valve operation during service, preventing or reducing oil flow to tank and possibly also leaving the Pressure port (P) open to the Actuator port (A), therefore the oil pressure holding the SAHR brake units off was not able to decay, resulting in the brake valve failure incident reported.

Figure 2: Photographs showing the porting valve from the recent service brake valve failure in 2013, highlighting the missing piece of spline and the fractured metal from one of the swaged ball ends.

To the knowledge of VLI, these 3 service brake valve failures are the only reported failures. The failure mode of the porting valve failures exhibited in each of the 3 reported incidents is one of fatigue. It is understood that each of the reported failures has occurred in a service brake valve with service life exceeding 8000hrs. Based on this information VLI is now recommending the service brake valves on all JUG-0-A UL/UV machines be replaced or overhauled at intervals not exceeding 5000hrs.
