# **Technical Bulletin/Safety Alert**

### **BULLETIN NUMBER;- TBSA (0501)**

## Subject:- Damage to scrubber protection/ access cover

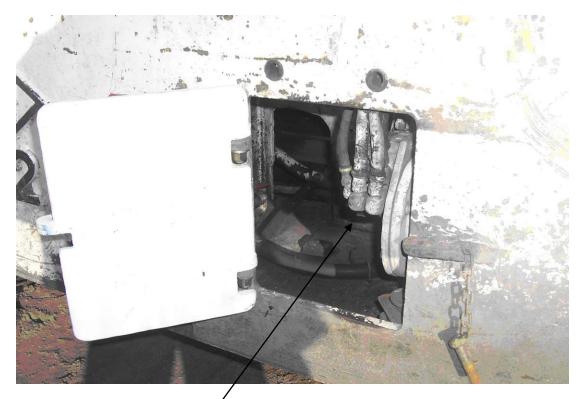
The impact of the vehicle damaged a cover over the float arrangement near the scrubber that in turn damaged the scrubber shut down mechanism. As a result excessive smoke was reported coming from the exhaust. The mine incident report noted a minimal amount of water was found above the test point of the scrubber system. The exhaust particulate filter was also changed at the time as it appeared to be unserviceable.

Damaged fittings and cam shaft in this area

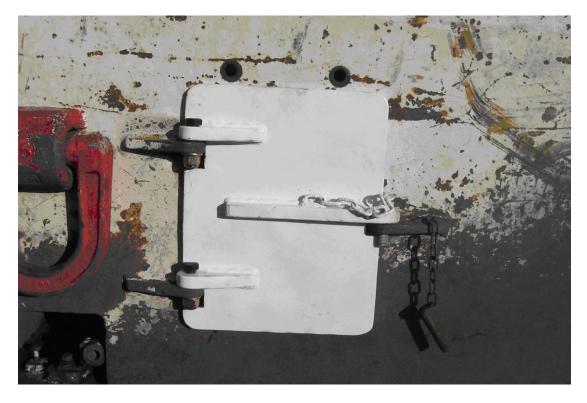
New design fitted cover over the scrubber float cam mechanism

Anderson Group of Companies as the agents for Atlas Copco Wagner products have redesigned a new cover to reduce the likelihood of a similar occurrence.

The cover now encompasses a more sturdy structure and has been designed to sit outside the parameter of the main frame and therefore further away from mechanism affected. This design also gives additional structural support. Please see photo below for new design.

Anderson's part number of the cover is :- 5571723300 and we strongly recommend this modification be carried out as soon as possible. The new cover has been designed to be retrofitted with no machine frame modifications. The hinge and latch point positioning may differ if previous repairs have been carried out by others.
