Technical Bulletin / Safety Alert

Unique ID No: GEN2012-TBSA-02

Subject: Driftrunner Steering Valve Installation

Applicable to: All VLI Driftrunner Vehicles

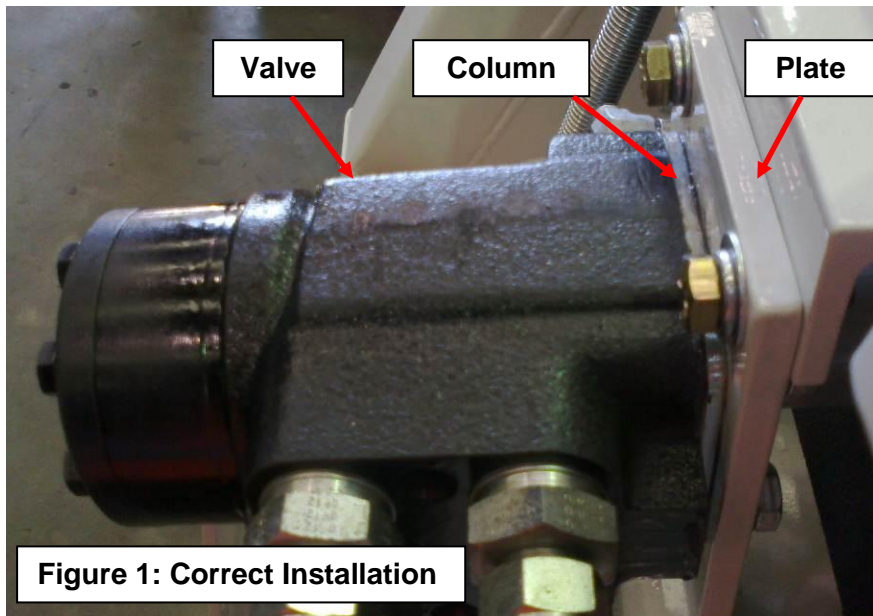
The steering column is to be mounted directly to the steering valve, and then to the mount plate, as shown below in Figure 1.

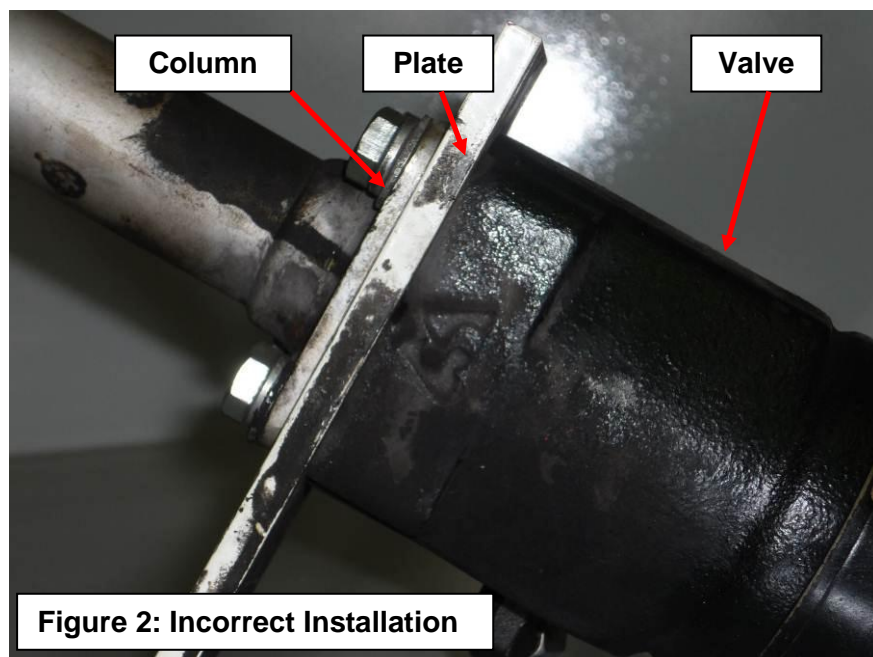
The incorrect method of mounting the steering column to the steering valve is shown in Figure 2, where the mounting plate has been placed between the steering column and the steering valve. This installation method reduces the length of engagement of the steering column pinion to the steering valve gear, potentially affecting the steering response of the vehicle.

End users should immediately inspect all Driftrunner vehicles to verify correct steering valve installation.

Vehicles with incorrect installations should be removed from service immediately and installation corrected.
