## **Technical Bulletin / Safety Alert**

**Unique ID No:** GEN2010-TBSA-04

**Subject:** JUG-A-0 UL/UV Exhaust Conditioner Makeup Tank Exhaust Check Valve

**Applicable to:** All JUG-A-0 UL/UV machines.

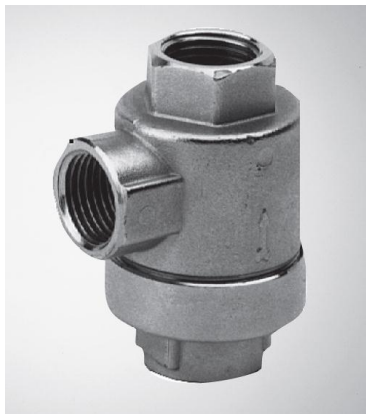
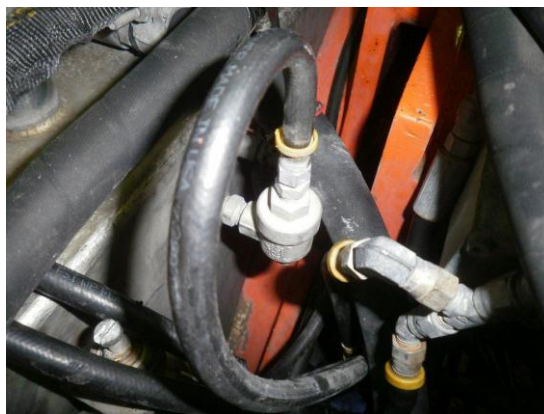
The exhaust check valve (0601-60007) is shown in Figure 1 for reference.

**Figure 1:** Photographs showing quick exhaust valve Part No. 0601-60007, and as installed.

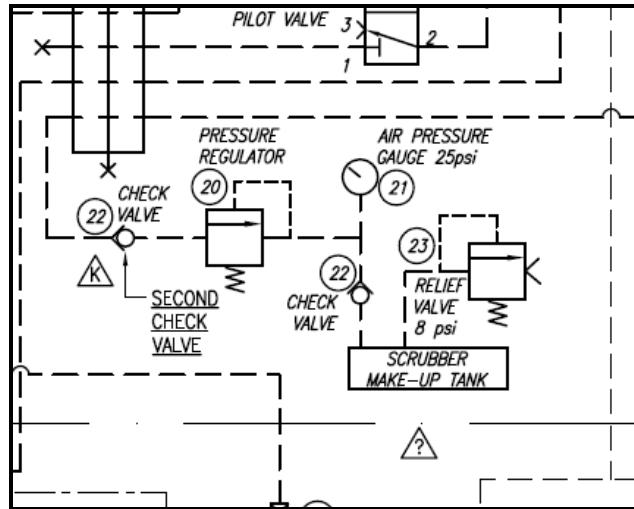
Previously (refer GEN2010-TBSA-04 Rev 1), the existing check valves (2 off part no. 0601-10022) installed in the air line between the manifold and the exhaust conditioner

Subsequently it was discovered that the absence of check valves at this position resulted in release of air system pressure from the main air circuit each time the machine was shut down, and in some instances insufficient air pressure remained in the circuit to enable the machine to be restarted. To counter this unintended outcome, a new stainless steel check valve (0601-10027) is recommended to be installed with the exhaust check valve to maintain air circuit pressure at shutdown. The exhaust valve continues to provide secondary protection to the main air circuit from moisture ingress, at the same time as providing self-evident fault indication in the event that the check valve fails, since air system pressure will be lost.

**Figure 2:** Original Pneumatic Circuit showing two (2) check valves (Item No. 22, Part No. 0601-10022) installed.

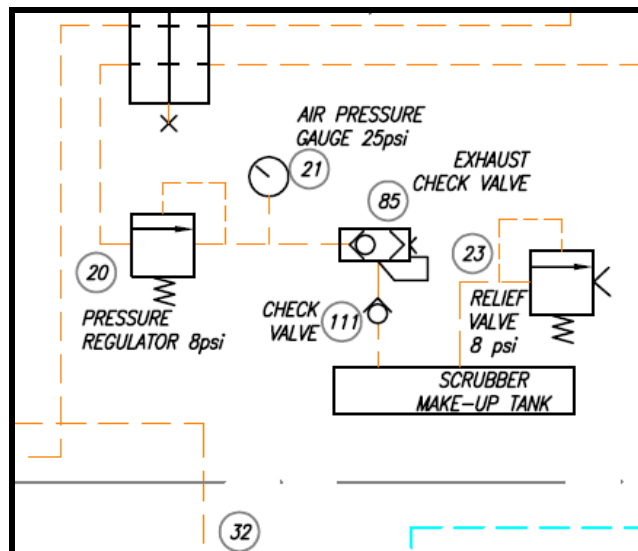
**Figure 3:** Recommended Pneumatic Circuit installation of exhaust check valve (Item No. 85, Part No. 0601-60007) and new check valve (Item No. 111, Part No. 0601-10027).

Replacement of the two (2) check valves, described above, with a single stainless steel check valve and quick exhaust valve reduces the risk of valve deterioration and failure due to moisture exposure, and improves protection of the shutdown circuit from moisture ingress.

It is recommended the described circuit changes be implemented at the next major service interval.
