Technical Bulletin / Safety Alert

Unique ID No: DES2008-TBSA-01

Subject: Possible Engine Shutdown Cylinder Failure

Applicable to: VLI Diesel Driftrunners & Brumbies

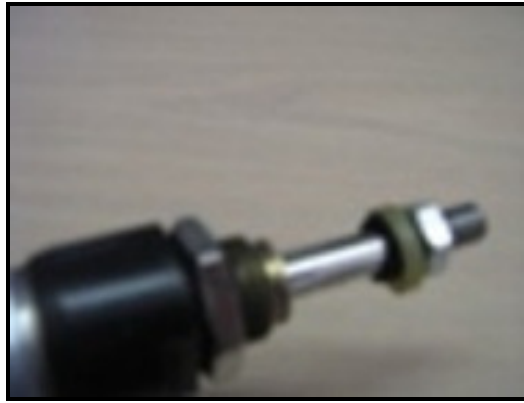
Figure 2.

Upon receipt seal on cylinder shaft was not in its correct position ie: inside of gland on shaft, instead was floating on shaft itself. (Figure 2).

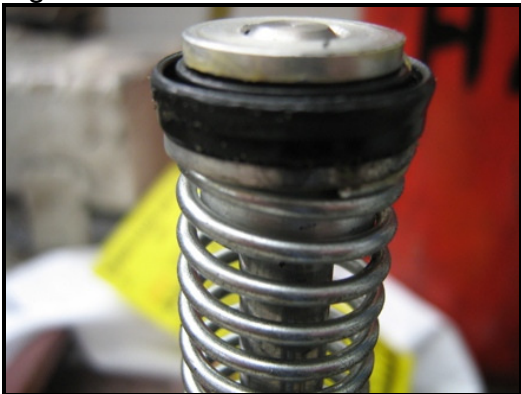
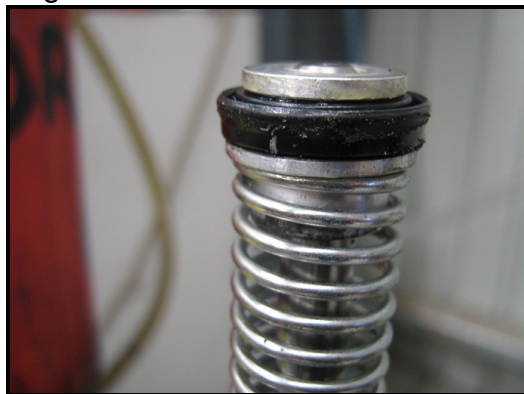
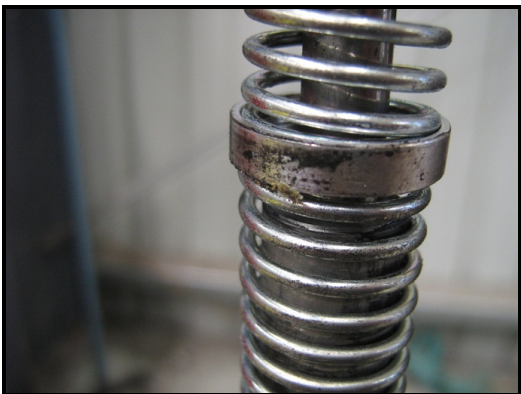
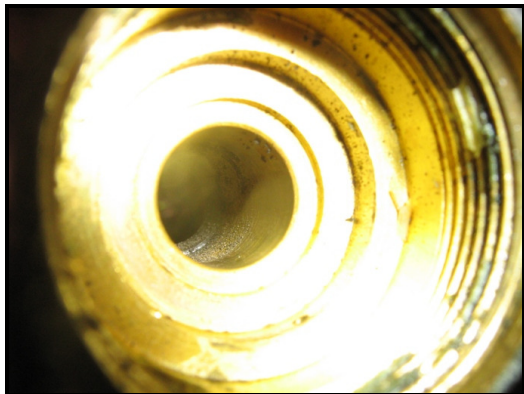
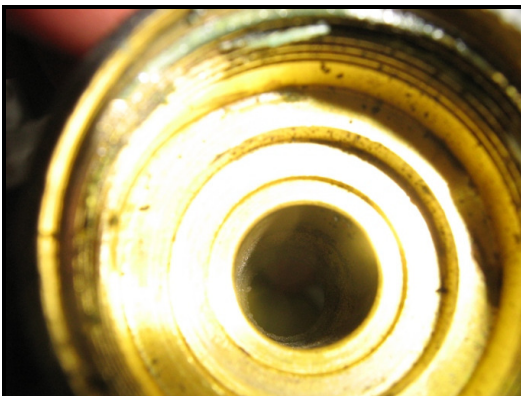
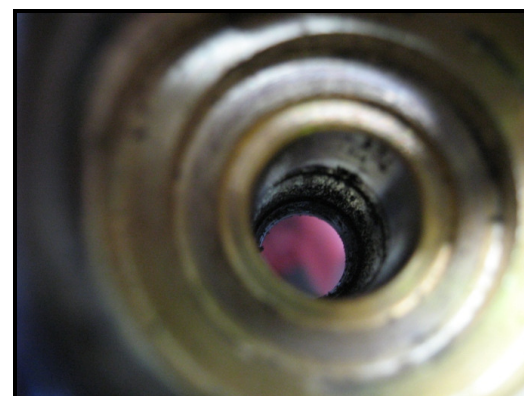
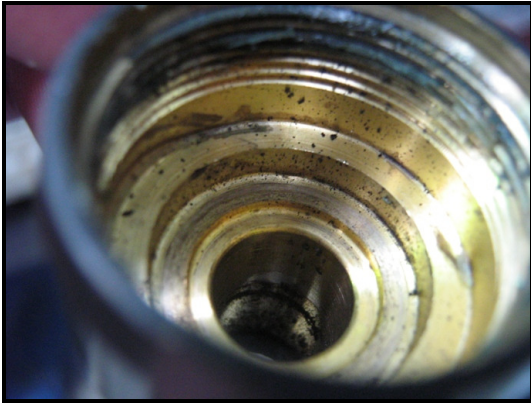
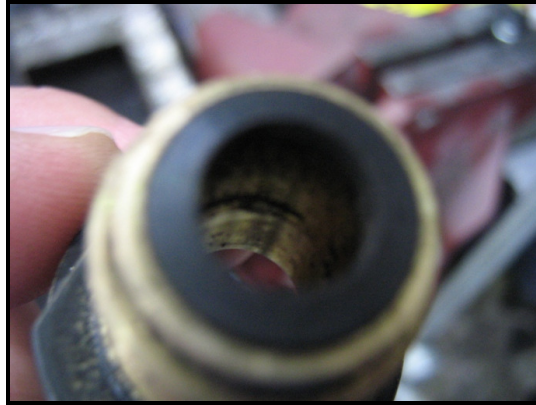
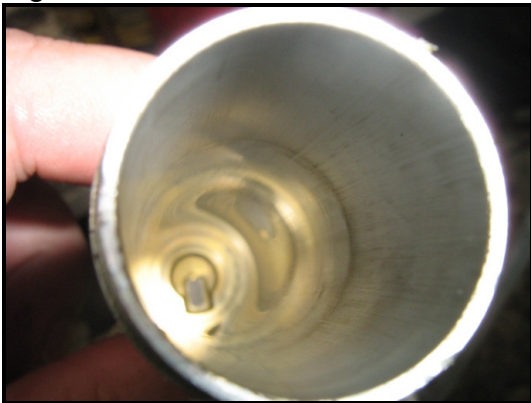
When disassembled a considerable amount of contaminants were found throughout the internal parts of the cylinder. (Figures 3-11).

It appears the cylinder failed to operate correctly due to contamination of the internal parts due to the ingress of foreign objects into the cylinder body. After dismantling, cleaning & lubrication of the shut off cylinder it functioned correctly without any signs of sticking whatsoever.

VLI Diesel recommends regular inspections/maintenance of all components fitted to the Drifrunner with particular attention to the pneumatic circuit, safety circuit & Engine componentry.

Immediate Action: All machines to have their Shutdown Cylinders inspected for integrity, ingress of contamination, & safe operation.

Machines to have the filtration fitted (if not already) as per Technical Bulletin TB04
