SAFETY BULLETIN

Ref Document No.	SB23001	Issue No.	1
Subject	COALTRAM® CT08/CT10LP Crowd Cylinder Failures		
Release Date	16 th August 2023

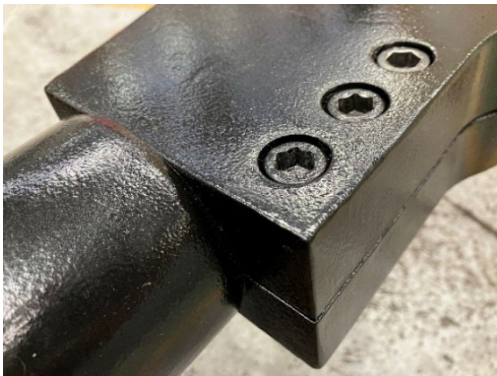
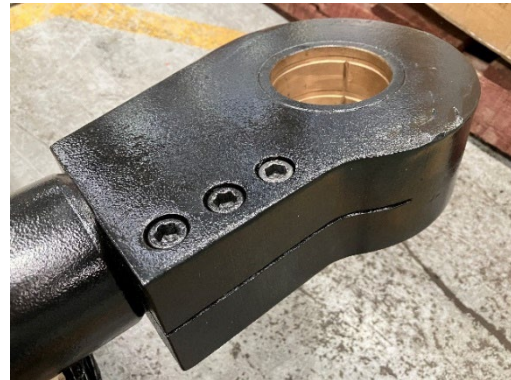
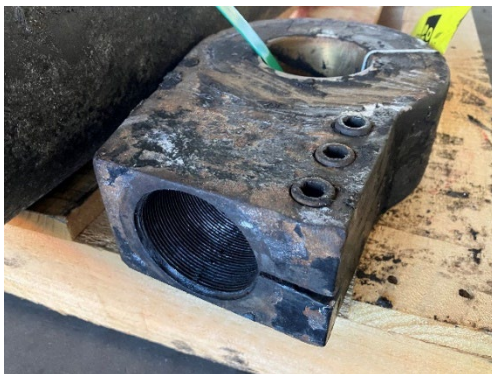
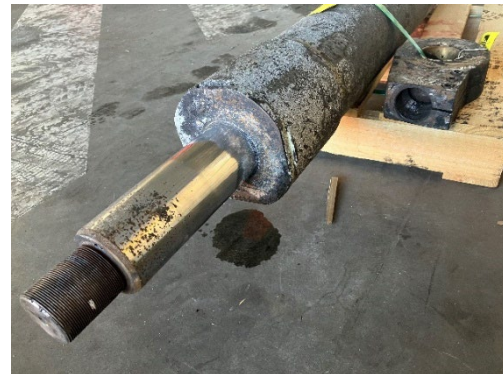
The crowd cylinder on CT08 and CT10LP models utilises a split clevis rod eye design. The cylinder rod has a threaded end, which mates with a female thread in the rod eye. The rod eye has a split clevis design, which clamps the rod using three M12 grade 12.9 bolts.

PPK Mining Equipment have received reports of two incidents where the crowd cylinder clevis eye has separated from the cylinder rod end during normal operation.

Investigations are ongoing, however early inspections indicate that in at least one case the rod had unwound from the clevis before losing engagement and separating from the rod eye.

1. It is recommended that all applicable crowd cylinders be inspected to ensure there are no visible signs the cylinder rod has moved in relation to the clevis. The clevis end wall must be seated firmly against the crowd cylinder rod end shoulder, with no gap.
2. Inspect all the clevis clamp bolts are in place and secure with no visible signs of movement.
3. If any signs of movement between the clevis end wall and cylinder rod shoulder are found, it is recommended that the cylinder be removed from service for repair or replacement and PPK Mining Equipment be contacted.
