ENGINEERING BULLETIN
COALTRAM®
Procedural Changes to Installation of Turbo

Ref Document No.	EB13001	Issue No.	1
Release Date

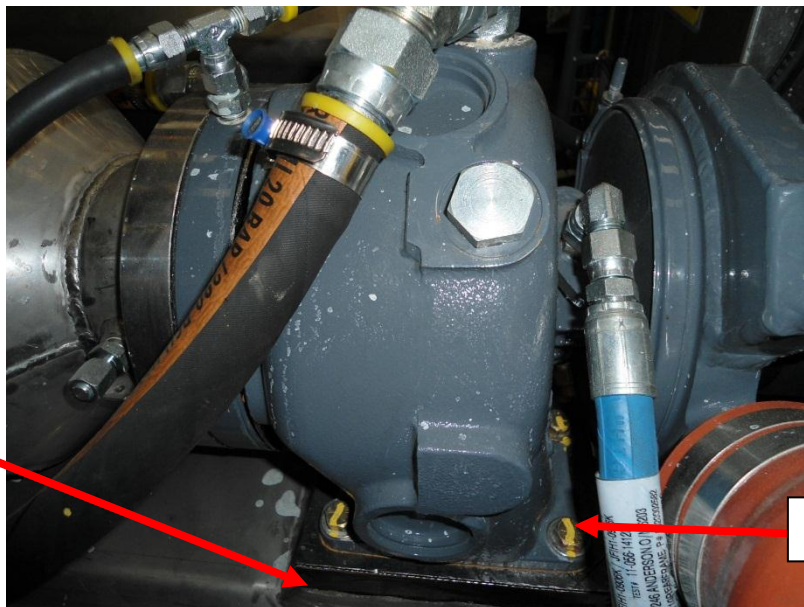
EXHAUST
MANIFOLD
TO TURBO
JOINT

Further investigation revealed a gas leak at exhaust manifold to turbo joint interface due to a fastener being loose securing the turbo to exhaust manifold.

FASTENER

Check bolt torque and adjust to correct specification if needed. Proceed with steps below.

Install bolts without applying a locking agent and torque to correct specification. Proceed with steps below.

1. Start engine and let run until engine reaches normal operating temperature.
2. Stop engine and allow system to cool to ambient temperature.
3. Individually remove each turbo to exhaust manifold mounting bolt, one at a time, apply Loctite 243 and tighten bolts to specified torque.
4. Test for gas tightness by way of soapy water test.
5. For further information refer to Safe Work Procedure SWP CT3.17
