## **Technical Bulletin / Safety Alert**

**Unique ID No:** DES2014-TBSA-02

**Subject:** MDR074246DES Inlet Manifold Flametrap Housing Fasteners

**Applicable to:** ALL VLI JUG-A-0 UL/UV Machines with MDR074246DES and MDR074246DES-1

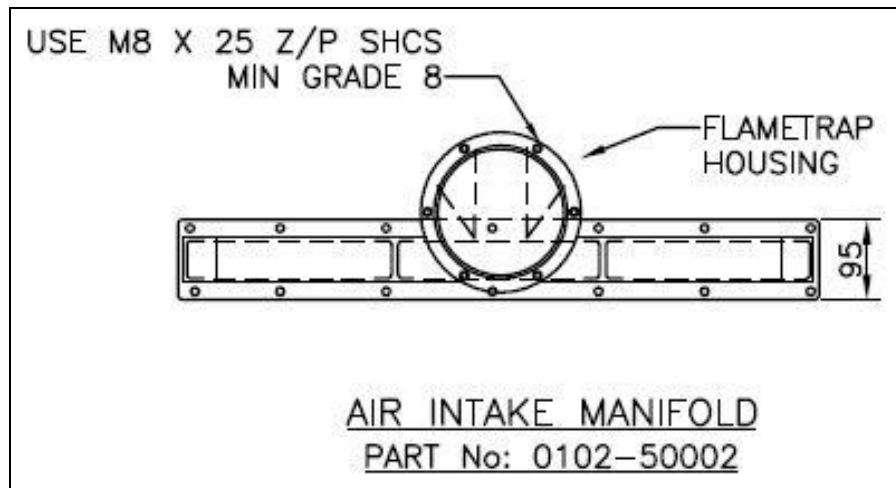
The relevant design registration drawing JHDES-101 Revision C identifies the required fasteners as “M8 X 25 Z/P SHCS Min Grade 8”, refer Figure 1, which are normally installed to blind threaded holes in the inlet manifold flametrap element housing flange.

**Figure 1: Excerpt from design registration drawing JHDES-101 Revision C with the intake flametrap housing fasteners identified.**

The fastener requirements specified on the design registration drawing JHDES-101 Rev C, as shown in Figure 1, are accurate for the V3 supercharger installation.

The inlet ducting configuration of the belt driven supercharger installation (V2) results in limited fastener access at the 11 o'clock position (as viewed in Figure 1), and therefore the use of a through bolt with a nut and washer in this location is required.

VLI can confirm that the use of a through bolt at this location on any MDR074246DES or MDR074246DES-1 inlet manifold flametrap housing fixed connection is acceptable, and recommends the use of SAE Grade 8 (or ISO Grade 10.9) fastener components as a minimum.

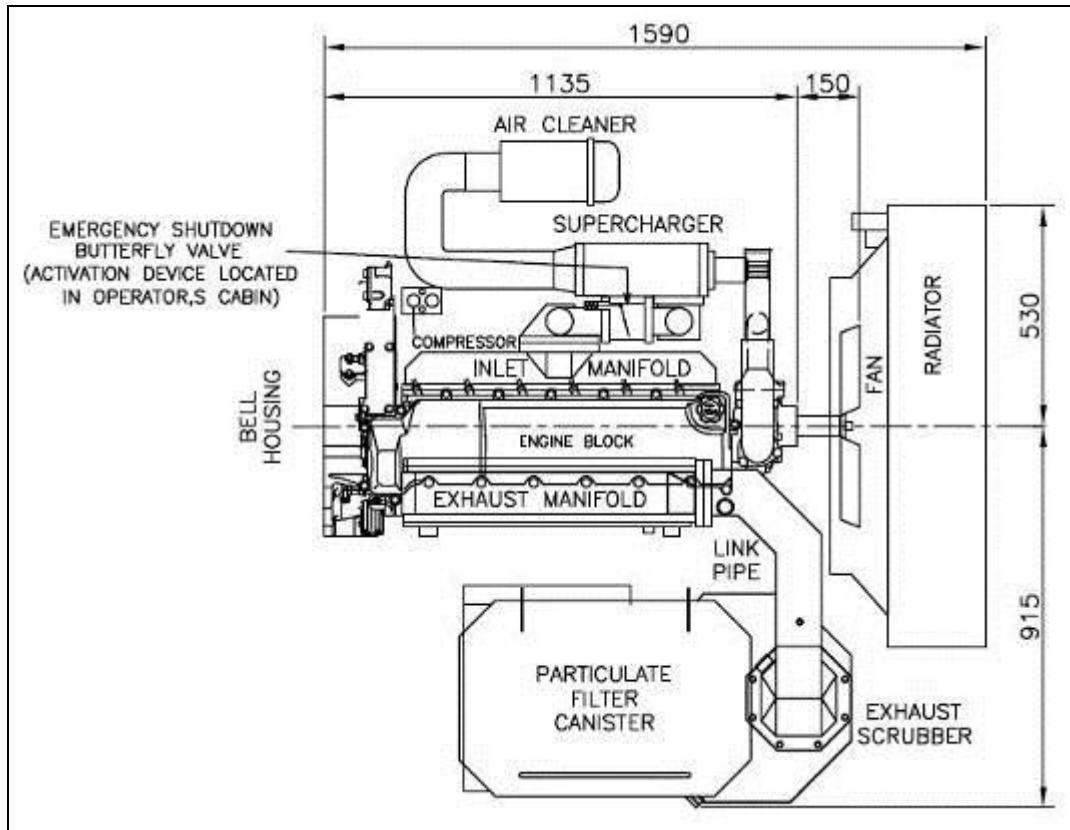
**Figure 2: Representation of a belt driven supercharger installation (commonly referred to as a V2)**

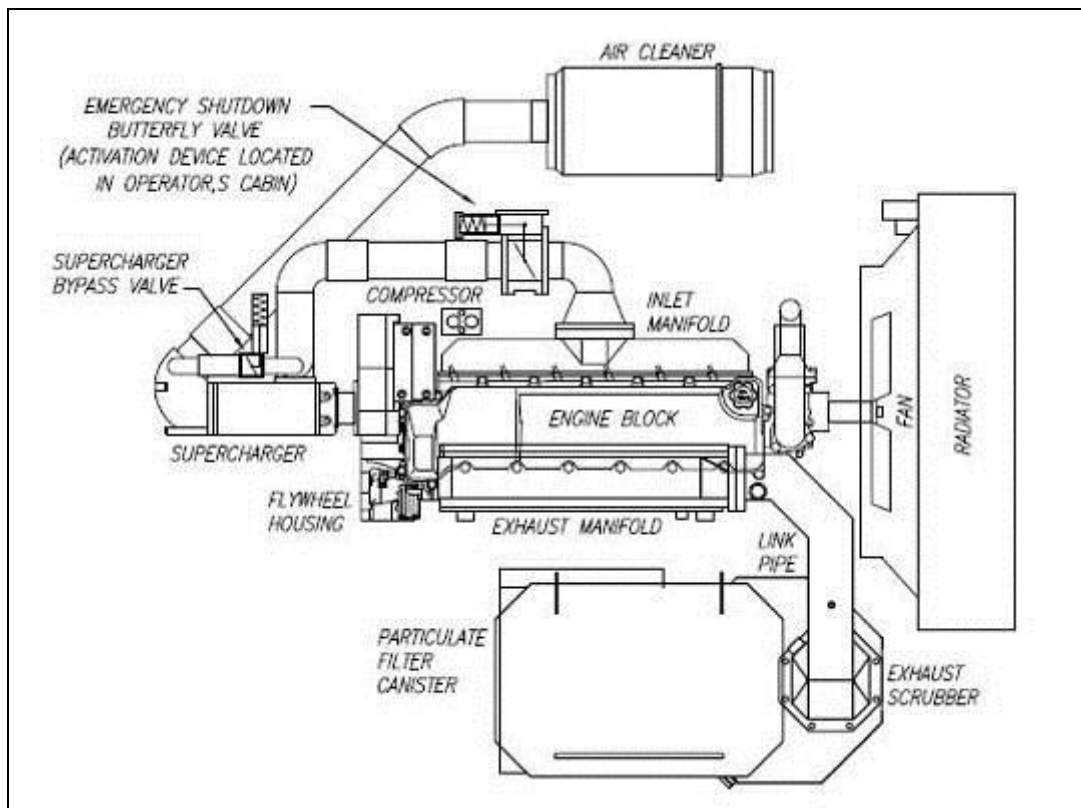
**Figure 3: Representation of a gear driven supercharger installation (commonly referred to as a V3)**

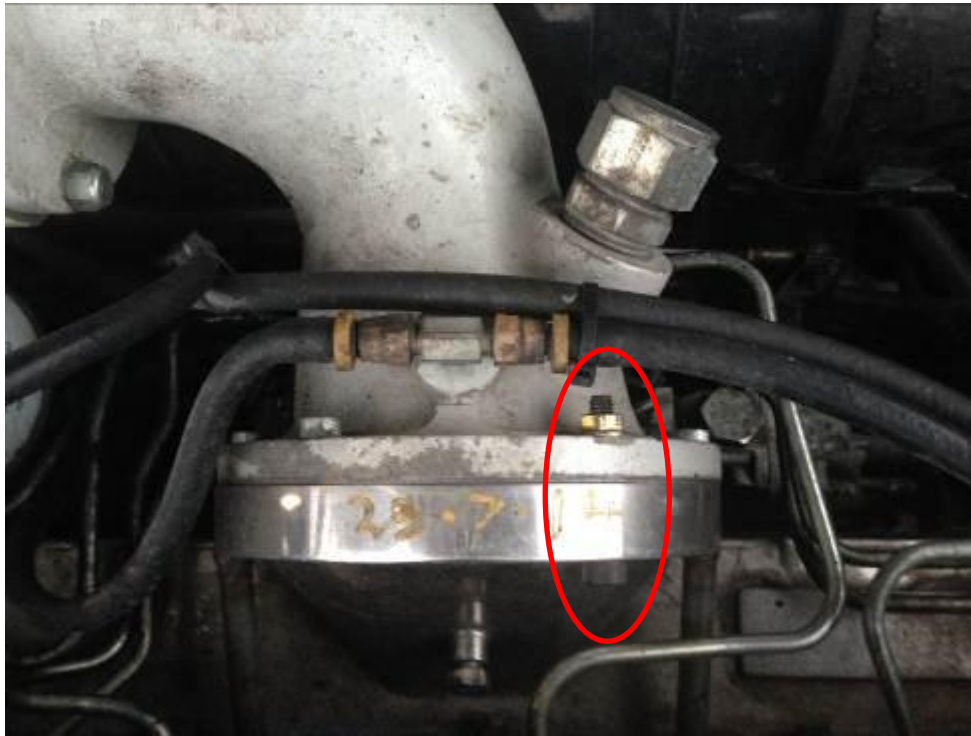
In some cases replacement inlet manifolds installed to gear driven supercharger installations (V3) have also contained the through hole and the through bolt fastener is used, see Figure 4 for an example.

**Figure 4: Photograph showing an example of the use of a through bolt fastener (as installed to a V3 engine configuration).**
