ENGINEERING BULLETIN

Ref Document No.	EB16001	Issue No.	1
Subject	CT08 and CT10LP Lift Boom Stiffening Plate Upgrade		
Release Date	14 th April 2016

Purpose – Advise COALTRAM® CT08 and CT10LP owners/operators that an upgrade to the lift boom is now available.

Applicability – COALTRAM® CT08 and CT10LP models

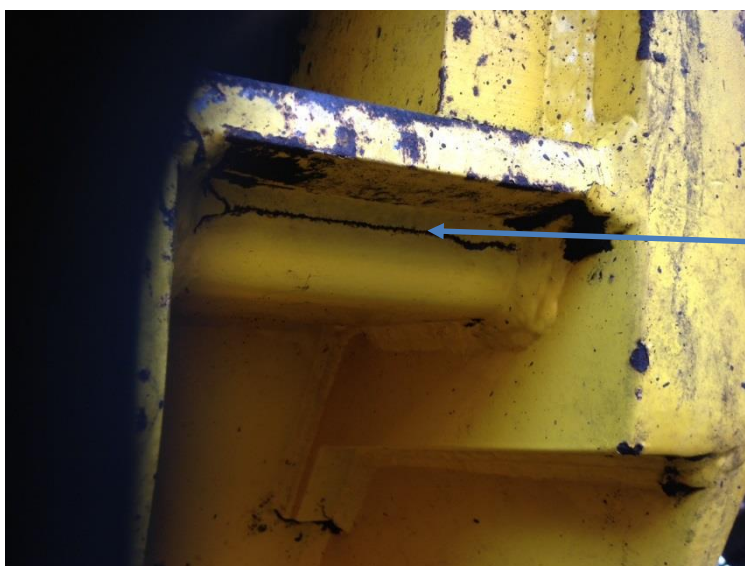
Photo 1

The cracking has low structural detriment, however prolonged inaction could instigate more significant structural failures.

PPK became aware of cracking associated with the lifting boom frame during routine servicing and inspection of the CT08 COALTRAM®. The cracking is fatigue in nature and propagates through the weld boundary between the weld material and parent metal. (Photo1)

Crack at weld boundary

1. PPK recommend that all CT08 and CT10LP COALTRAM® lifting booms are inspected for cracking in the lift cylinder pockets and front pivot clevis cross brace. Specific boom inspections should be scheduled into the next 250 hour service for each vehicle.
2. If cracking is detected repairs should be scheduled and the upgraded stiffening plates installed.
3. Routine inspections for cracks should continue to be conducted as per service sheets.
4. PPK, recommend completing the installation of the stiffening plates in a PPK workshop as the boom requires removal for the installation of the new plates. Stiffening plates required for the upgrade are 2 off – 5520010026 and 1 off – 5520010027.

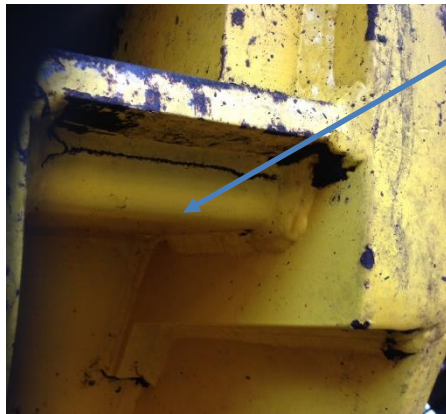
Photo 2

The boom lift cylinder pockets (Photo 2) cracked through a capping or sealing weld of the existing rolled stiffener. The upgraded stiffener (Photo 3) replaces the existing rolled plate stiffener and fills the void behind.

Existing stiffener (rolled plate)

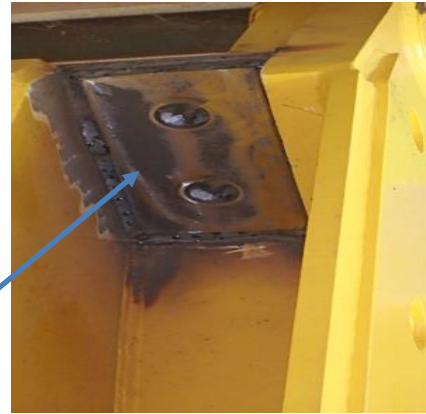
Photo 3

Upgraded stiffener

The three upgraded stiffening plates provide additional support to the affected areas.

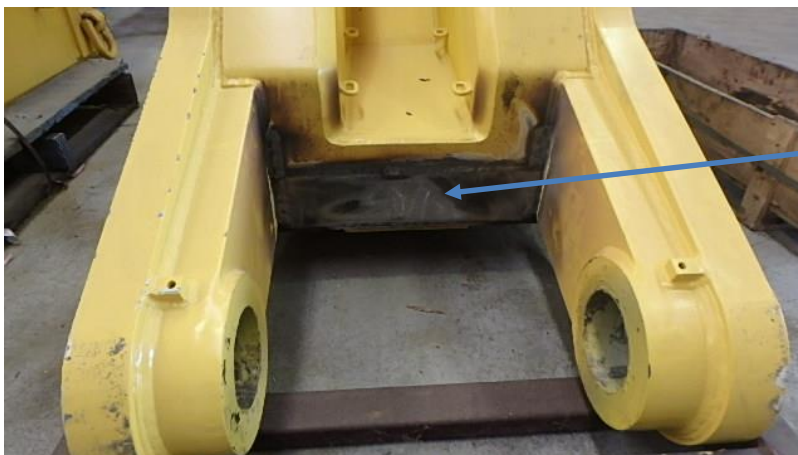
Photo 4

The addition of the 3rd stiffening plate to the front pivot clevis cross brace is included to further reduce the torsional flex of the structure between the clevises. (Photo 4)

3rd stiffening plate installed
