## **Technical Bulletin / Safety Alert**

**Unique ID No:** GEN2009-TBSA-02

**Subject:** Mine Loader Driveshaft Centre Bearing Failure

**Applicable to:** All JUG-A-0 UL/UV Machines

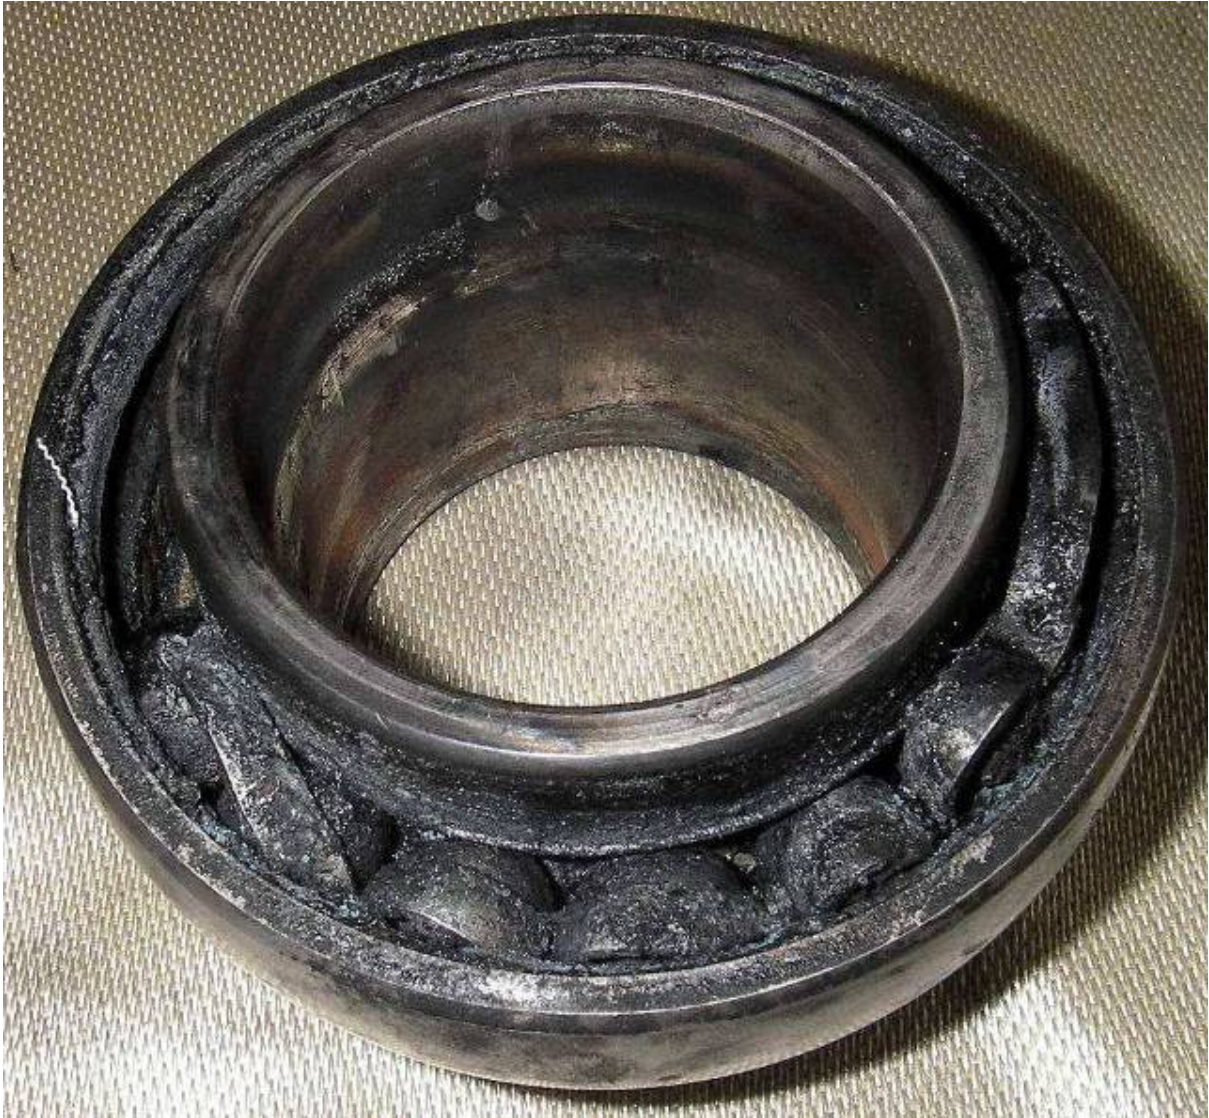
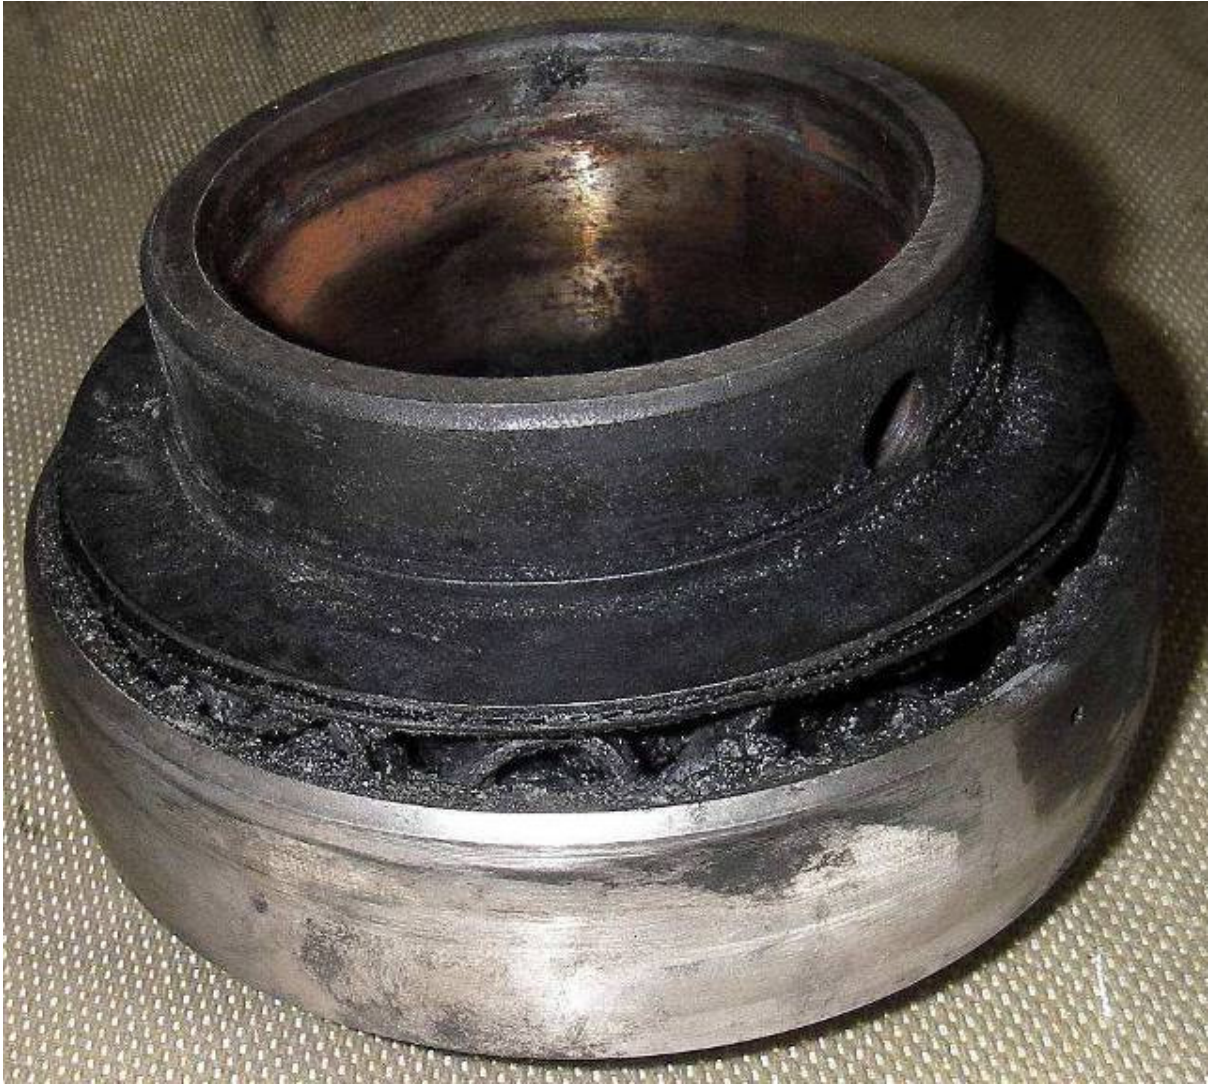
A general view of the bearing in the as received condition is shown in figures 1 & 2. The bearing had the following markings on the end of the inner raceway.

There was still some grease present in the bearing, although it had become very dry and contaminated from the fire. The grease had a very gritty texture and was very hard as well.

Figure 1 Ball roller bearing in the as received condition (before cleaning)

Figure 2 Ball roller bearing in the as received condition (before cleaning)

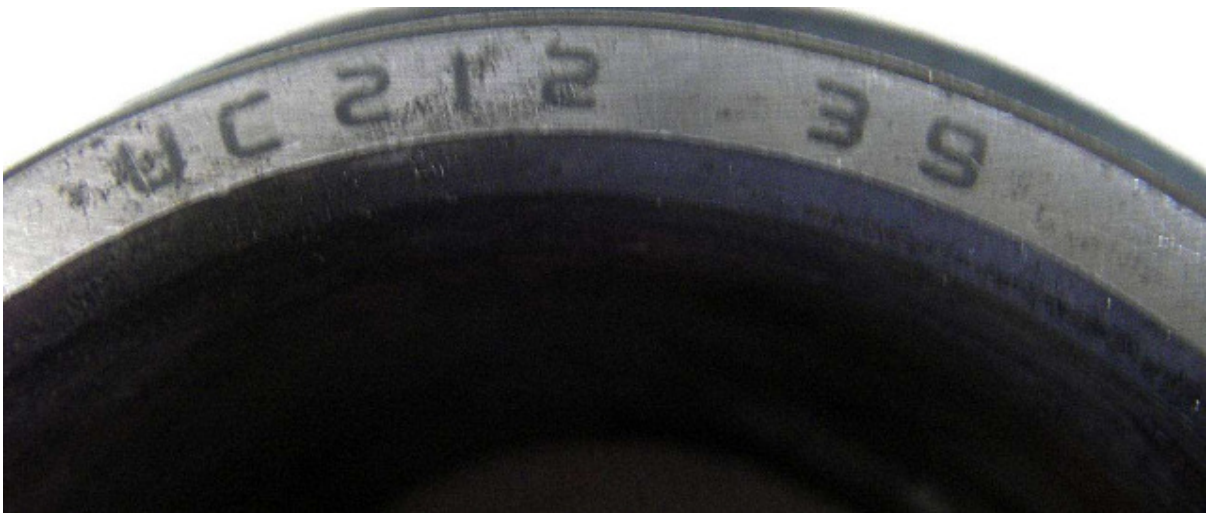
UC212 39 (see figure 3)

Figure 3 Identity number on inner raceway

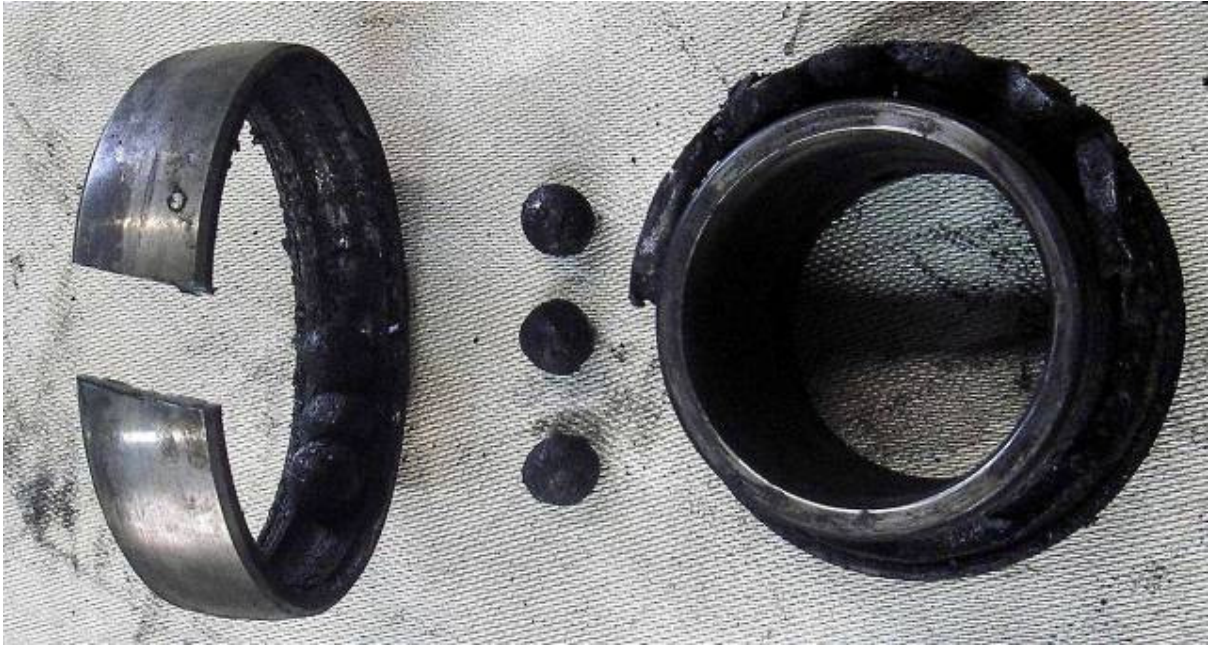
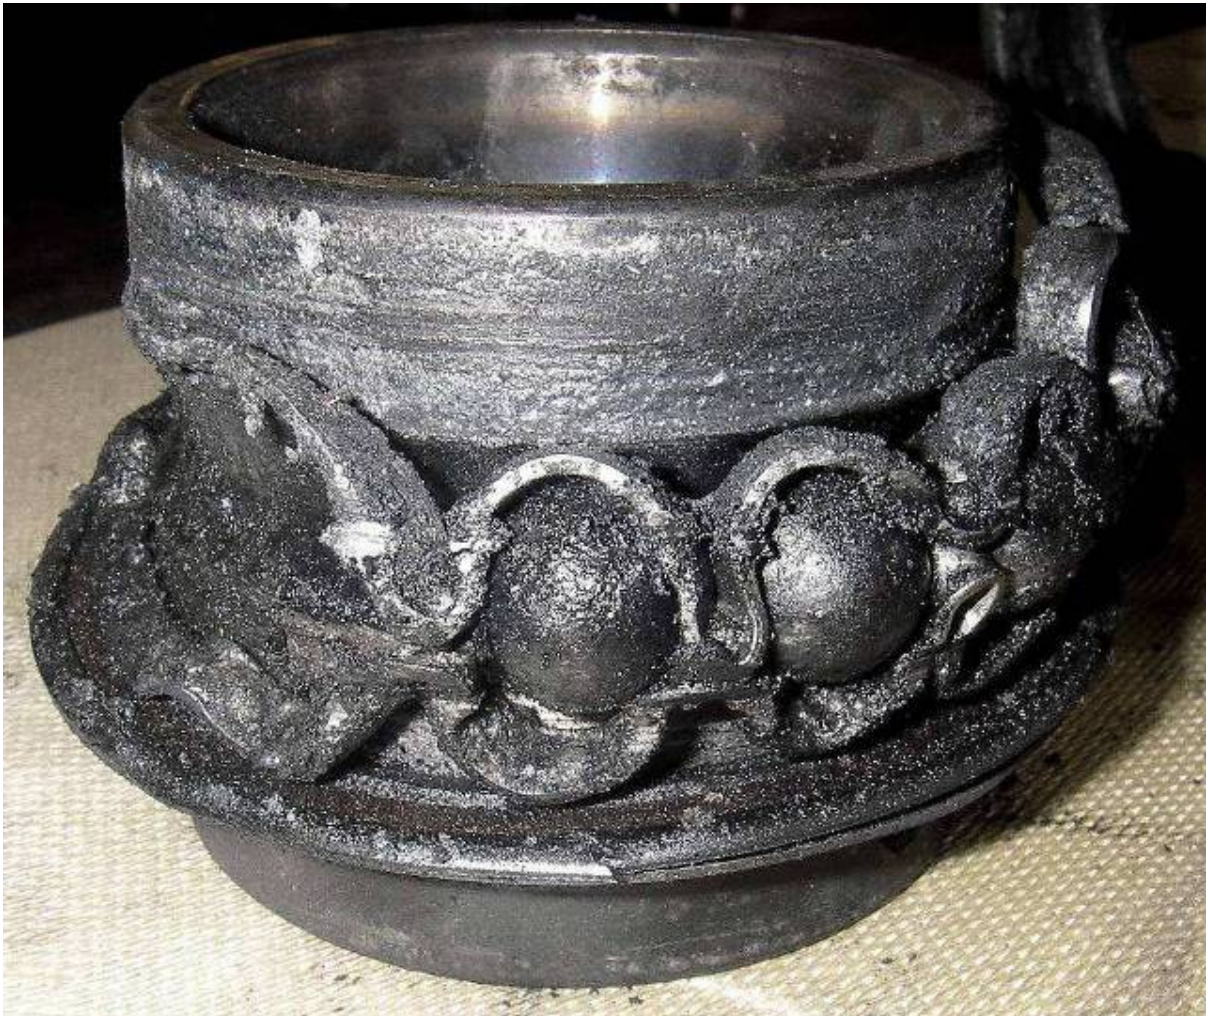
The outer raceway was removed to allow inspection of the cage, rollers, inner raceway and the interior of the outer raceway, see figures 4 & 5. Approximately ½ of the cage that holds the rollers in place was missing. The remainder of the cage was severely damaged and distorted, see figure 6.

Figure 4 Bearing after removal of the outer raceway

Figure 5 Close up of the bearing without the outer raceway

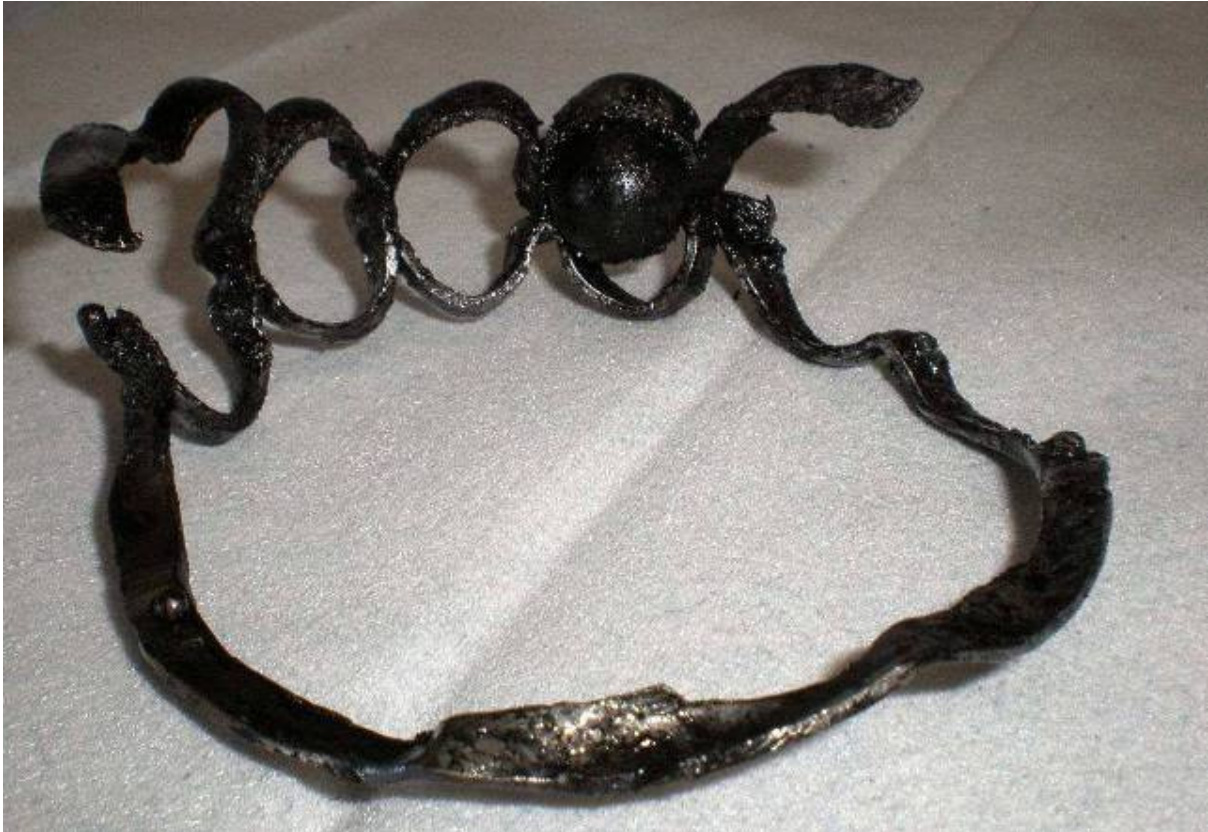
The cage has been almost completely destroyed during operation. There is no evidence of any fatigue on the remaining part of the cage, although there is still significant damage and deposits, which could be obscuring any evidence or the evidence, could be on the piece of the cage that is missing.

Figure 6 Close up view of the remainder of the cage

Check the type of lubricant used and ensure it is correct to the manufacturer's specifications.

Ensure that the correct amount of lubrication is used.

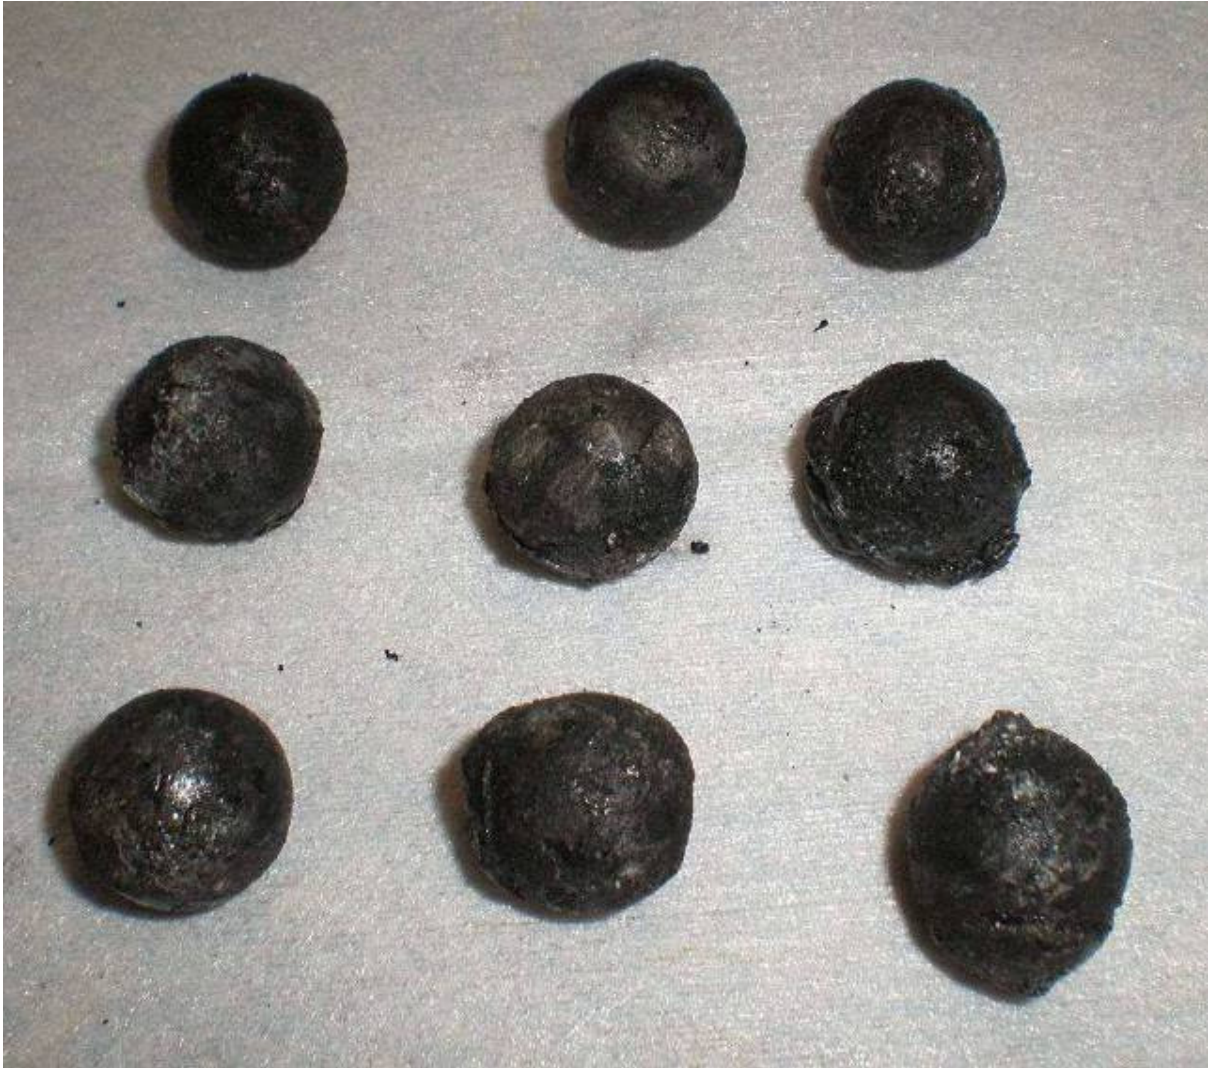
From the cage, there should have been 15-16 rollers within the bearing. On examination, only ten (10) were still present. Four (4) rollers were located within the remains of the cage, three (3) rollers were stuck to the outer raceway and the remaining three (3) were loose when the outer raceway was removed. All of the rollers show signs of damage and wear, with several rollers being badly misshapen, see figure 7. The ball rollers that were recovered from the bearing show signs of plastic deformation and colouring caused by excessive heat see figure 8.

Figure 7 View of the ball rollers; note the severe deformation present in some of the balls

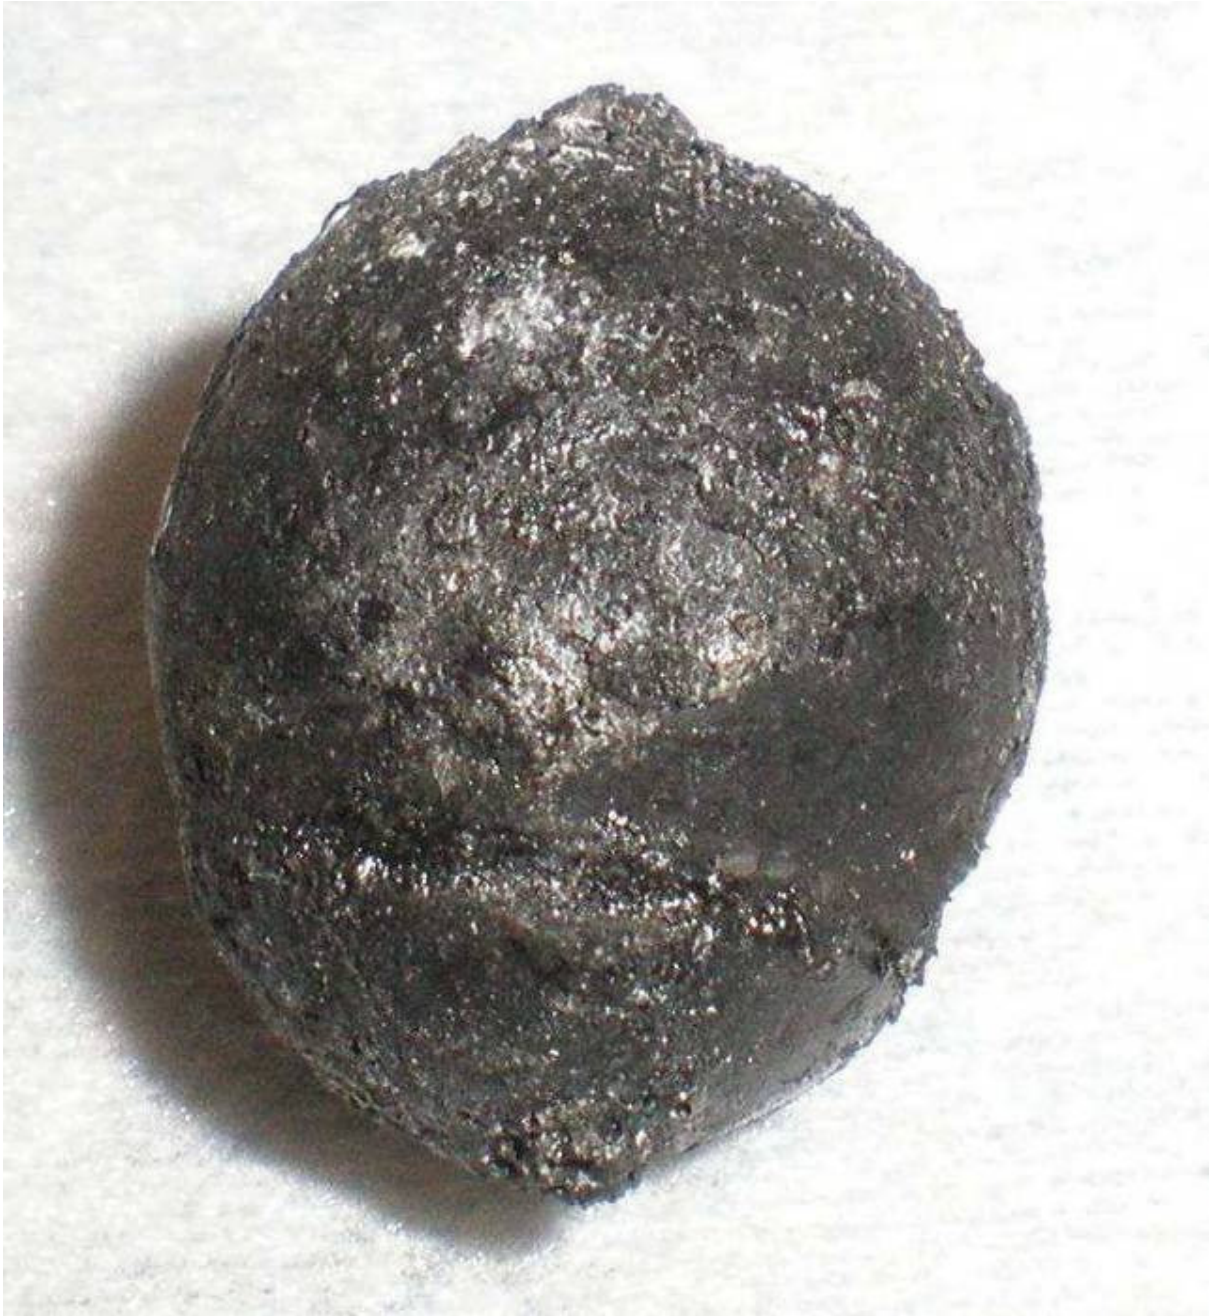
Figure 8 Close up view of a discoloured and deformed roller ball

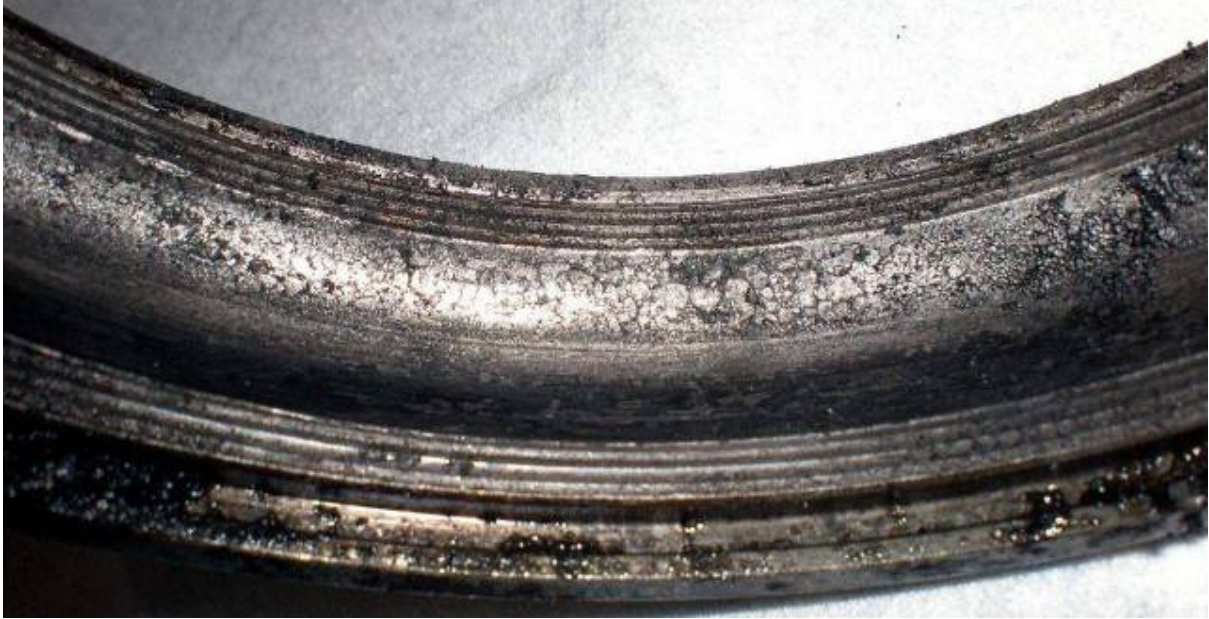
The outer raceway interior is heavily coated in a hardened/carburized layer of grease (from excessive heat). Underneath this layer, the raceway surface exhibits signs of light spalling/peeling, see figure 9. The exterior surface of the outer raceway shows signs of excessive heat, with one area blued, indicating a temperature in excess of 400 °C.

Figure 9 Close up view of the outer raceway spalling

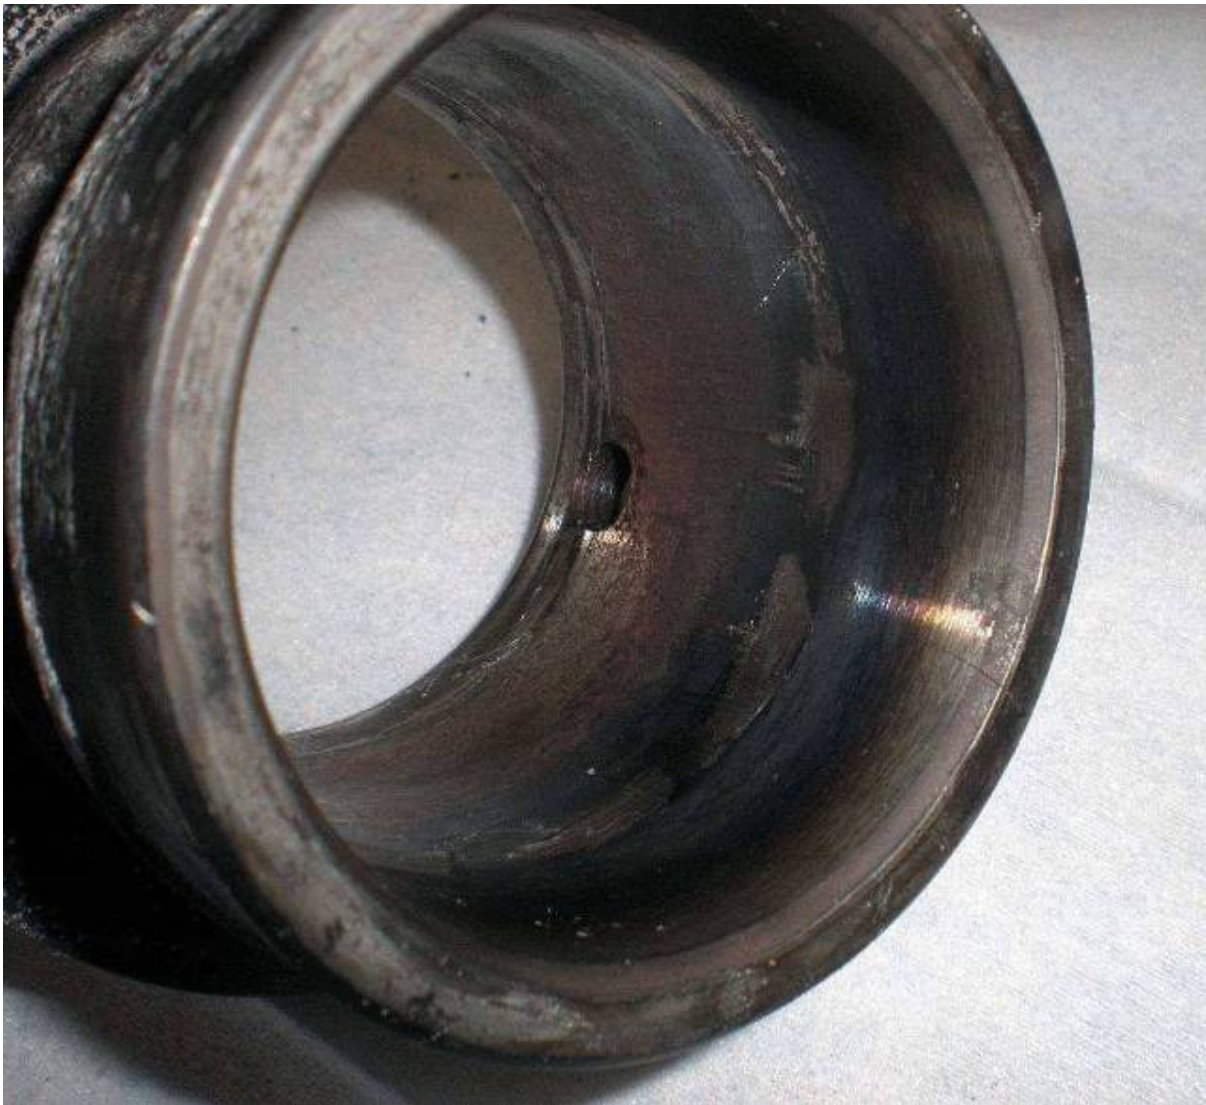
The inner raceway has a similar thick coating of hardened/carburized grease as the outer raceway. After some of the hardened layer was removed, light spalling/peeling was evident on the inner raceway. The interior surface of the raceway that would have been in contact with the driveshaft shows signs of exposure to extreme heat, see figure 10. This heat has caused the material of the raceway to soften resulting in the marks shown in figure 11.

Figure 10 Close up view of the inner raceway heat affected zone

The excessive heat that has been generated in this bearing suggests an inadequate lubrication problem. The bearing has seen temperatures probably in excess of 400 °C, which has softened the material causing failure.

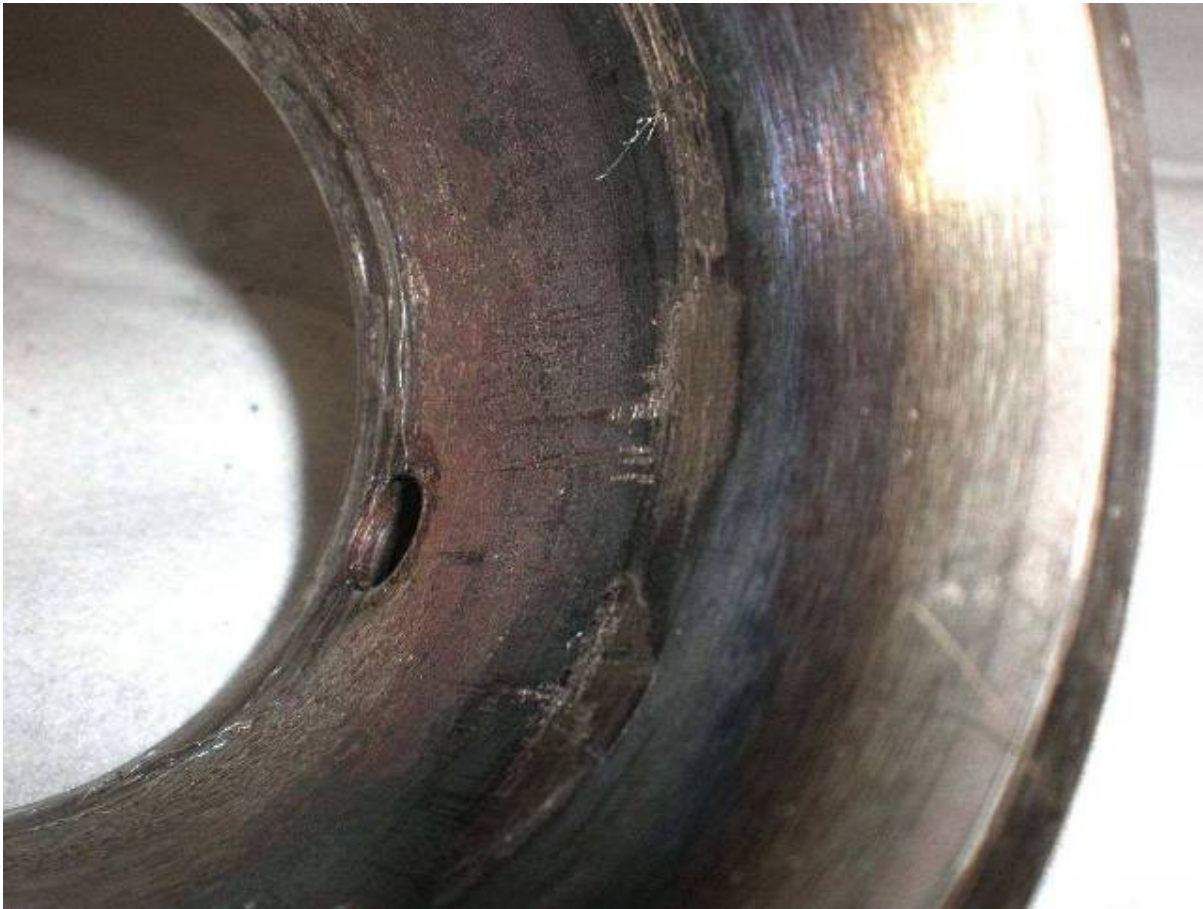
Figure 11 View of the damage caused by the driveshaft
