## **Technical Bulletin / Safety Alert**

**Unique ID No:** TBS2011-TBSA-02

**Subject:** VLI Drifrunner Transport Braking System – Service Brake Diaphragm

**Applicable to:** Design Registered Transport Braking Systems  
(MDR 083991 TBS, MDR 083991 TBS-1 & MDR 096013 TBS)

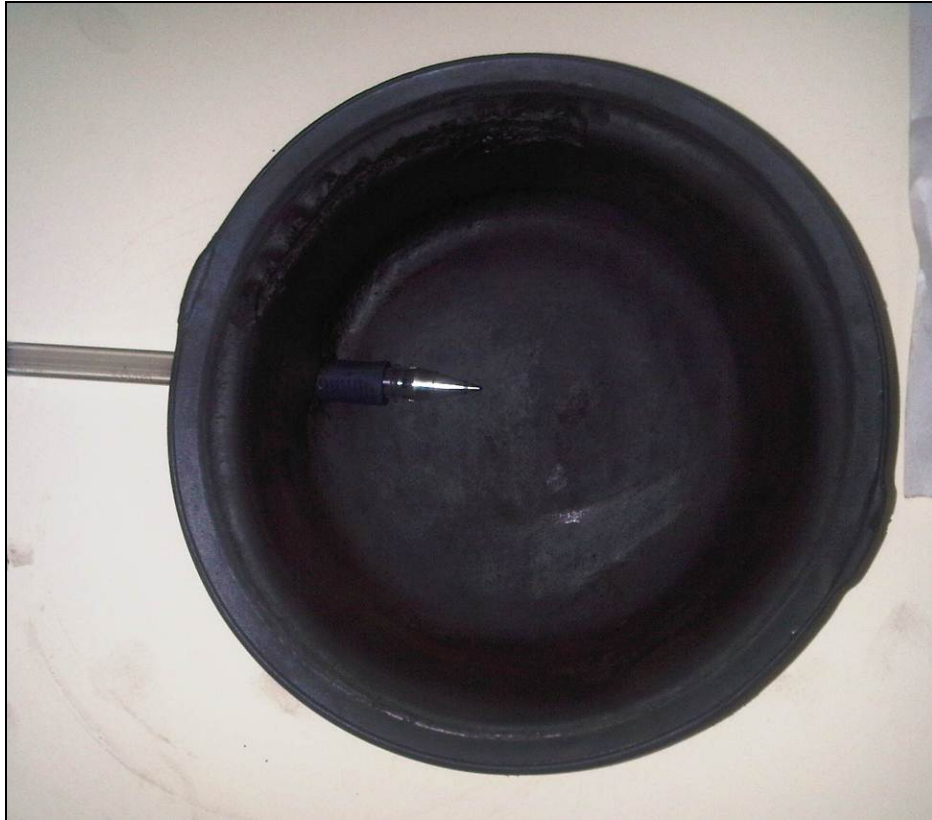
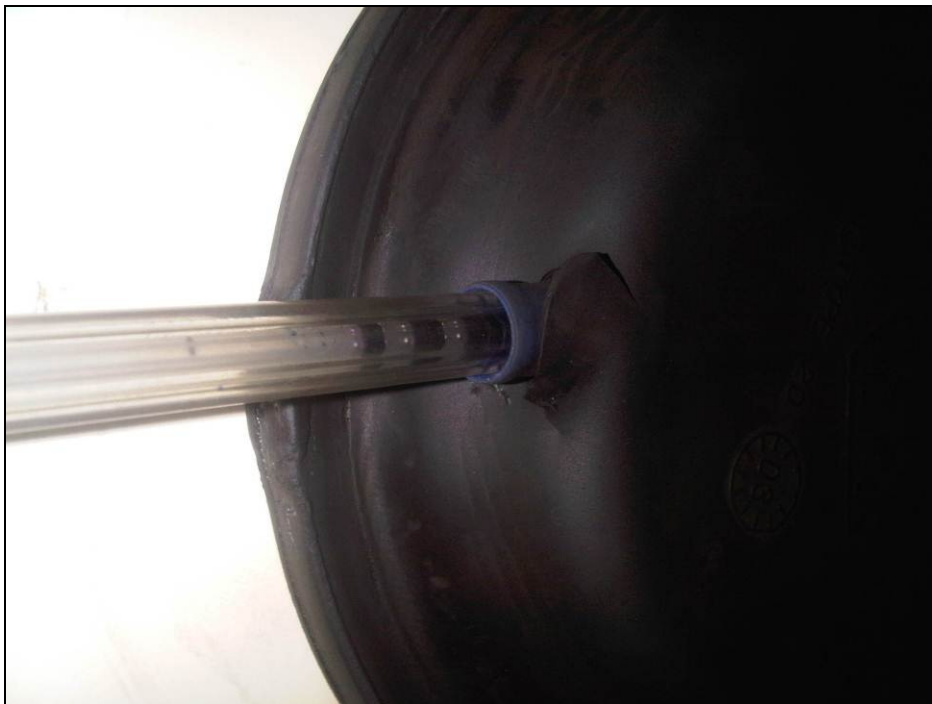
The incident involved the failure of the service brakes of the equipment whilst in operation. The emergency / park brake was used to stop the machine. Subsequent inspection of the brakes identified a hole in one of the service brake diaphragms.

The following images show the service brake diaphragm after removal from the machine, with the hole highlighted.

Based on the age of the machine, the estimated diaphragm component life was 8 years. This was the first known occurrence of a diaphragm failure on a VLIDD machine. Based on the information and evidence received, it was not possible to identify the root cause of the diaphragm failure.

1. As identified within the incident report the system redundancy met the requirement of Safety CAT 3.
2. The diaphragm component was risk ranked in the original design FMEA with no previous failure known. The re-ranking with a known event has changed the likelihood to possible accordingly the ranking is now 2c (18 Medium). In order to reduce this risk ranking to 2d (21 Low) the OEM is recommending a component change out every 5 Years.

Based on the transport braking system design FMEA review and re-ranking of the diaphragm component, following this failure, VLIDD is recommending that service brake diaphragm components are replaced every 5 years.
