## **Technical Bulletin / Safety Alert**

**Unique ID No:** GEN2016-TBSA-01      **Rev:** 00

**Subject:** Driftrunner F&G Series - Bonnet Crush Injury

**Applicable to:** All VLI Driftrunners- F & G Series

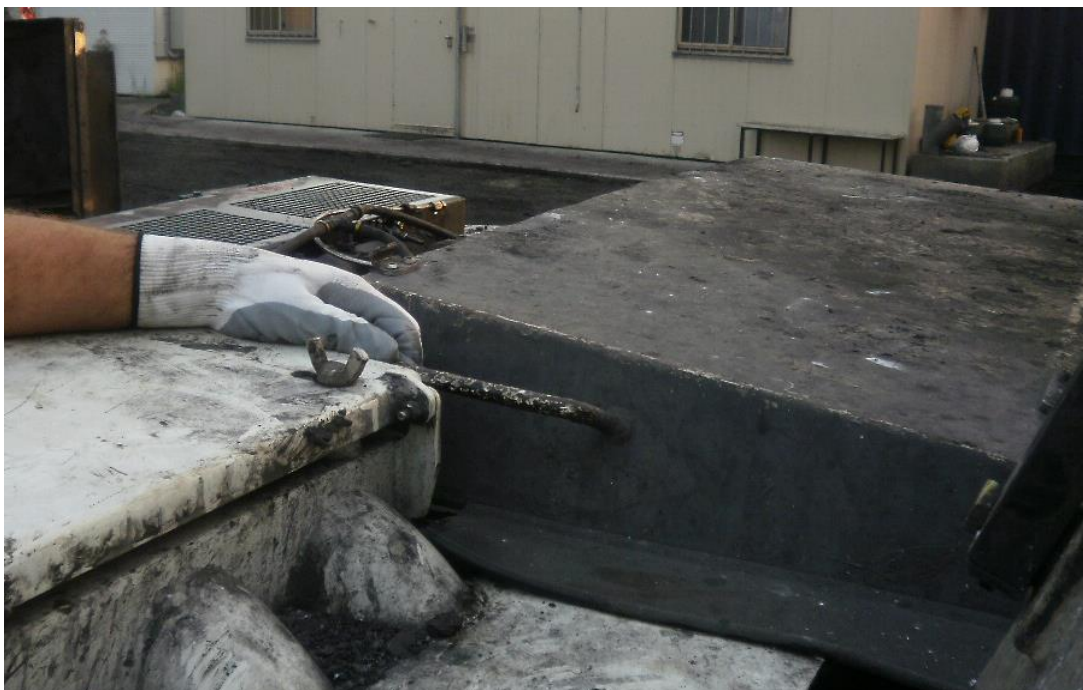
An Operator has sustained a significant injury when he had his hand/fingers lodged between the rear bonnet & the Diesel Particulate Filter Housing on a Driftrunner, whilst he was lowering the bonnet from the Off Drivers Side (ODS).

**Figure 1 - remove handle & grind back flush to remove burrs. Ensure gas strut is fitted to assist bonnet lift.**

- ODS rear bonnet handle removed.
- Gas strut is to be fitted to the ODS to assist the bonnet lift which is now effected from the Drivers Side (DS) of the machine.
- ODS rubber catch lug removed from front bonnet.
- Over Centre catch fitted to the top of the ODS side of bonnets for retention.

Inspect all VLI F & G Series Driftrunners that have a Diesel Particulate Filter Housing installed, to ensure that the above modification to the bonnet has been carried out.

If these modifications have not been carried out, it is recommended that you have this rectified as soon as possible.

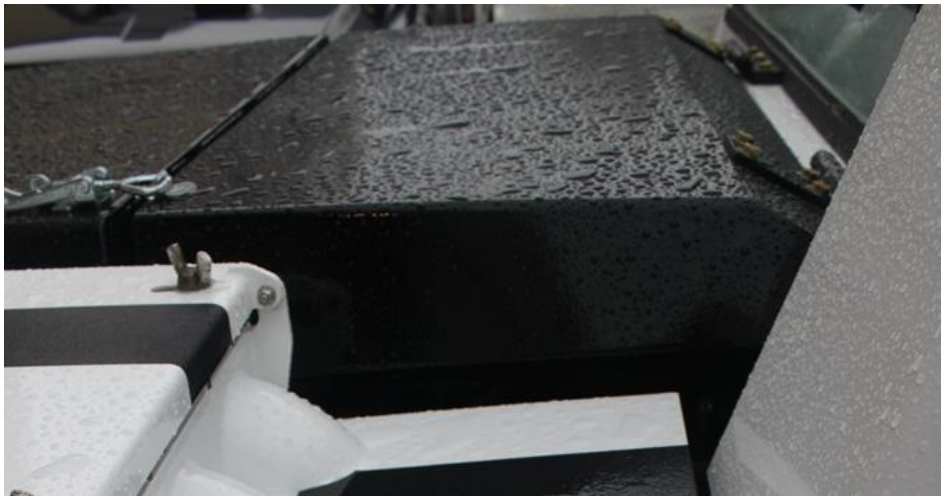
**Figure 2 - completed bonnet view.**
