SAFETY BULLETIN

Ref Document No.	SB14002	Issue No.	1
Subject	Cap Screw Failures		
Release Date	30 May 2014

To advise COALTRAM® owners of possibly faulty socket head cap screws installed in ExDES components.

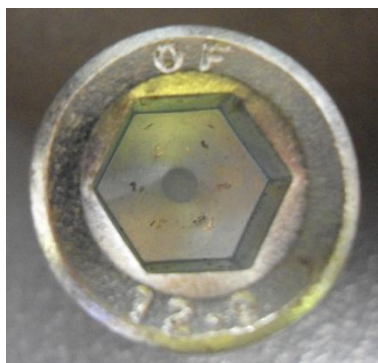
- The cap screws were installed by a different person for each machine.
- The cap screws had been tensioned correctly.
- The tension wrench calibration was tested and deemed to be within tolerance.
- Not all cap screws installed failed. The ones that failed all had the same markings on the head which was different to those that had not failed.
- Failed bolts had "OF" stamped on head.

- The failed bolts were traced to an order and batch of bolts delivered to

PPK 30/03/14.

1. COALTRAM® LHGW854 at Westcliff and LH6040 at Newstan need to be checked for faulty cap screws at the first available convenience. This will require checking the exhaust manifold, removal of the catalyst to check the turbo adaptor plate and removal of the exhaust manifold to check the exhaust manifold adaptor plate.
2. If cap screws are found with the same head markings as the failed cap screws they should be replaced. If none are found the engine may be re-assembled.
