ENGINEERING BULLETIN

Ref Document No.	EB15002	Issue No.	2
Subject	Load Frame Pins		
Release Date	3 rd September 2015

Purpose – Advise COALTRAM® owner's of a revision to the recommended replacement intervals for load frame pins and split cap bolts.

Applicability – COALTRAM® models CT10, CT10LP and CT08

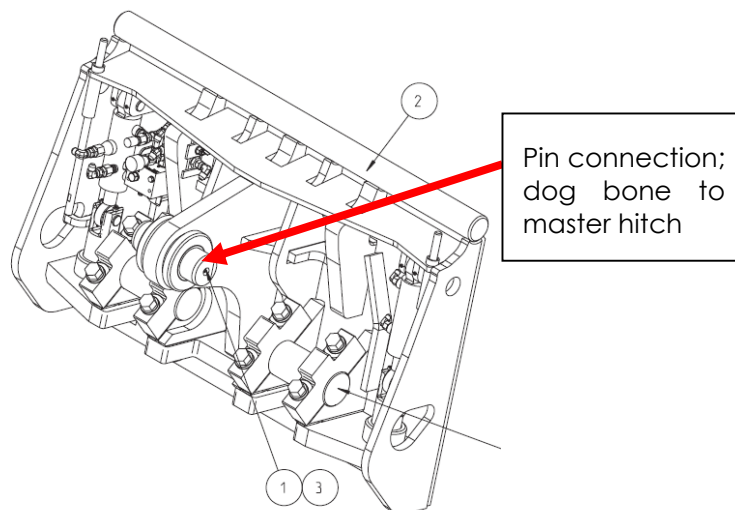
Figure 1: Location of pin failure

The pin failure occurred on a Coaltram CT10 reported to have completed over 13,000 hours of operation. The pin that failed was at the connection between the dog bone and master hitch as shown in figure 1 below. This pin is the same used across all Coaltram CT10 master hitch's; QDS, KAT, RAS

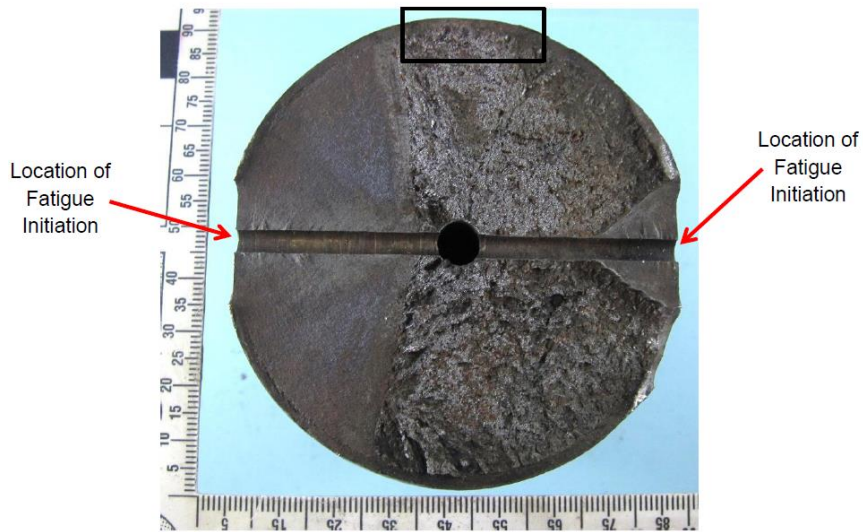
Figure 2: Fracture face of broken pin

The pin failed due to fatigue with cracks beginning from the grease points (see figure 2). The original design of the pin had the grease porting drilled through the whole diameter of the pin and the orientation of the grease port was located at the position of maximum bending stress. The design of the pin has been revised, re-orienting the grease porting to the position of least bending stress and the porting is now drilled to exit on one side of the pin only (see figure 3).

1. CT10 - 8,000 hour service:
 - a. Crowd cylinder pins should be ultrasonic tested for cracking and inspected for wear. This includes all pins between the crowd cylinder and attachment to the master hitch. If the pins are **not** ultrasonic or non-destructive tested, they should be replaced.
 - b. **IMPORTANT** - If ultrasonic testing reveals grease porting drilled all the way through the diameter of the pin, the pin should be replaced.
 - c. All split cap bolts used for retaining pins relating to master hitch crowd function should be replaced. (Split cap bolt kit part number 5520009362).

2. CT10 - 12,000 hours:
 - a. Ultrasonic testing of all pins for cracking and inspection for wear. If Ultrasonic testing is not completed, PPK recommend replacing all pins.
 - b. Replacement of all split cap bolts, excluding crowd cylinder split cap bolts. (Split cap bolt kit part number 5520009704)
3. CT10 - 16,000 hours:
 - a. Replace all connection pins. (Pin kit part number 5520009581 – kit contains pins and seals. Bushes should be inspected and replaced as required).
 - b. All split cap bolts used for retaining pins relating to master hitch crowd function should be replaced. (Split cap bolt kit part number 5520009362).
4. Follow PPK service sheets for all other recommended maintenance.

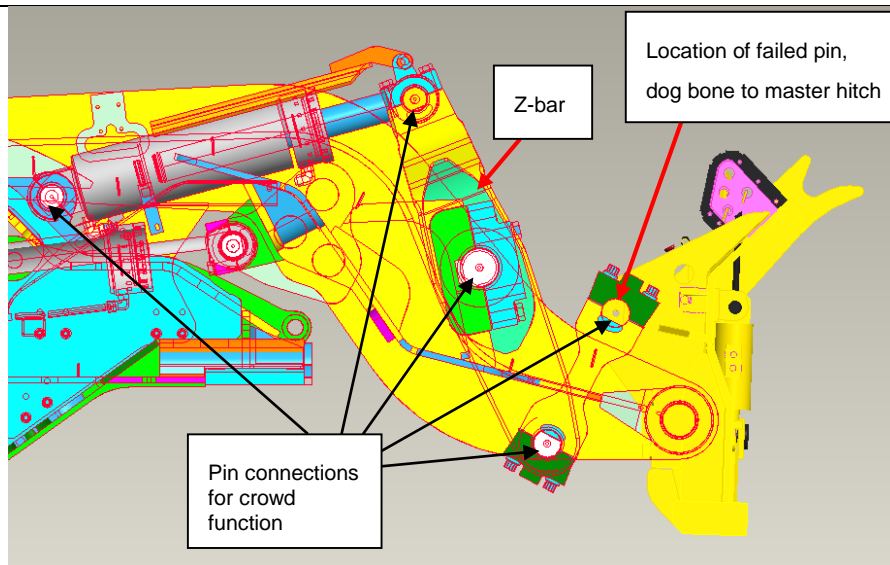
Figure 4: CT10 Crowd Linkage

The Coaltram CT10 has a different crowd mechanism to the Coaltram CT08 and CT10LP vehicles. The CT10 crowd cylinder attaches to and operates through a Z-bar arrangement using additional linkages and pins to attach to the master hitch. The CT08 and CT10LP crowd cylinder connects directly to the master hitch. The differences are illustrated in figure 4 and 5 below. There has not been any recorded failures of pins on the CT08 or CT10LP vehicles.
