## SAFETY BULLETIN

| Ref Document No. | SB15002 | Issue No. | 1 |
| Subject | Steer Amplifier Valve | | |
| Release Date | 11 <sup>th</sup> February 2015 | | |

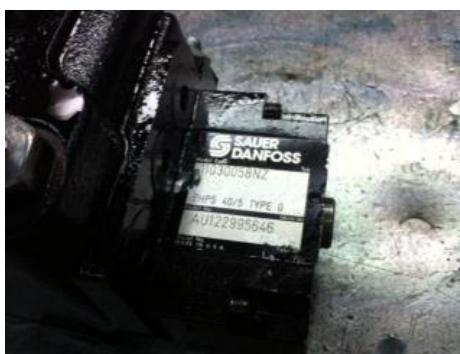
Figure 1: Serial Number

1. Check steer amplifier valve for affected serial number range:
  - a. The first three or four numbers are the critical numbers in the serial number. The first two are the year it was manufactured in, the third and possibly fourth numbers are the month of that year (depending on which month it was made in). For example AU122995645 means it was built February 2012;
  - b. Steer amplifier valves assembled after February 2014 will not require any dismantling, COALTRAM® should be used as normal;
  - c. Steer amplifier valves assembled before February 2014 should follow recommendations two and three below.
