Technical Bulletin / Safety Alert

Unique ID No: TBS2013-TBSA-01 Rev: 1

Subject: JUG-A-0 Unplanned Movement - Incident Notification

Applicable to: Design Registered Transport Braking System. (MDR089245TBS & MDR108880TBS-1)

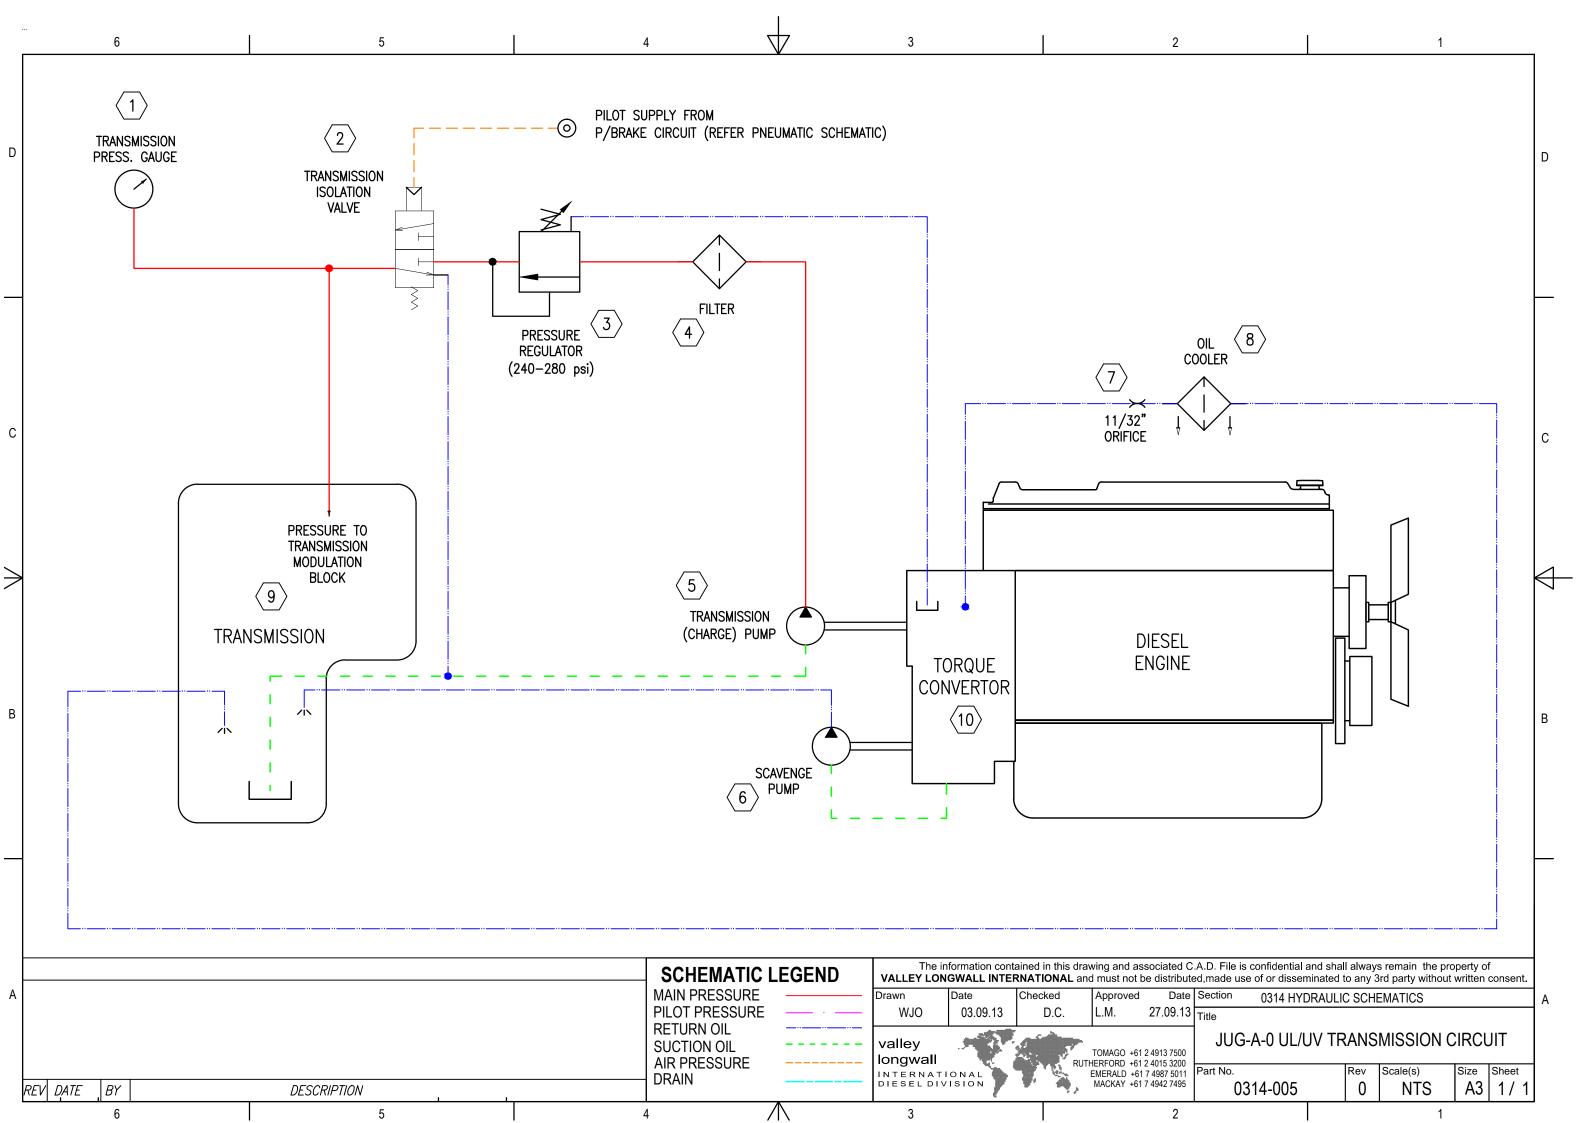
SECTION 0314-005 TRANSMISSION CIRCUIT

VLI have concluded that the current de-clutch function should be retained and that a transmission isolation valve be included in the transmission hydraulic circuit as an additional means of transmission isolation. This arrangement also provides redundancy for both the de-clutch valve and the transmission isolation valve.

The addition of the transmission isolation valve to the transmission hydraulic circuit is an additional layer of protection to the existing equipment design.

VLI recommends all equipment owners and end users consider upgrading their JUG-A-0 UL/UV vehicles to include the transmission isolation valve at the next major service interval. Revised parts pages and circuit drawings will be supplied with upgrade components.
