PRODUCT TECHNICAL BULLETIN

COALTRAM CT08 CT10 CT13

Exhaust Leak at the Exhaust Conditioner to Exhaust Pipe fixed joint

Ref Document No.	TB12001	Issue No.	1
Release Date	November 2012

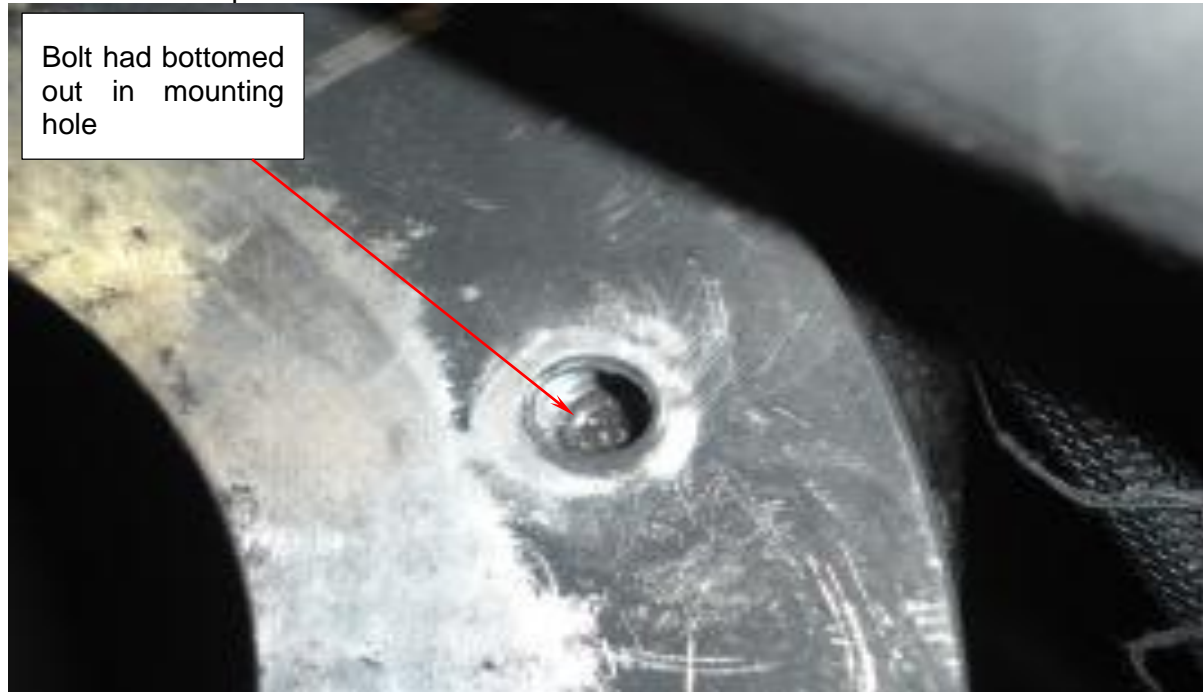
During a routine service the fixed joint was inspected using soapy water. Several small bubbles were observed at the joint between the gasket, exhaust conditioner and exhaust pipe. The vehicle was in service for over 6 months and had passed weekly checks.

Further investigations found that the vehicle was fitted with 3/8" x 1 1/4" (Part No 5530755000) socket head cap screws. The threads were binding in the exhaust conditioner mounting flange. When the bolts were removed from the exhaust conditioner mounting flange a witness mark was evident at the bottom of the blind threaded holes and on the end of the bolts.

The bolts binding, reduced the clamping pressure on the joint gasket and after a period of time an exhaust leak developed at the fixed joint. As the thickness of the scrubber flange may alter due to manufacturing processes, the overall depth of the bolt hole may vary, which in turn will determine the length of bolt required to allow sufficient thread engagement without binding.

The in service repair consisted of replacing the bolts with 3/8" x 1 1/8" (part no. 5520003968) socket head cap screws and tensioned to rectify the issue.

1. All COALTRAM owners and end users are to contact the DMS Service Department to schedule an inspection as soon as practicable.
2. All end users are to inspect the exhaust conditioner to exhaust pipe joint on a weekly basis with soapy water to insure no exhaust leaks, until DMS have inspected the exhaust joint.
3. At the earliest opportunity the joint retaining bolts shall be individually removed by DMS Service Department personnel and inspected to ensure correct thread engagement without binding.
4. If there is evidence of bolts binding they are to be replaced with the shorter 3/8" x 1 1/8" SHCS bolts and tensioned. Installation procedures and verification check reports will be used by DMS Service Department to ensure a satisfactory outcome to the corrective action. Refer TB12001 Addendum - Inspection Form
