Technical Bulletin / Safety Alert

Unique ID No: GEN2008-TBSA-03 **rev:** 0

Subject: Operator Covered in Hydraulic Oil

Applicable to: All JUG-A-0 UL/UV "V1" & "V2" Machines

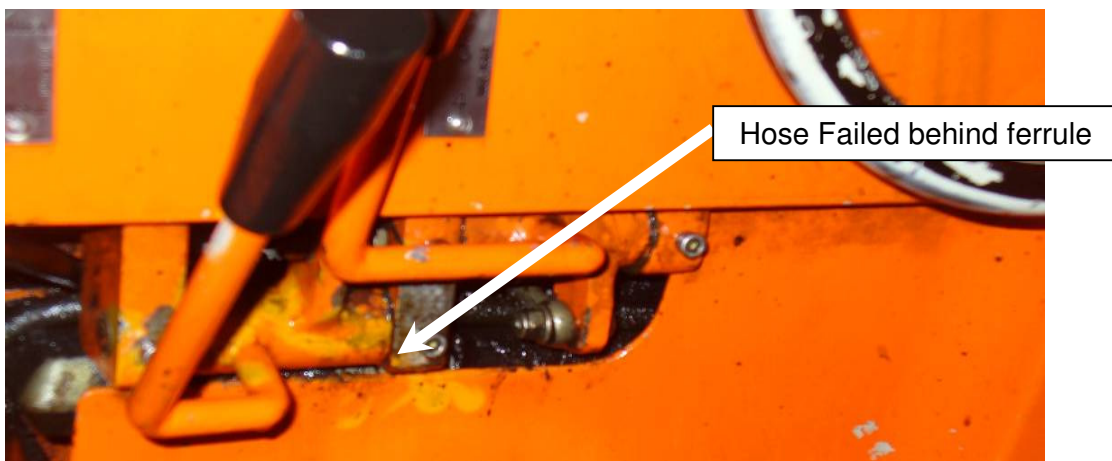
A nightshift operator was operating a JUG-A-0 when a hydraulic hose blew behind the ferrule and sprayed hydraulic oil through a hole in the cover and covered him in the oil. The hose contains a maximum working pressure of 2700 PSI. The cover is shown below and point of failure is indicated.

Cover at least the first 300mm of this end of the hose with burst sleeve.

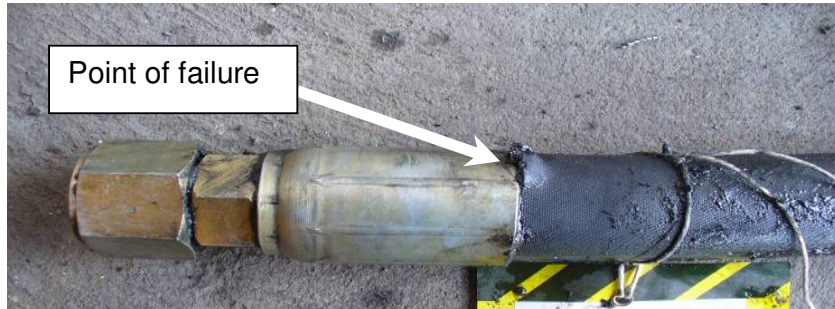
The hose was replaced with a hose fitted with suppression sleeving as per the Colliery standard. The hose failure is shown below.

As the system has the capability of going to 2800psi the hose that failed is under rated & should not be used. The failed hose has ruptured at the end of the ferrule where it has either "worked" through, its length was too short, or the assembly process was incorrect. These are all possible causes that could lead to hose failure.

End users should inspect all of these hose assemblies to ensure they are the OEM standard, part no. 0312-10028.

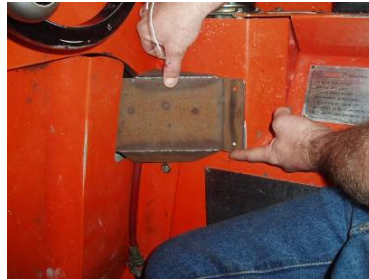
Identified in this incident was the potential for any exposed joystick hoses to generate a similar incident. To prevent this it is recommended to fit the cover shown below. Part no. 0508-50043.
