Technical Bulletin / Safety Alert

Unique ID No: DES2012-TBSA-04 **Rev:** 1

Subject: MDR090376DES Exhaust System - Incident Notification

Applicable to: VLI Diesel Pty Ltd Diesel Engine Systems covered under design registration no. MDR 090376 DES (Drifrunner & Brumby)

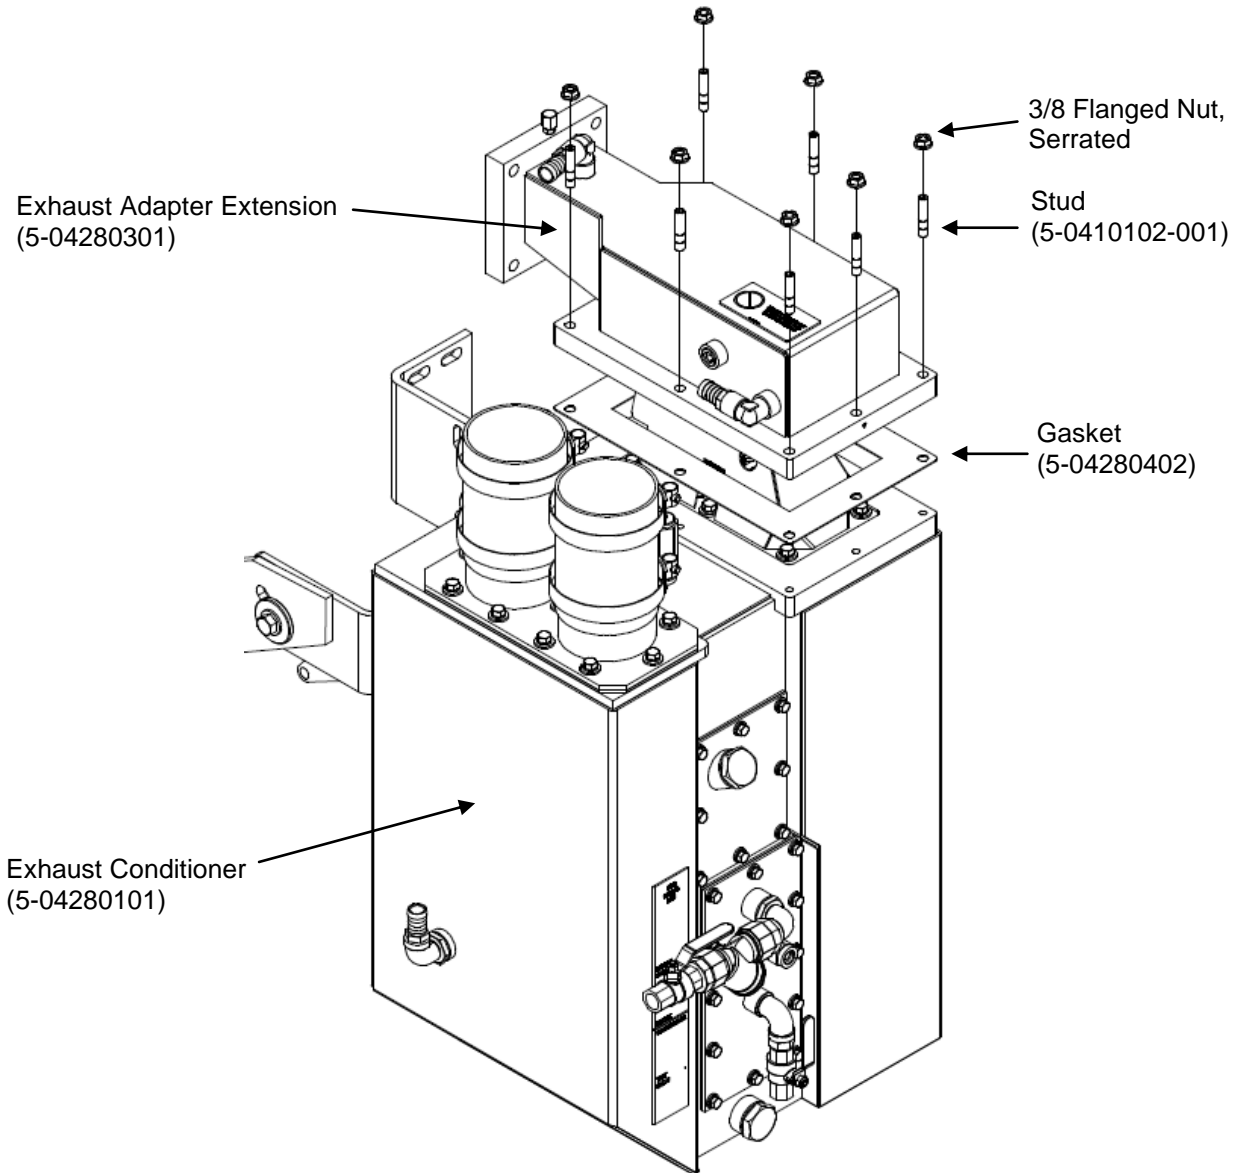
Figure 1: MDR090376DES Exhaust Conditioner Assembly

Investigation of the incident by VLI identified that machining to the mounting flange on the exhaust conditioner tank had reduced the depth of one of the threaded bolt holes to the minimum nominated tolerance; subsequently the bolt appeared to have become thread bound at this location, resulting in the reported leaking joint. It was considered likely that the joint integrity was intact on initial installation, and that subsequent in-service thermal cycling had resulted in the failure of the joint integrity.

Upon review of the exhaust conditioner tank to exhaust adapter extension assembly design and the allowable minimum tolerances of the component flanges, it was identified that there was potential for the thread engagement of the nominated bolts to render them thread bound.

The revised fastener installation for the exhaust adapter extension to exhaust conditioner fixed joint is shown below:

To address the potential for the issue that resulted in the incident described above, VLI has developed a stud fastener (Part No. 5-0410102-001) to replace the previously used hex head bolts in this position.

All new Design Registered Diesel Engine Systems, MDR090376DES, to include the stud fastener (Part No. 5-0410102-001).

VLI recommends that end users and equipment owners of Design Registered Diesel Engine Systems, MDR090376DES, install the stud fastener (Part No. 5-0410102-001) at the next scheduled Code D mechanical inspection.
