# ENGINEERING BULLETIN

Ref Document No.	EB15003	Issue No.	1
Subject	Deutsch DT Series connectors used on the MONEx System		
Release Date	16 <sup>th</sup> February 2015

To notify Coaltram® users of the importance of maintaining the condition / IP67 rating of the Deutsch DT Series connectors used on the MONEx System.

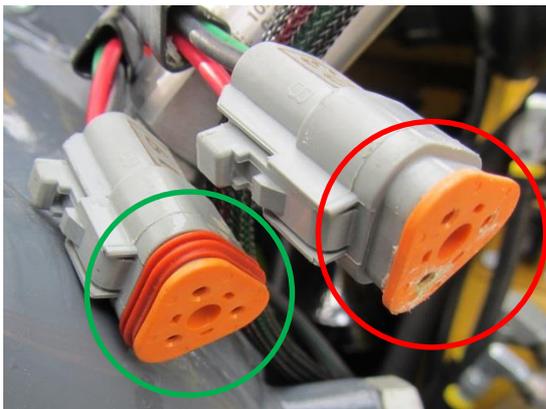
Root cause analysis revealed missing seals and missing blanking plugs as the cause of the contamination and corrosion. Below is a series of examples found on in service COALTRAM®'s.

The following figures show a missing seal (Figure 1) and an O-ring fitted in lieu of the manufacturers seal (Figure 2) on 3-pin Deutsch plugs.

Figure 1 - Missing Seal

PPK recommends thorough cleaning and / or replacement of contaminated Deutsch connectors, seals and blanking plugs to minimise the likelihood particle and fluid ingress which results in erroneous and intermittent faults. The following examples show a Deutsch 3-pin connector plug seal (Figure 9 - Part No: 5520009482), a Deutsch 6-pin connector plug seal (Figure 10 - Part No: 5520009483), a Deutsch 6 Pin Blanking Plug (Figure 11) and correct fitment of the blanking plugs (Figure 12).

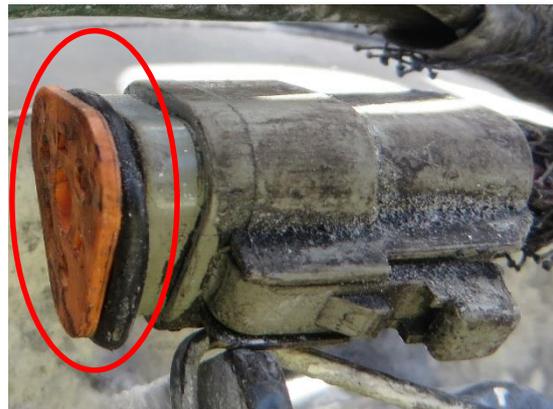
Figure 2 - O-ring

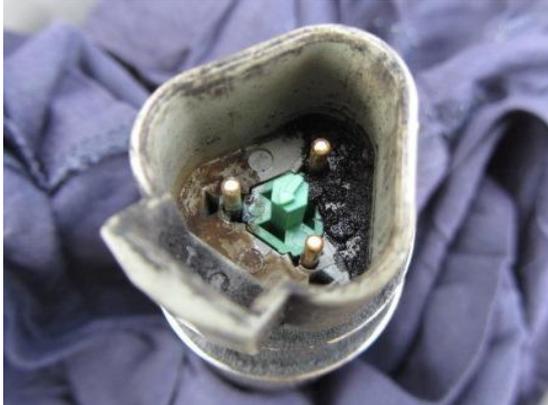
The following figures show particle ingestion (Figure 3) and liquid ingestion (Figure 4) introduced as a result of the missing seals.

**Figure 3 - Particle Ingression**

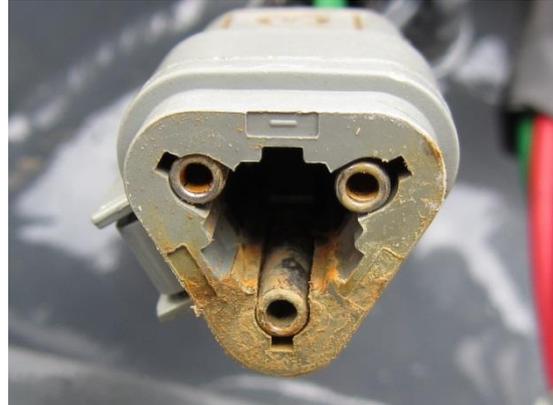
**Figure 4 - Liquid Ingression**

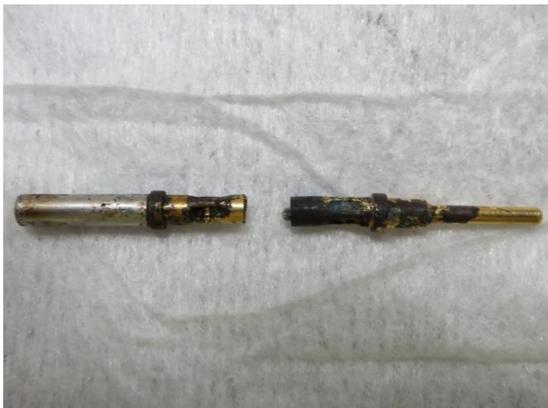
The following figures show corrosion and contamination (Figures 5 and 6) as a result of the particle and fluid ingestion.

**Figure 5 - Corrosion**

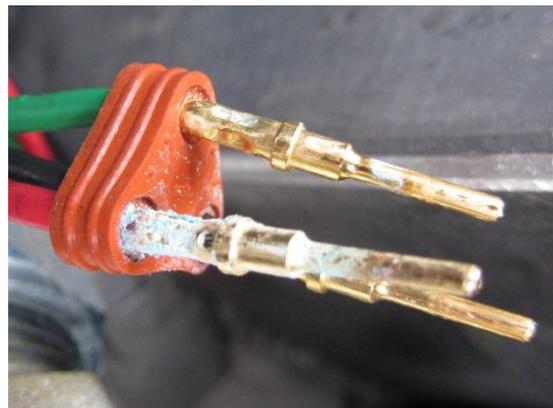
**Figure 6 - Corrosion and Contamination**

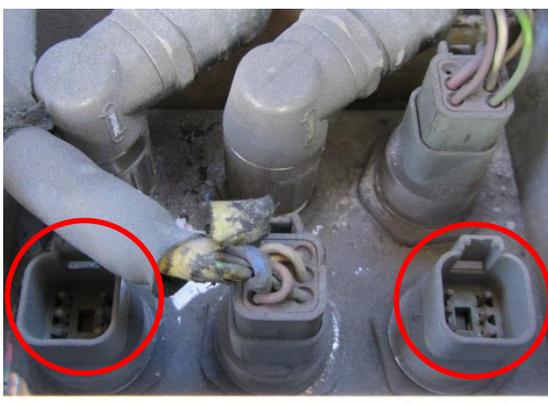
The following figures show missing 6-pin Deutsch connector blanking plugs on the Power Manager (Figure 7) and the resultant contamination (Figure 8) which was causing intermittent faults.

Figure 7 – Missing Blanking Plugs

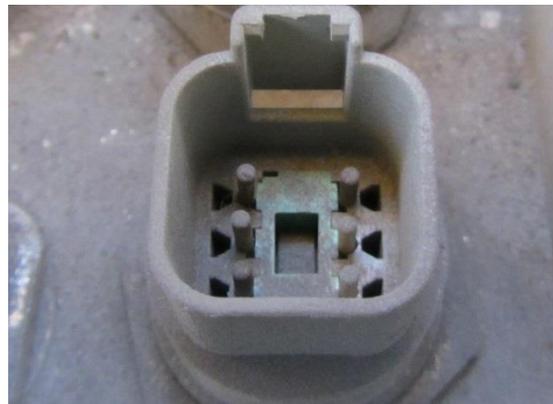
Figure 8 – Contamination
