# TECHNICAL BULLETIN

Ref Document No.	TB15007	Issue No.	1
Subject	Brake Pedal Piston Pin Retaining Clips		
Release Date	21 <sup>st</sup> December 2015

**Purpose** – Advise COALTRAM® owners/operators of a change to the retaining clips used on the brake pedal piston pin.

**Applicability** – All in service COALTRAM® models CT08, CT10, CT10LP and CT13.

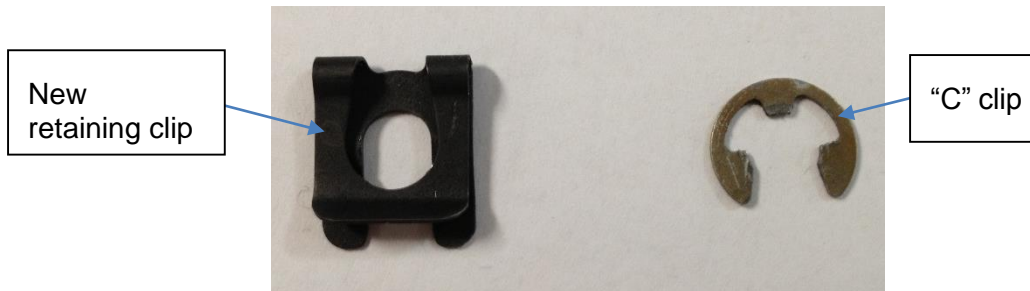
Figure 1: Clip comparison

PPK has sourced a superior clip to retain the pin which can be retrofit by only replacing the clips. The clips sourced have a tab that locks over the pin to prevent it from detaching. See images below for an illustration.

1. Coaltram owners/operators inspect their Coaltrams at the next available opportunity to ensure the "C" clips are in place.
2. At the next available service replace the "C" clips with the new retainers. Two (2) retaining clips will be required per Coaltram. Clips can be ordered from PPK Mining Equipment service part number 552009938. Follow SWP CT6.55 for retrofit procedure or contact your PPK service centre.

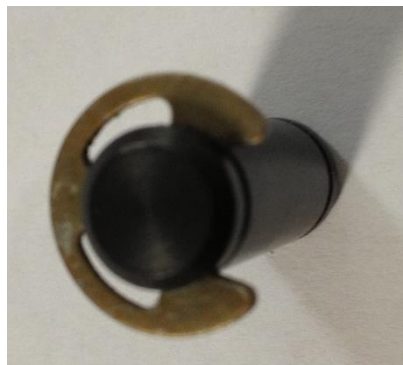
Figure 2: "C" clip installed on pin

The brake pedal in the COALTRAM® is connected to the hydraulic piston via a pin retained with two "C" clips. PPK has received reports of these "C" clips detaching, allowing a possibly dangerous situation if the pin was to disengage from between the pedal and the piston.
