ENGINEERING BULLETIN

Ref Document No.	EB17002	Issue No.	1
Subject	COALTRAM® CT08/CT10LP Lift Cylinder Anchor Point		
Release Date	April 26, 2017

Purpose – Advise COALTRAM® owners and operators of an upgrade available to limit possible damage to the CT08/CT10LP boom lift cylinder anchor point on the load frame.

Applicability – In service COALTRAM® models – CT08 & CT10LP

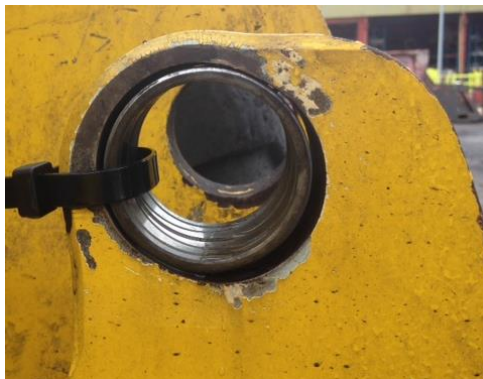
Figure 1

Some Coaltram CT08/10LP's have been experiencing an abnormal amount of wear in the boom lift cylinder anchor points. The bush has remained in-tact and has not worn, though, the hole in the frame has stretched and elongated. Wear has then accelerated as the bush and pin move around in the hole.

See photos below for evidence. Note, the top surface should be flat, not raise before rounding down.

This has been caused by excess force in the retract direction of the lift cylinders. This is most likely caused by an excessive amount of force pushing the boom in the up direction.

Installing relief valves on the rod side of the lift cylinders will reduce the likelihood of requiring maintenance including building up and line boring of the anchor points.

Contact your PPK service centre for pricing on installation or follow the attached SWP CT6.58 in accordance with site procedures. A kit of the required parts is available under part number 5520010199.
