Technical Bulletin / Safety Alert

Unique ID No: GEN2010-TBSA-03 Rev: 1

Subject: JUG-A-0 UL/UV Pneumatic Horn Circuit

Applicable to: All JUG-A-0 UL/UV V2 & V3 machines.

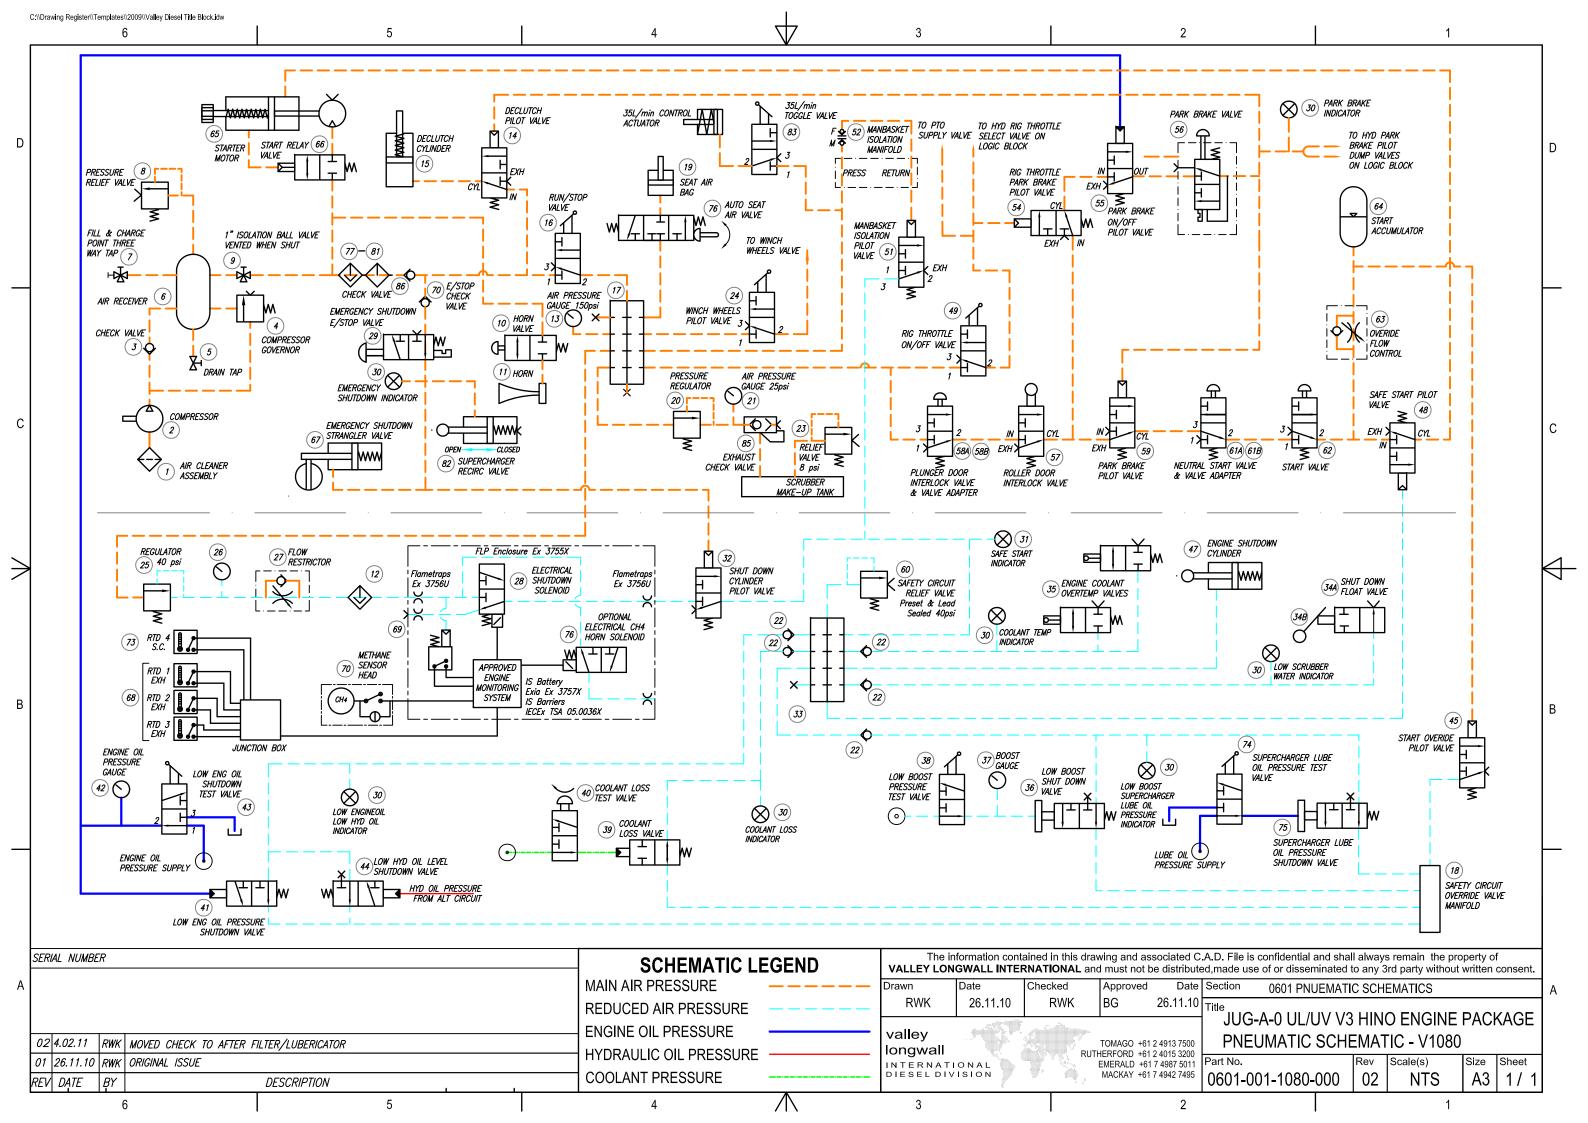
Pneumatic schematic revised.

Investigation of the occurrence described above identified that the rate of air delivery to the circuit containing the horn valve and horn was insufficient to replenish the air being exhausted by the horn, when the horn valve was activated continuously for extended periods. In this case, air pressure in the circuit was able to reduce to less than 60psi, which was the minimum pilot pressure required for the park brake valves.

It is recommended the pneumatic horn circuit is separated from the pneumatic circuit and installed as per the revised schematic shown in Figure 1 below. Figure 2 shows the original installation schematic. The complete revised pneumatic schematic is also attached.
